## Report EXT Andorra 2011

Accident involving  
an AS 350 B3 helicopter,  
registration EC-LHP, operated  
by Heliand (CAT Helicopters),  
in Pleta de Juclar (Canillo –  
Principality of Andorra),  
on 15 June 2011

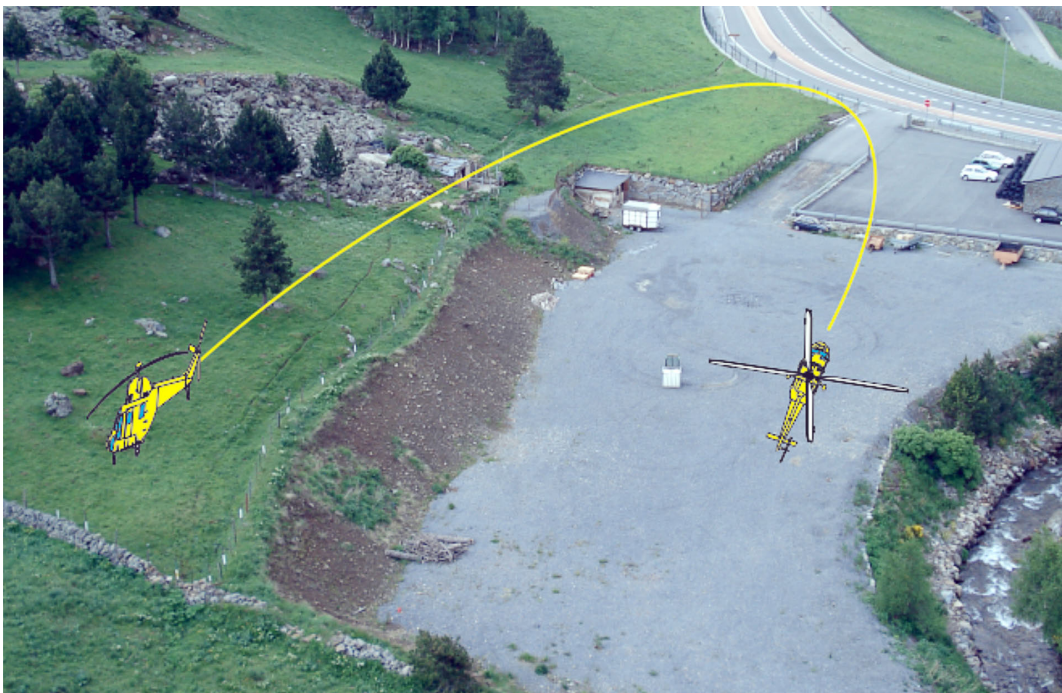
Figure 1. Site from which the helicopter took off for the shelter and where the load was dropped off

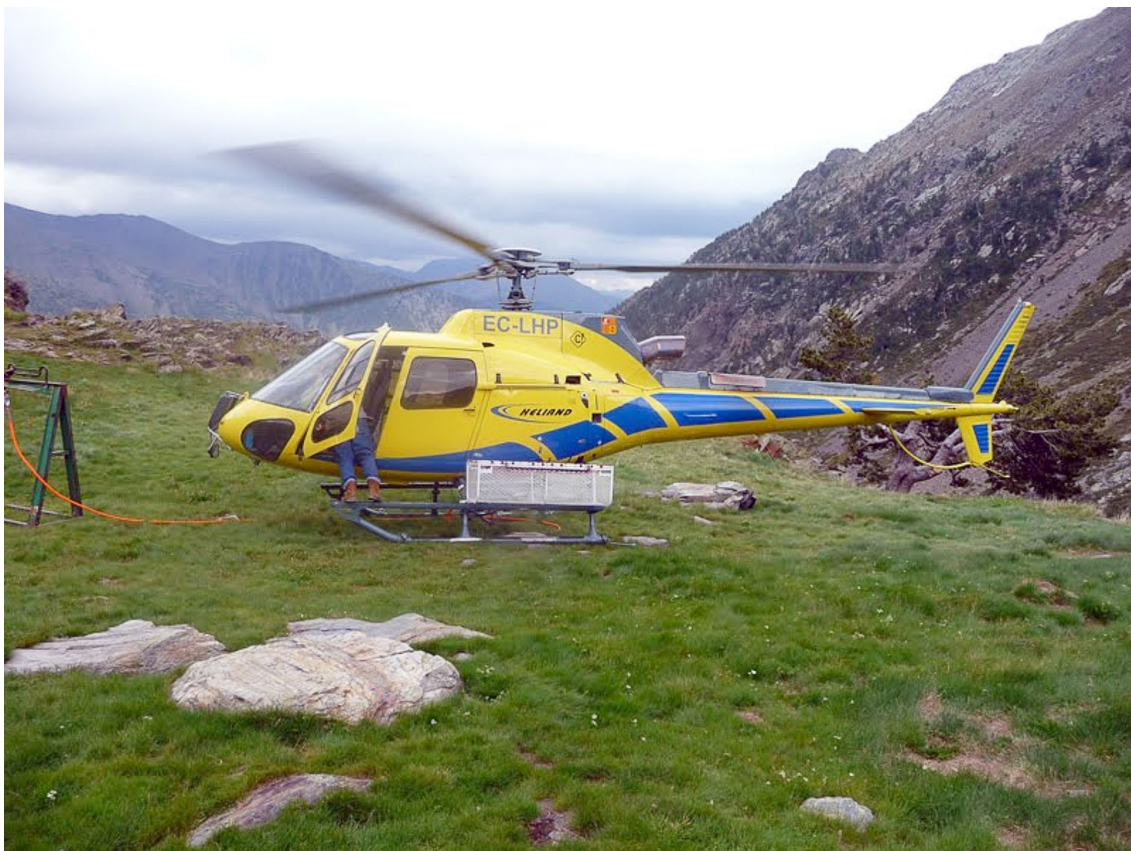
Figure 2. View of the accident aircraft

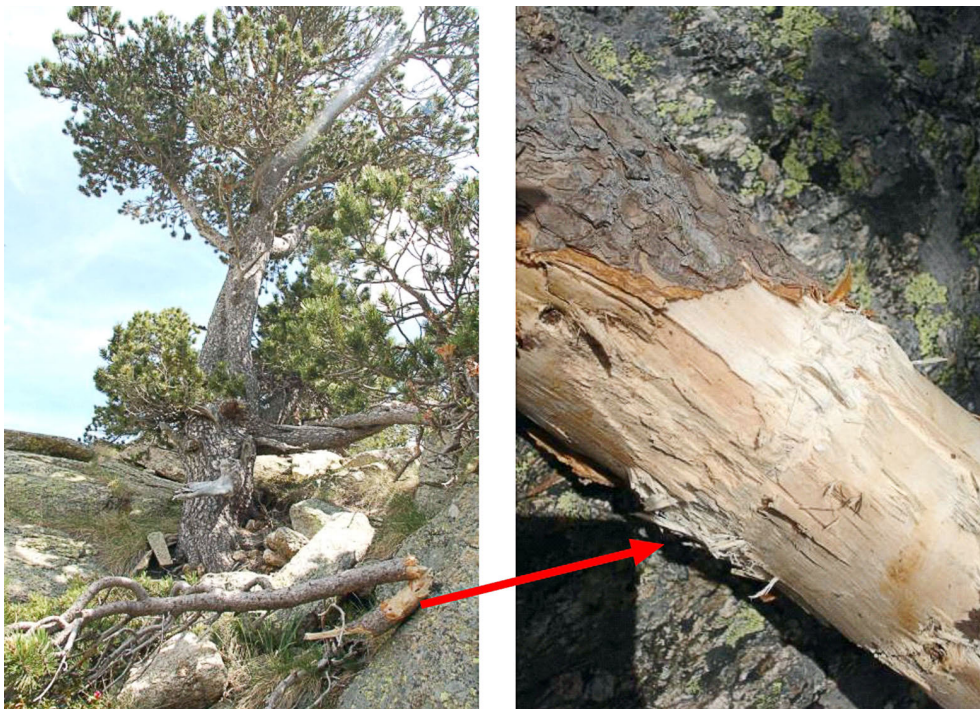
Some 50 m ahead of the wreckage, just at the start of the crag, there was a group of black pines, the branches on one of which were cut. The pine was about 8 m tall and the signs of damage started some 3 m from the top. The broadest and most damaged branch was found torn from the trunk and evidenced signs of friction and abrasion as well as a clear groove around the part without any bark (see Figure 7). Other, smaller branches above this one had also been torn from the trunk and were being held up by the undamaged branches.

Between that pine tree and the impact area there were scattered branches and bits of the polyamide-nylon mesh and core of the sling, the protective plastic sheath of its top end, still bearing a label with the specifications (length, load factor, composition, etc.) and cut lengthwise, as well as blade fragments (fiber and foam) later identified as being from the tail rotor.

Figure 7. Branch abraded by the sling

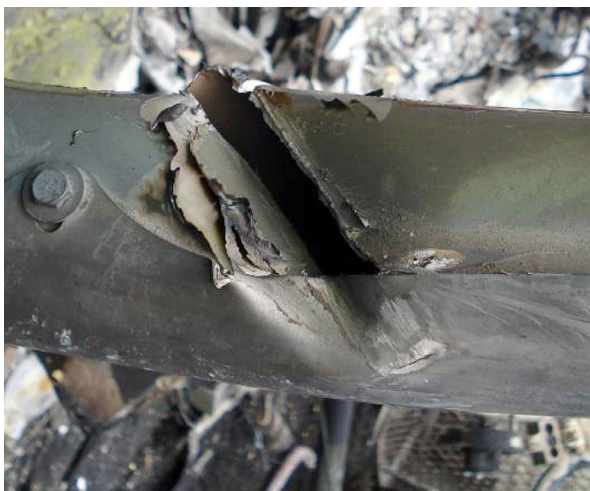
Upon reaching the site of the main wreckage, a pine tree was found with the ends of its branches cut, but not torn out. Also found were the remains of another pine tree that was completely split, there being very little left of its trunk, with the remaining pieces being found between the trunk and the main helicopter wreckage. To the left of the pine tree in the direction of the flight there were three marks on the rock at varying heights, the lowest of them filled with dirt. The average distance between the marks and the split pine tree was about 6 m. Alongside the torn off parts there were components from the floor of the cockpit where the tail rotor control pedals were attached, the pitot tube and dark glass from one of the cockpit doors. The cockpit and the engine were consumed by the fire and were at a 270° angle from the aircraft's original flight path.

Figure 8. Damage to the right skid

The skids and the load hook cradle were facing up. Although subjected to the fire, they retained most of their structure, except for the bottom bar on the cradle, which was found with its rubber coating, and the aft part of the left skid, which was undamaged by the fire and found just ahead of the main wreckage (between it and the impacted pine tree). The aft part of the right skid indicated that the skid structure had been torn off by another metal component (see Figure 8). The load hook was in the closed position with no traces of the sling.

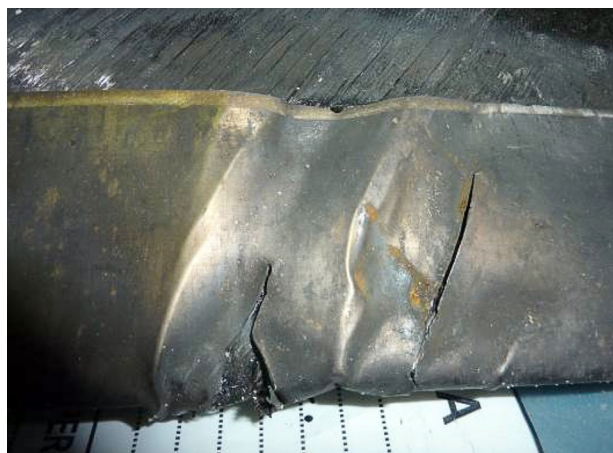
Figure 9. Marks on one of the main rotor blades

The assembly consisting of the main gearbox, the mast and the main rotor was torn from the airframe and underneath the main wreckage. The three blades remained attached to the rotor head. Two of them were damaged by the fire, and one was bent by a rock below the mast. The tip on the left blade was worn and had soil remnants on it. Its tip was damaged. There were two parallel notches, 2 and 3 cm wide, in the burned area of the blade that had been bent. These notches were some 250 cm away from the blade root, on the leading edge of the blade.

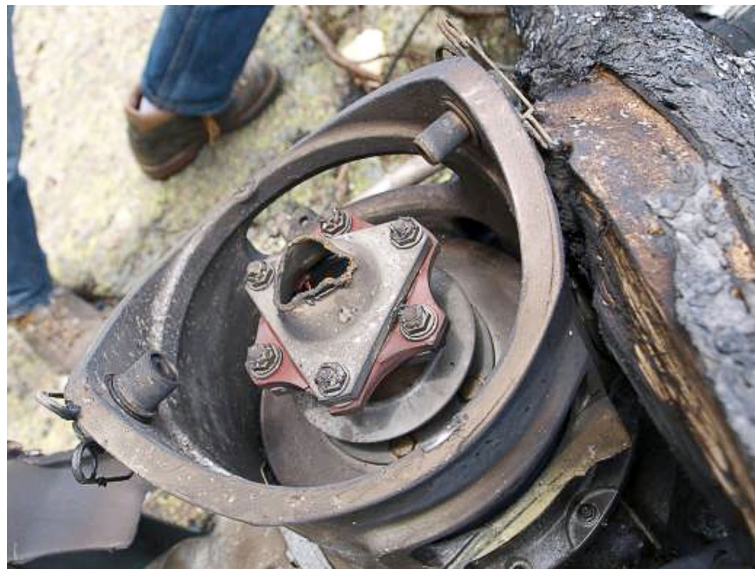
The controls and servos exhibited continuity to the rotor head. The main driveshaft from the engine to the BTP<sup>11</sup> was broken on the BTP side and showed significant signs of twisting stress (see Figure 10). The swash plate assembly had been pushed up toward the rotor head and also showed signs of twisting. The attaching rivets had been sheared off. It was proposed that a detailed inspection of the main gearbox be conducted after the fact so as to rule out any failure of this component.

Figure 10. Fracture of the main driveshaft on the BTP side

The main driveshaft was analyzed in a hangar in an effort to rule out any mechanical faults of this component. This inspection was carried out by experts from the manufacturer, in concert with expert CIAIAC consultants. The conclusion reached was that the damage found was consistent with an impact and that no signs were found indicative of a failure of the main driveshaft components.

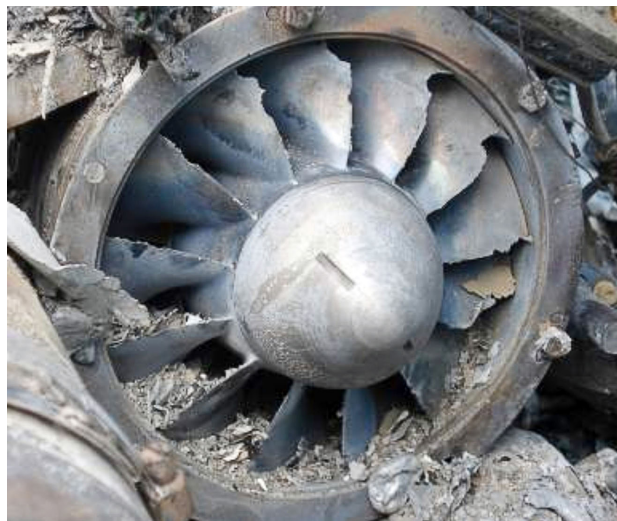
- The damage to the leading edge of the blades on the compressor wheel and the debris found in the direction of the incoming air indicated that the power generating part of the engine was rotating at the time of the incident.
- The main driveshaft from the engine to the BTP had fractured on the BTP side and showed signs of having failed under considerable torsional stress.
- The fracture of the driveshaft resulted in the turbine sudden acceleration up to the design blade shedding speed<sup>12</sup>. The damage found on the reinforced outer casing was caused by the energy of the detached blades.

Figure 11. Damage to the blades

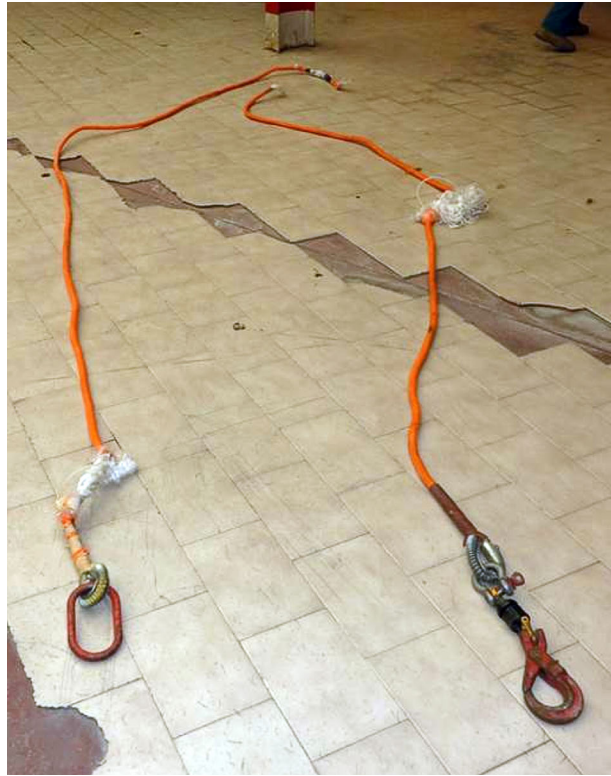
- The remaining 5.5-m long part was still attached to the ring used to hook on to the helicopter.
- The ring was intact and, at first glance, did not show any abrasion. The part used to attach this ring to the sling through a metal reinforcement was missing its protective sheath and parts of the resin-impregnated rope that reinforce the end piece.

- The part closest to the break showed signs of abrasion and there were indications that the sling had been stretched.

Figure 12. Sling

A clean portion of the sling, the paint on the main rotor blade (clean area) and a part of the impregnated sling were chemically analyzed. The findings indicated that the composition of the paint on the blade was the same as that deposited on the sling with the exception of some chlorine and potassium deposits, which could have originated from materials that tainted the samples. The laboratory noted, however, that the technique used was not sufficient to determine scientifically if the paint was the same.

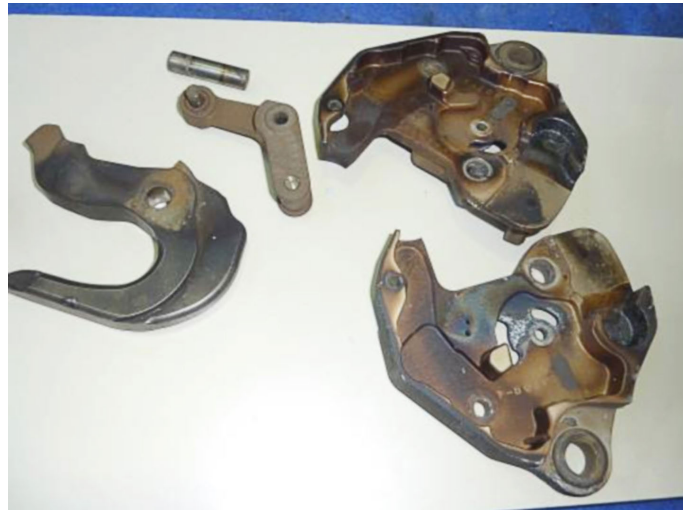
In a similar fashion, the hook was inspected by the manufacturer at the CIAIAC's facilities with CIAIAC personnel present. The hook, despite having been exposed to the fire, appeared to be in fair condition. It was found in the closed position and was not attached to the sling. The electrical connector was destroyed. The bumper was apparently consumed in the fire and the mechanical connector was damaged. There was also a mark on the surface of the latch. The hook remained closed and could not be opened using the manual release handle. It was disassembled. The mechanical wire was properly hooked to the handle, which, although it rotated correctly, would not open the latch. The entire electrical assembly had been damaged in the fire, making it impossible to test the hook for proper electrical operation. Once the covers were removed, the latch was able to move without any problem. The entire length of the actuating wire, from the hook to the collective lever, was accounted for except for 50 cm. In light of the damage found during the disassembly, it was concluded that the hook had not been opened by an overload condition.

The possibility remains that the geometric configuration of the hook and the sling hooking system (end piece, end cap and plastic label listing the characteristics of the sling) during the landing could have been such that even with the system armed, the sling may not have fully released. The hook would, however, have remained open and the sling could have fallen due to gravity during the flight.

Figure 13. Disassembled hook

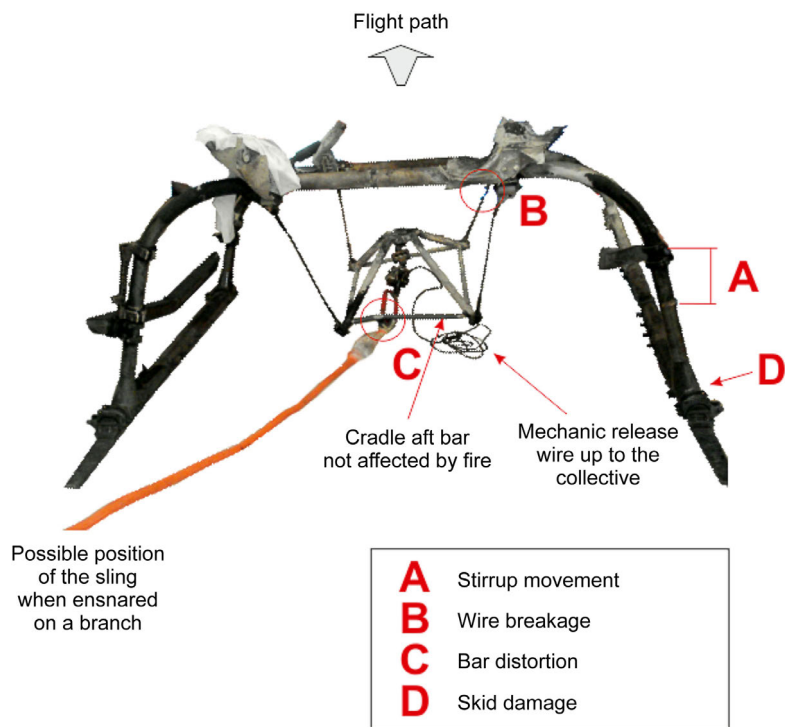
- The force of the rotor blades caused the aft bar on the forward wire of the hook cradle to break. The aft bar was found near the main wreckage, alongside the impacted pine tree and it was not damaged by the fire.

Figure 14. Damage to the hook cradle and skids

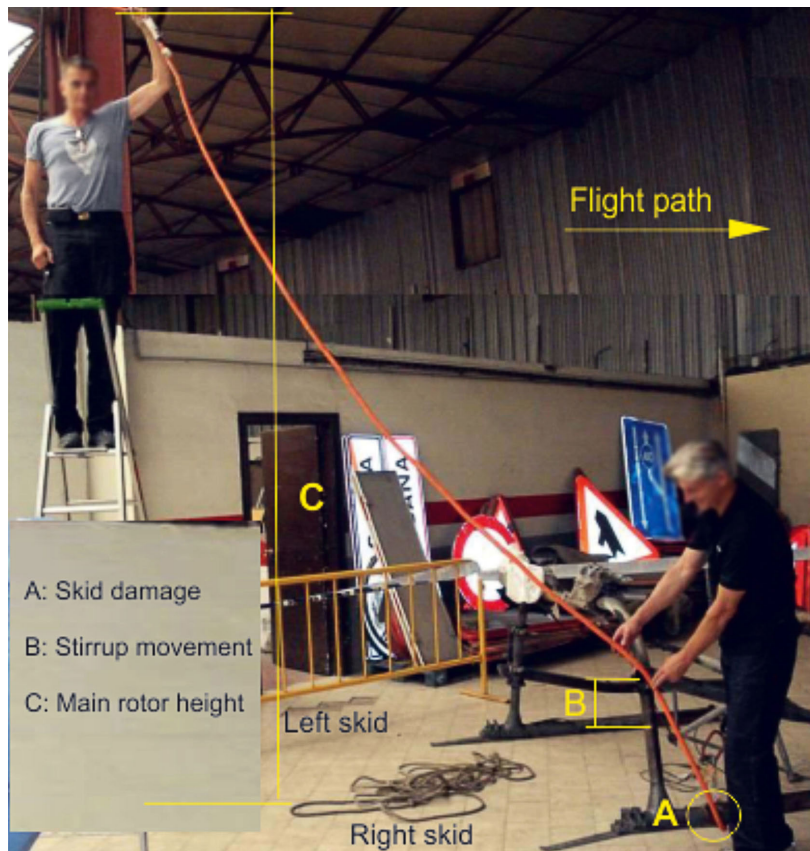
Figure 15. Reconstruction of the position of the sling in the rotor blades

- The sling was released but, due to the rotating action of the blades, was dragged by the blades. During this, the end cap on the ring that attached the sling to the hook struck the right skid and cut it, and finally produced an upward movement of the stirrup.
