## Report EXT A-001/2012 Afghanistan

Accident involving an MD-83  
aircraft, registration EC-JJS,  
operated by Swiftair, S.A., at the  
Kandahar Airport (Afghanistan),  
on 24 January 2012

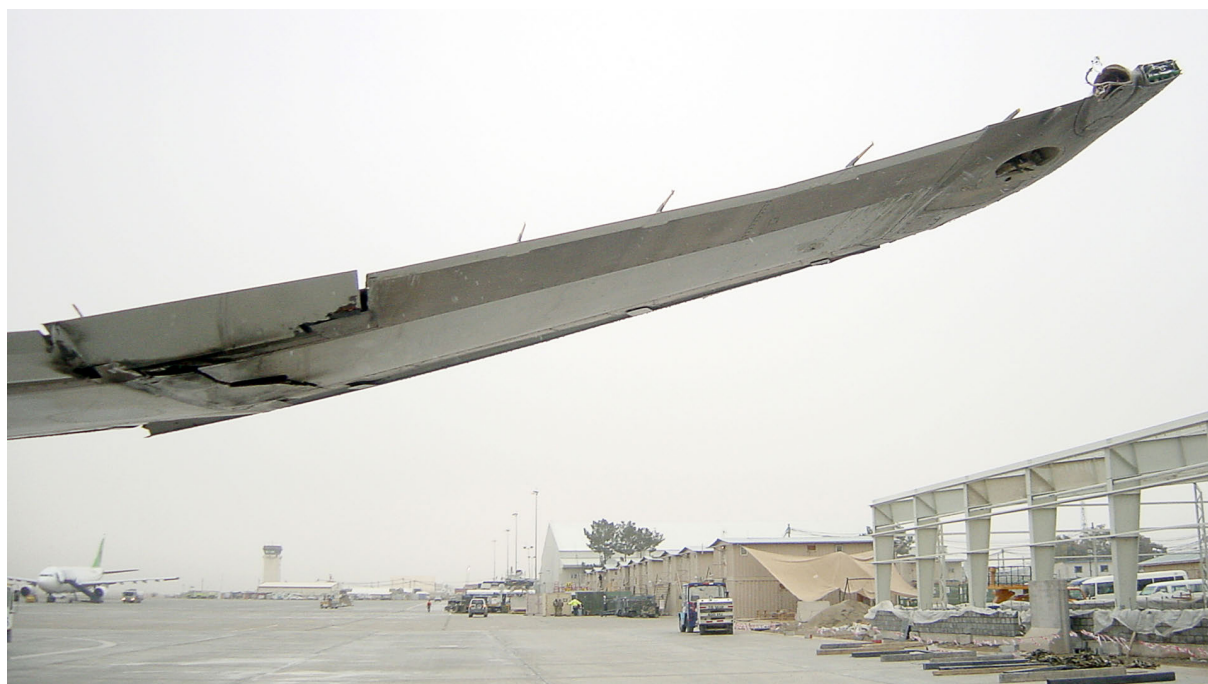
The last 3.6 m of the right wing (from section XRS 477 to the wingtip) was significantly and permanently bent upward. This entire area scraped along the ground, resulting in considerable scratches and gashes in this section of the underside of the wing. The outermost leading-edge slat (number 5) was severely damaged, while the number 4 slat was scratched.

As for the moving surfaces on the wing's trailing edge, the outermost aileron and its trim tab were heavily damaged, as was the outboard flap, though to a lesser extent. The wingtip and its lights also suffered significant damage.

Figure 1. Damaged right wing seen from behind

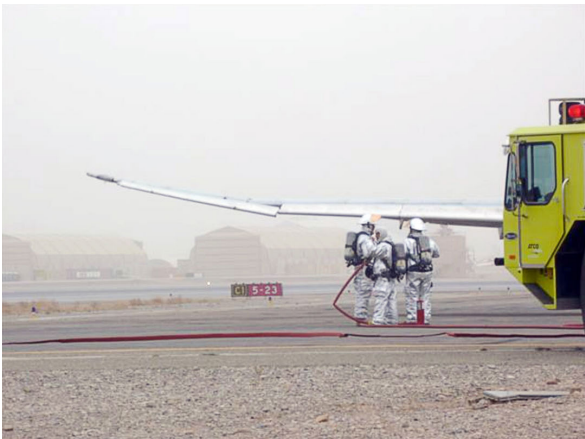
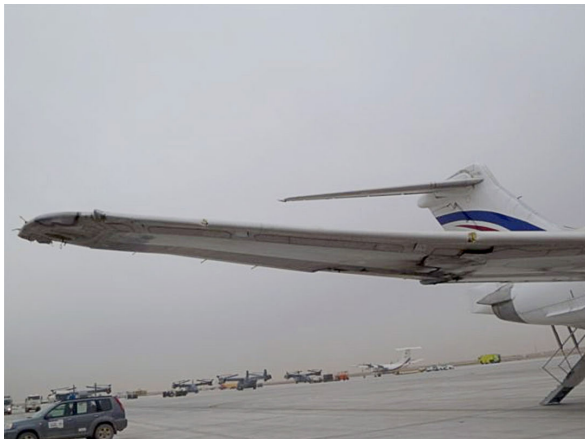
Figures 2 y 3. Damaged right wing seen from the front

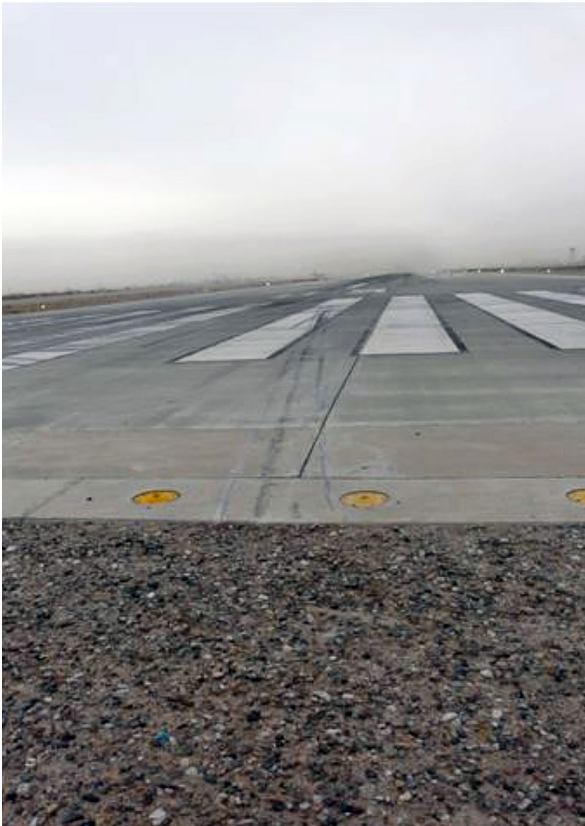
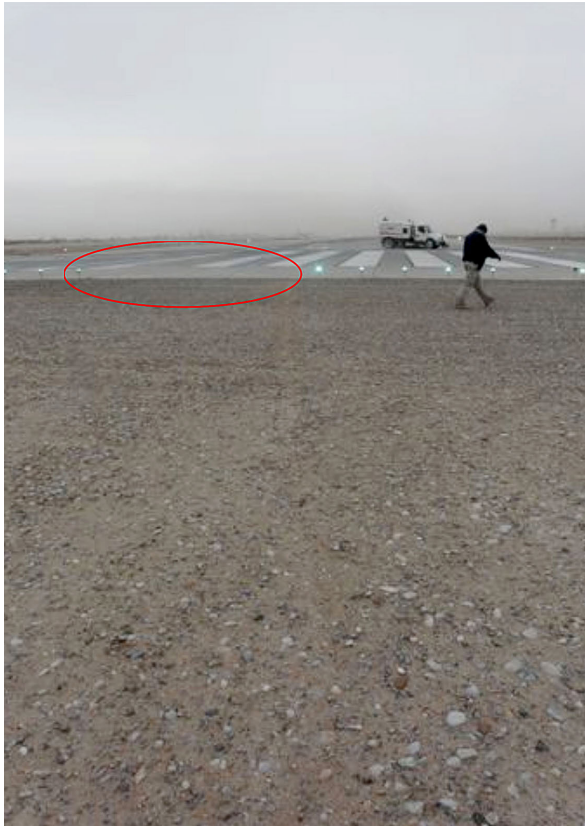
The wing made contact with the ground some 20 m before the threshold, resulting in damage to five threshold lights (see area in red in figure 5).

Figures 4 y 5. Runway 05 threshold after the accident

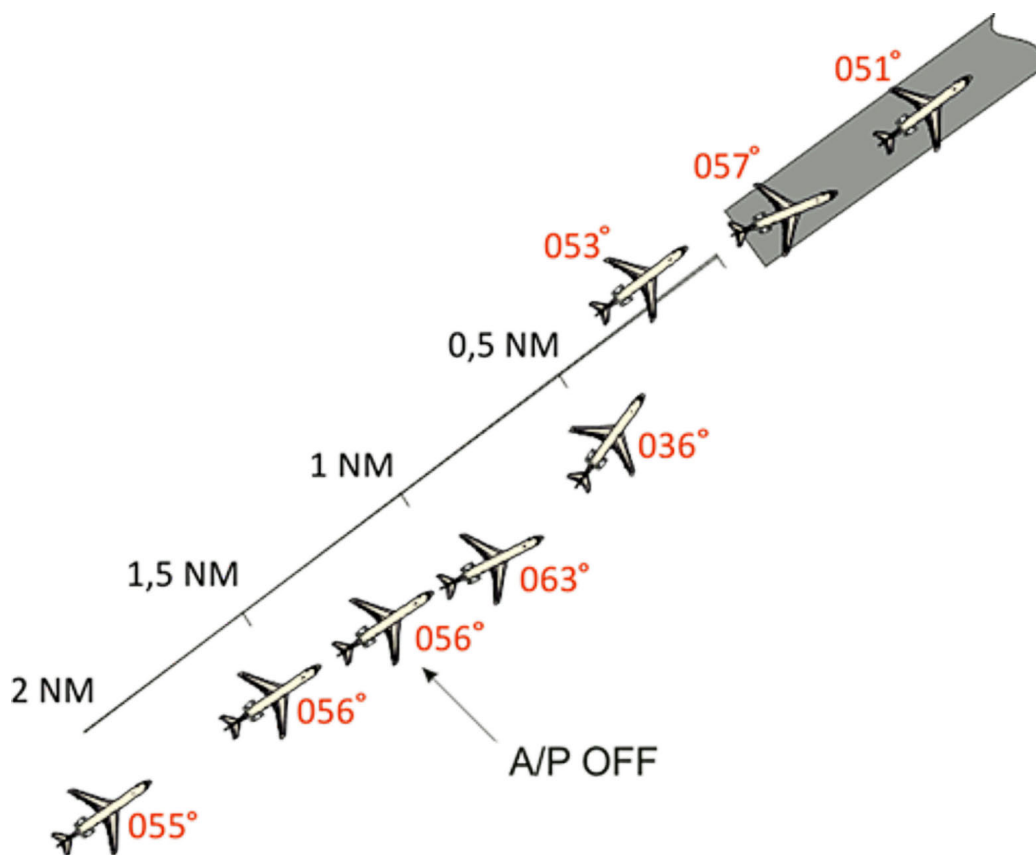
Figure 6. Aircraft's estimated flight path<sup>21</sup> and headings with respect to the approach centerline  
Note: aircraft and centerline separation not to scale.

- At 03:57:48, the approach minimums were reached (3,700 ft and a RA of 394) one mile out. The airplane had a pitch angle of  $-1$  and a right roll angle of  $8^\circ$  and was passing through course  $063^\circ$  to  $068^\circ$  at a speed of 152 kt.

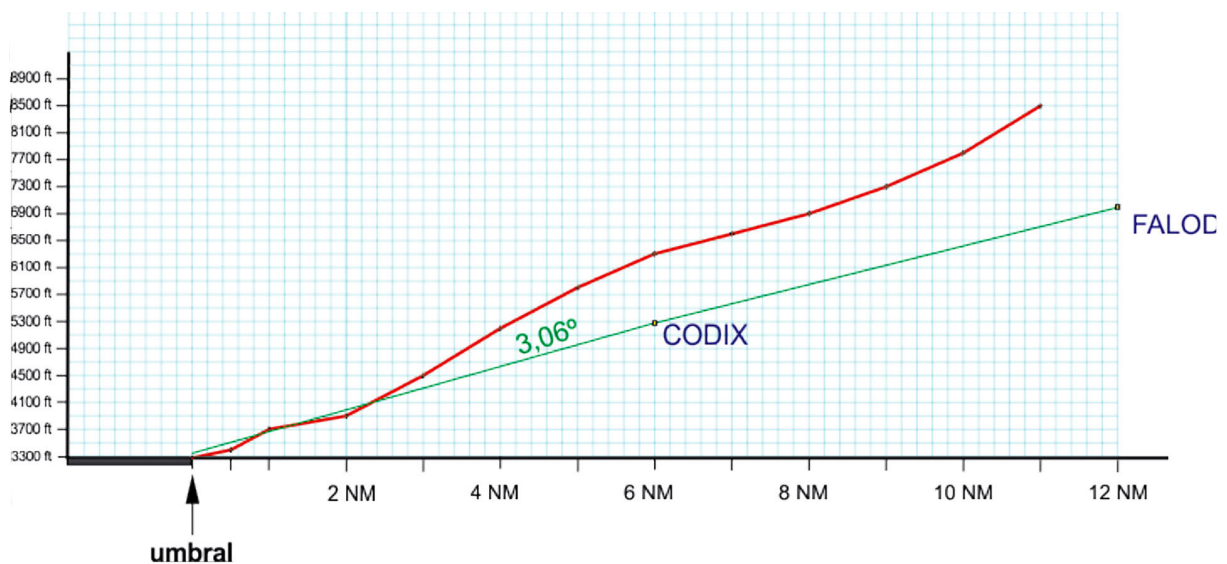
The above data were used to make the following graph showing a profile of the difference between the aircraft's approach path and the published RNAV (GPS) 05 maneuver with a 3.06° slope (see Appendix A).

Figure 7. Approach profile – actual versus published

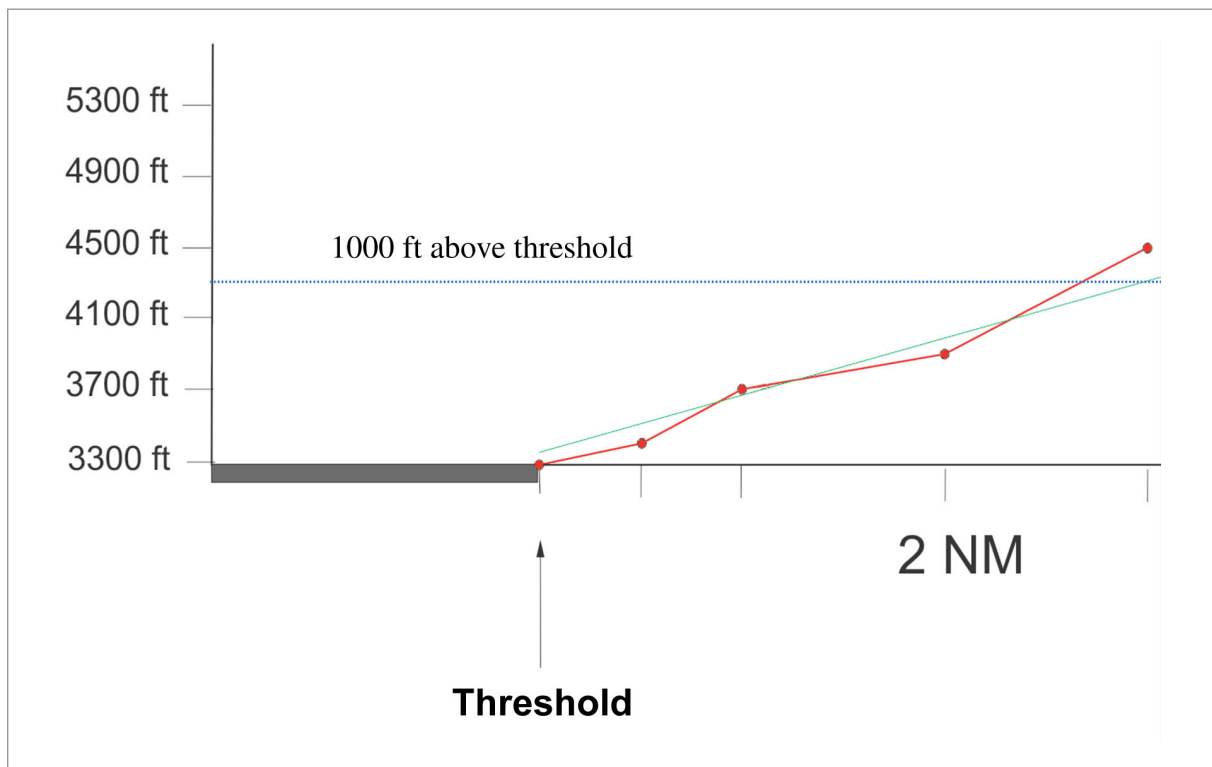
Figure 8. Detail of previous figure

The graph shows that even though the profile was above the glide slope throughout the approach, in the last segment (final mile), the maneuver was conducted below the glide slope.

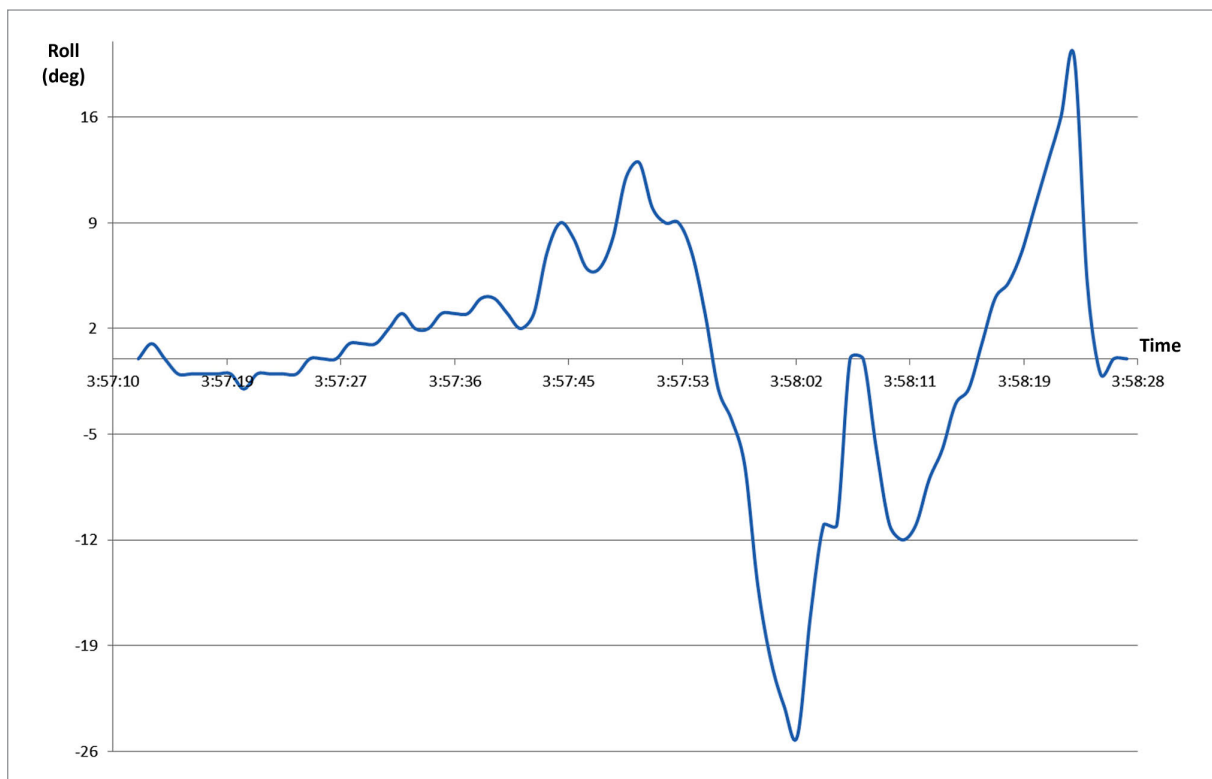
From 03:57:56 on, that is, 27 seconds before impact, the roll was to the left, while at 03:58:16, the roll tendency changed, with the roll angles shifting to the right. The altitude was 102 ft and the heading  $038^\circ$  with a speed of 130 kt. This maneuver at such a low altitude seems to indicate an effort to line up the aircraft with the runway by

Figure 9. Roll angle in the last 1,000 ft of RA

means of a sharp roll to the right that reached a value of  $20^\circ$  combined with an input to the right pedal that deflected the rudder up to  $15^\circ$  in the second before impact.

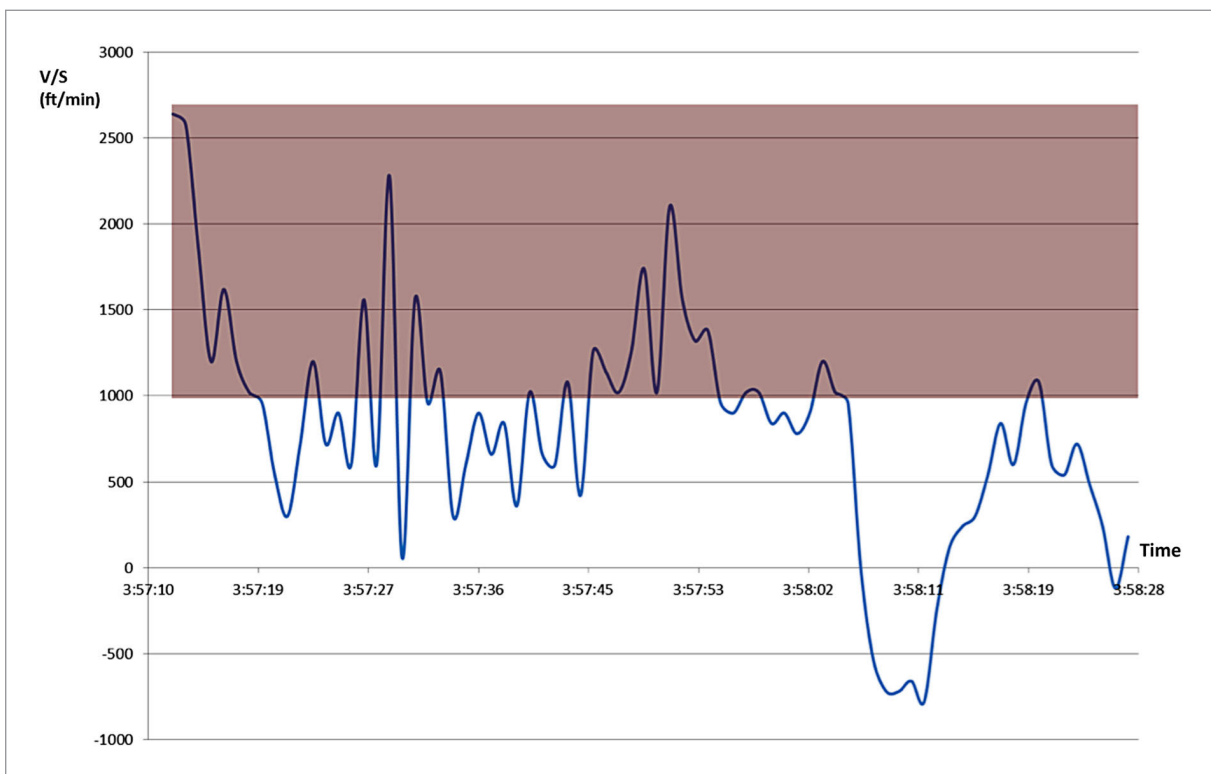
The maximum rate should have been 1,000 ft/min, but as the graph below shows, the descent rate exceeded this maximum on several occasions (red area).

There was even an interval between 03:58:07 (70 ft RA) and 03:58:12 (122 ft RA) when the aircraft climbed (shown in the graph 12 as a negative descent rate).

Figure 12. Descent rate in the last 1,000 ft of RA
