Report ULM A-007/2017

Accident involving an ICP SAVANNAH ULM aircraft, registration EC-ES1, in the vicinity of the Sant Feliú de Buixalleu restricted aerodrome (Girona, Spain) on 9 April 2017

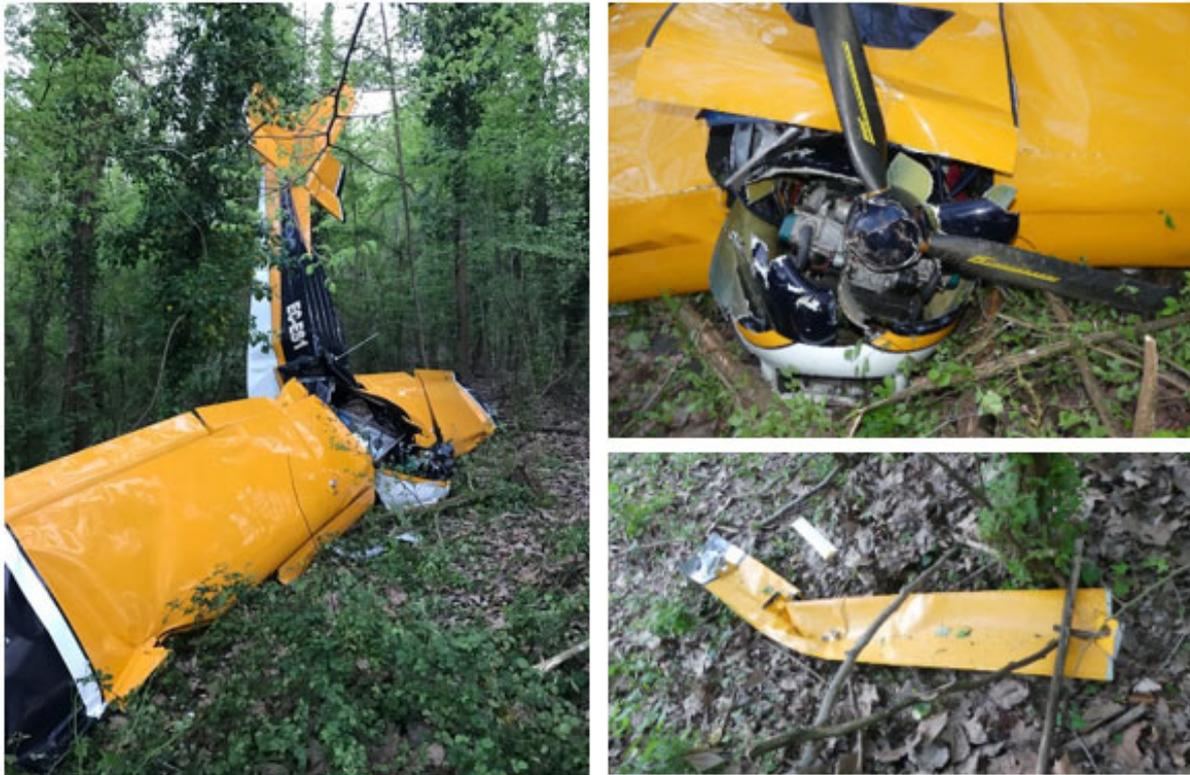
The front parts of both wings were damaged by the impacts against the trees. These impacts broke the slat on the right wing at about its halfway point, causing the outboard fragment of the slat to detach.

Two full blades and the root of the third were still on the propeller. Neither of the two blades showed impact marks or signs of damage under rotation.

The fragment that detached from the third blade was on the ground under the engine. It also had no marks indicating that it was rotating during the impact. There were marks, however, consistent with a bending force to the rear.

Figure 2. General view of aircraft (left). Close-up of engine and propeller (top right) and the detached slat fragment (bottom right)

As the photographs in Figure 2 show, especially the one on the left, the aircraft's nearly vertical impact against the ground caused significant warping of the fuselage, characterized by considerable bending along the trailing edges of the wings.

The aircraft's cabin is located just beneath the wing, meaning the most significant warping occurred just behind the cabin. This made it possible for the cabin compartment to maintain its overall shape, though the compression caused all of the glass in the cabin (windshield and side windows) to break.

Although the most significant damage to the fuselage was aft of the wing, there was some damage due to bending that affected the bottom of the fuselage between the nose and the trailing edges of the wings.

The fact that none of the three propeller blades had damage consistent with a rotating condition; the fracture mechanism of the detached blade, bent backwards; and the fact that the overload clutch did not show any signs of having experienced any significant load inputs, all clearly indicate that the engine was not supplying power when the aircraft impacted the ground.

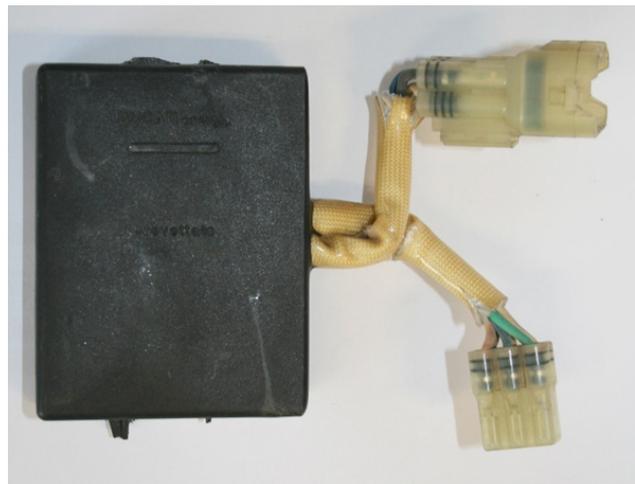
Figure 3. Photograph of electronic module in circuit B a

The test was repeated by installing completely inoperative module. The engine was verified to start normally with the other module. The magnetos were tested several times 15 seconds to 5 minutes after starting the engine, and the electronic module was verified to remain fully inoperative.

The experience acquired on the performance of electronic modules with failure modes like the one in the accident engine leads us to conclude that this kind of problem is only exhibited when the modules are at temperatures below 25° C, and moreover that the failure is temporary and lasts for a very short time (15 to 20 seconds).

- One of the electronic modules in the engine ignition system was found to be working improperly.
