DUTCH  
SAFETY BOARD

# Fatal fall overboard during loading operations

M/V Azoresborg, Bilbao, Spain, 27 February 2013

*The Hague, May 2014*

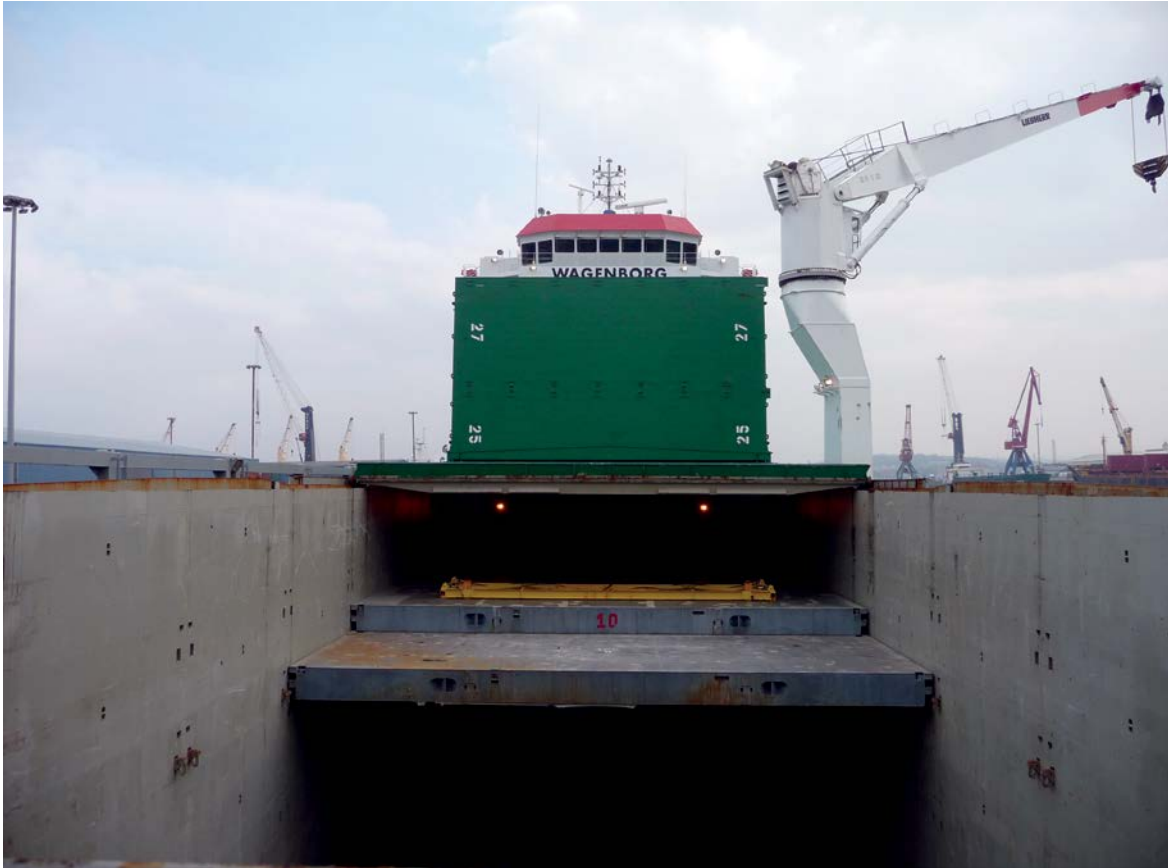
Tweendecks are used to divide the hold into multiple compartments to enable simultaneous carriage of different cargoes (see figure 2). The tweendeck can be installed at three different heights in the hold and consists of several pontoons, each weighing around 33 tons. To store tweendeck pontoons, which are not being used, two positions on deck are available. One of these is located between the aft hold and the accommodation. Pontoons may be stored here in port and during a sea-voyage. In port pontoons may also be stored temporarily between the fore hold and forecastle. Finally, at sea the pontoons can be positioned on top of the hatchcovers or inside the hold.

Figure 2: A tweendeck on board the Azoresborg (hold 2). (Source: Dutch Safety Board)

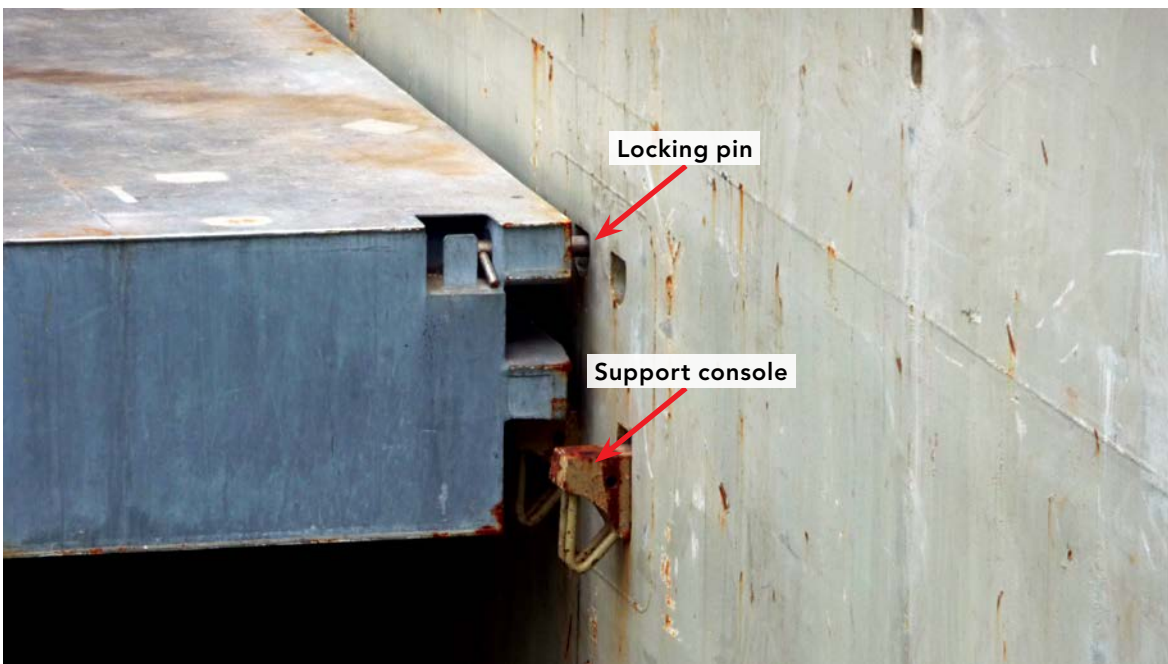
Four support consoles support each pontoon. The consoles each weigh around 45 kg and have to be manually installed by the crew. After the tweendeck has been installed, it is secured by a locking pin (see figure 3).

Figure 3: Consoles in cargo hold. (Source: Dutch Safety Board)
