Report on the investigation of the
keel failure and capsizing of
the Comar Comet 45 Sport yacht
Tyger of London

1 nautical mile south of Punta Rasca, Tenerife
on 7 December 2017

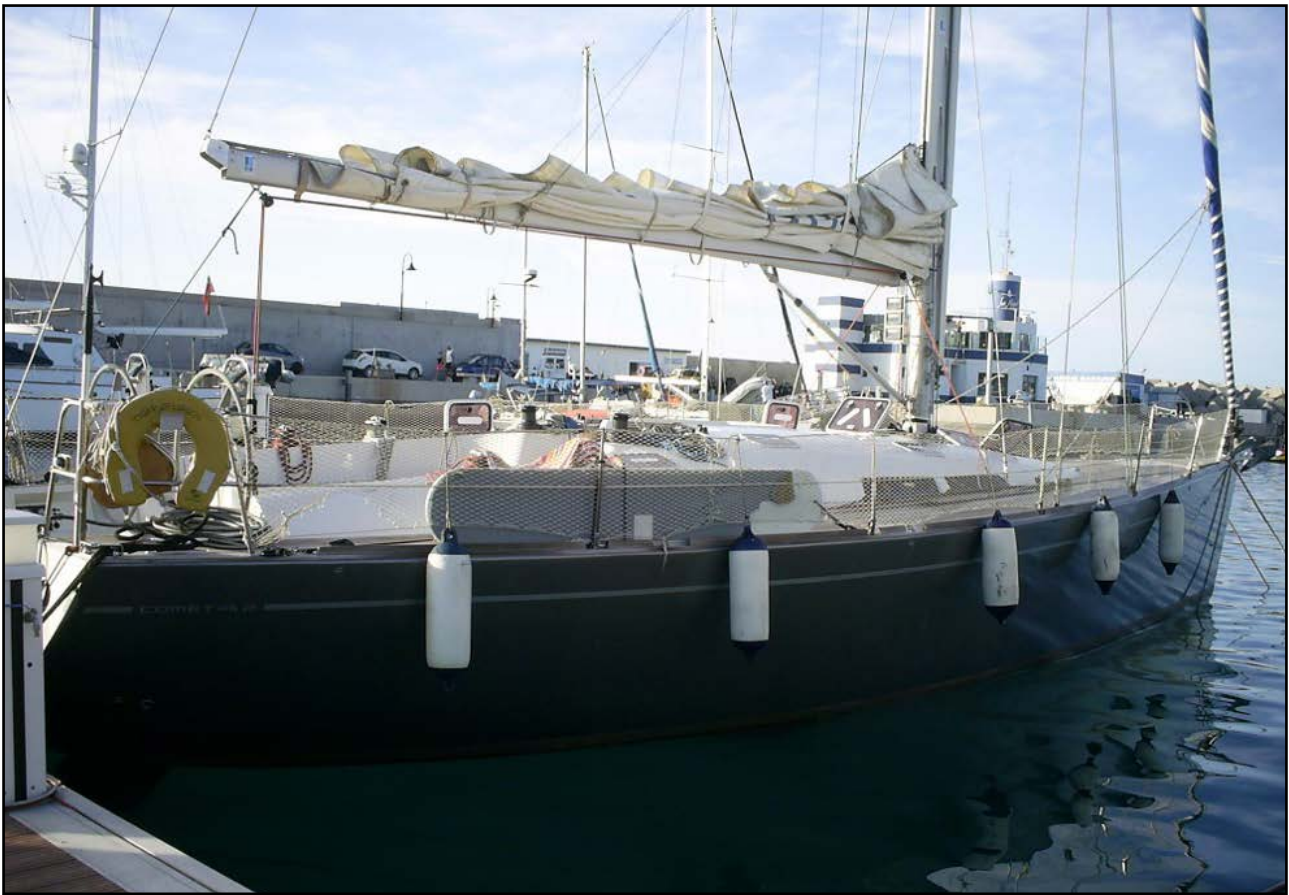
Figure 3: *Tyger of London* berthed at Marina San Miguel, Tenerife, showing guardrail netting

As the vessel heeled over, the crew fell from the cockpit. Some of the crew struggled to unclip their lifelines. However, they had all managed to release themselves and, as they entered the water, their lifejackets inflated automatically. Four of the five crew members quickly swam clear of the upturned yacht. One was trapped by the netted guardrails (Figure 3), but after 30-40 seconds managed to swim clear.

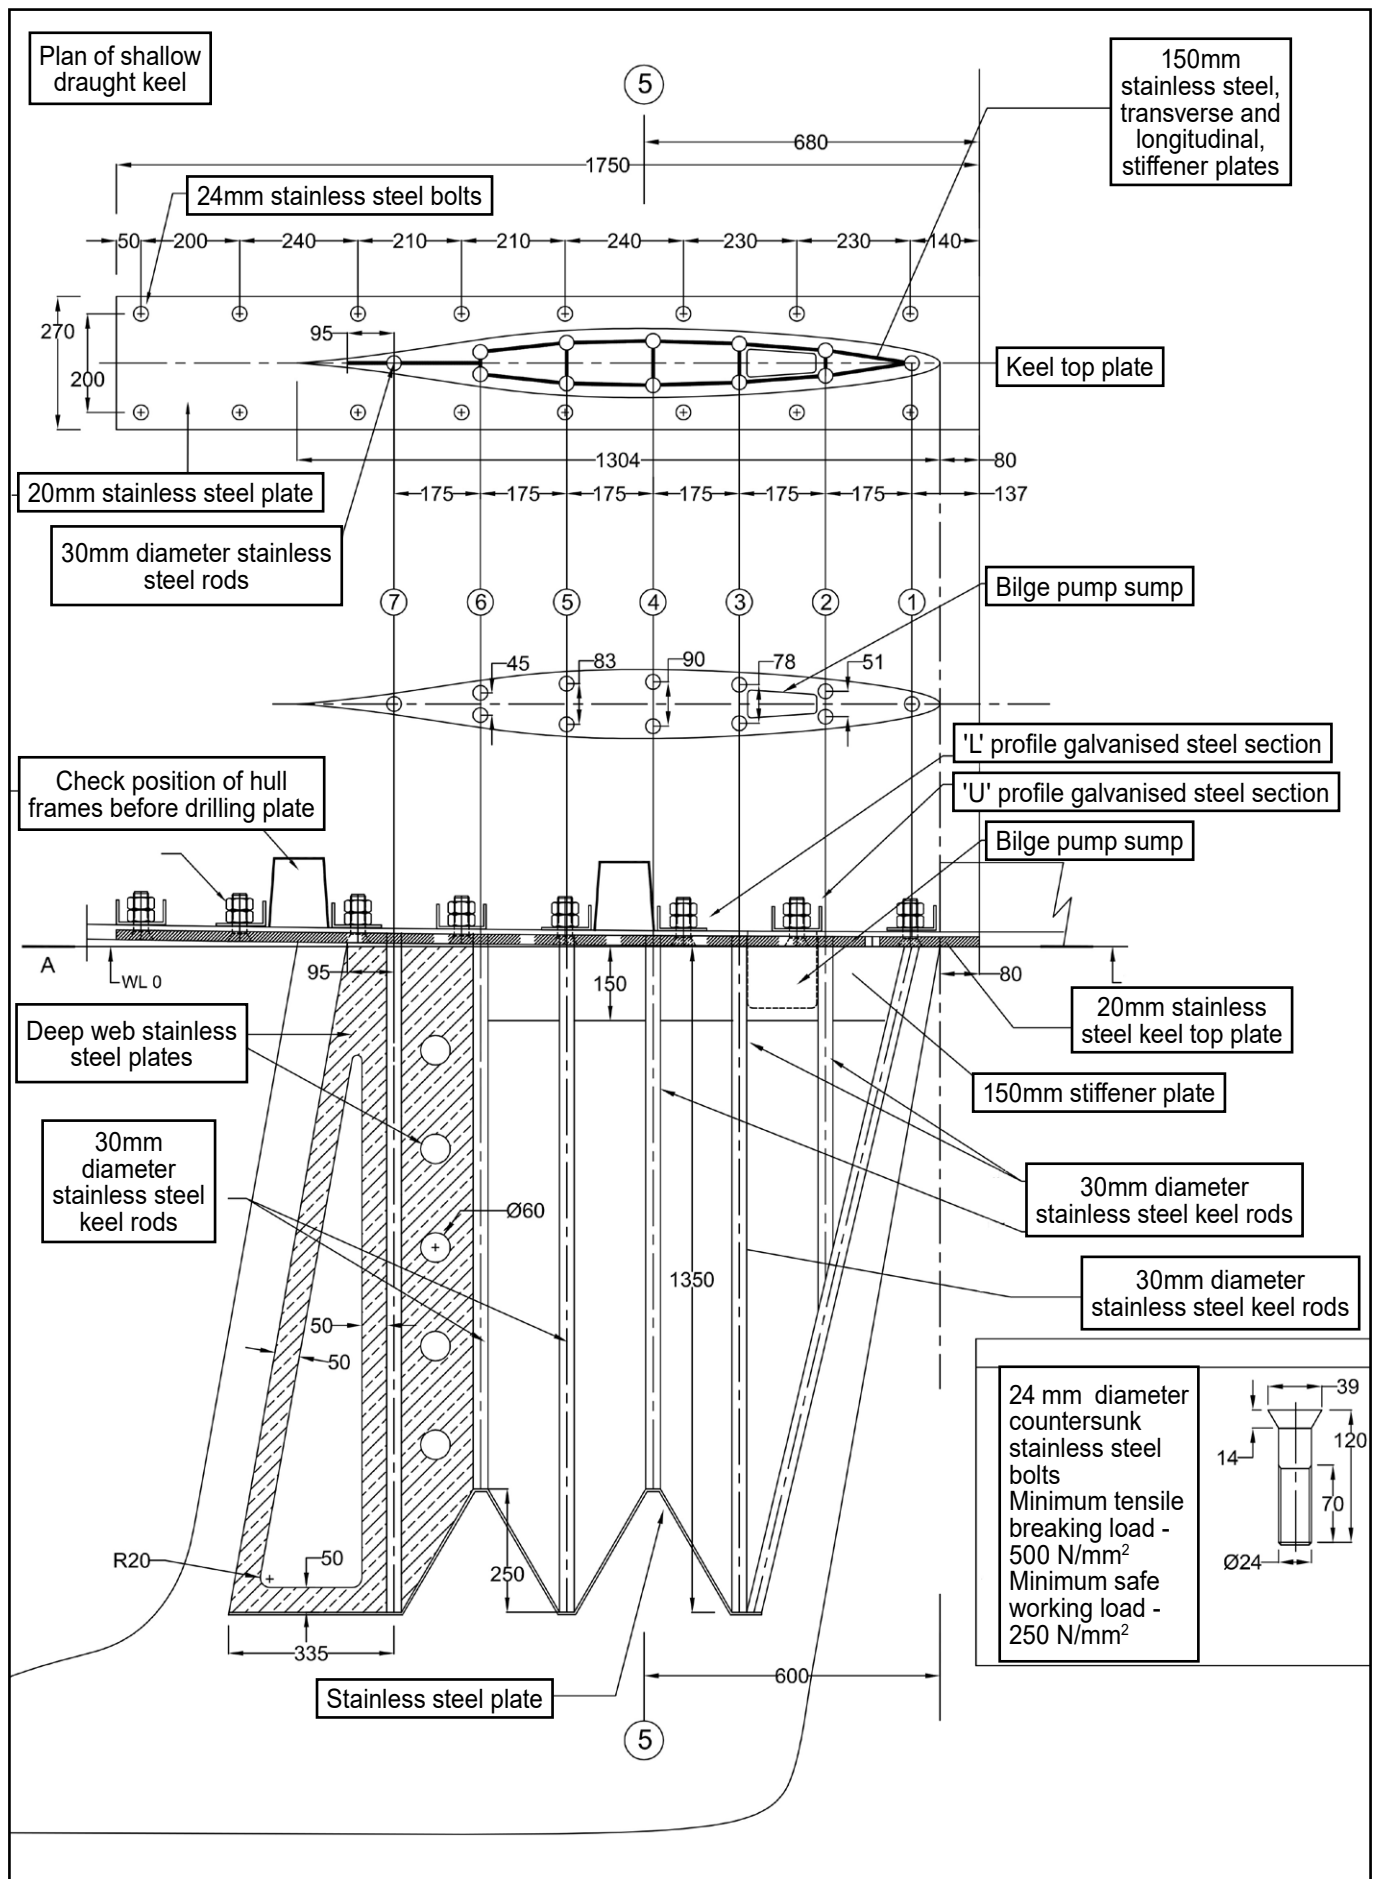
Figure 8: Drawing of Comar Comet 45S shallow draught, lead, cruising keel

The keel drawings (**Figures 8 and 9**) for *Tyger of London's* cruising keel showed:

- A lead keel fin, which was cast around,
- A stainless steel keel frame, made up of: a rectangular top plate into which 12 x 30mm diameter rods were threaded and welded; 150mm interconnecting, transverse and longitudinal stiffener plates welded to the rods, but not to the top plate; and two deep web centre line plates that stiffened the rear of the keel.

After attempting to manufacture the stainless steel frames on one or two occasions as designed, the fabricator proposed some changes to the shipyard. These included changes to the manner in which the 30mm diameter threaded rods were welded to the underside of the stainless steel top plate. Specifically, rather than weld the full circumference of each rod as it passed through the underside of the plate, the fabricator proposed to weld only the outside of each rod, but to extend the weld on to the interconnecting plates (**Figure 9**). It was also agreed that the sump for the bilge pump, shown in the designer's drawings, was not required.

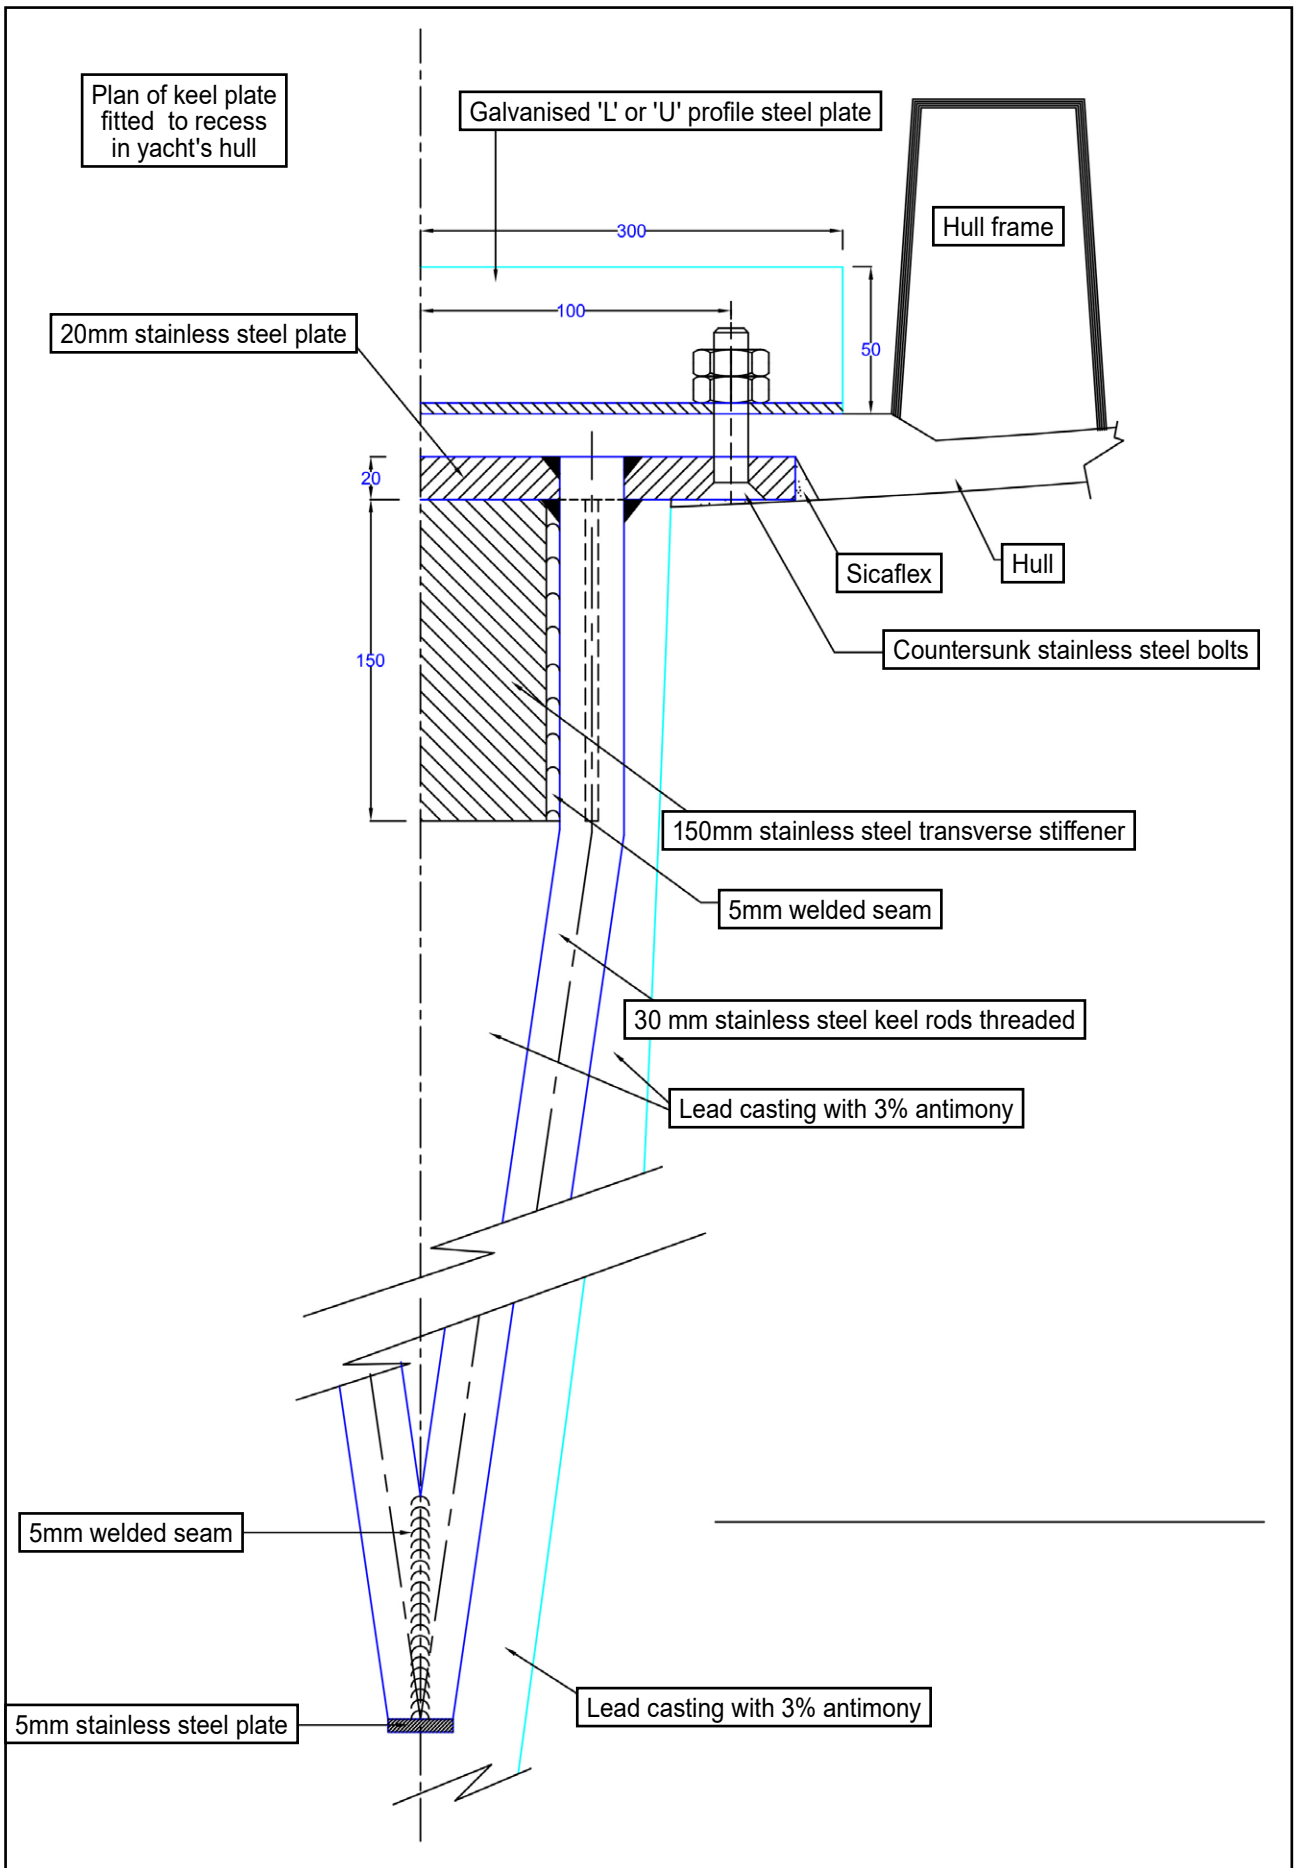
Figure 9: Drawing showing cross-section of Comar Comet 45S shallow draught, lead, cruising keel

In contrast, the unusual design of the Comar Comet 45S shallow draught keel was more complex. Its construction relied on a top plate attached to the yacht using 16 bolts. However, the majority of the 3.7t mass of the keel was hung from 12 rods, threaded and welded to the top plate and hidden within the lead casting.

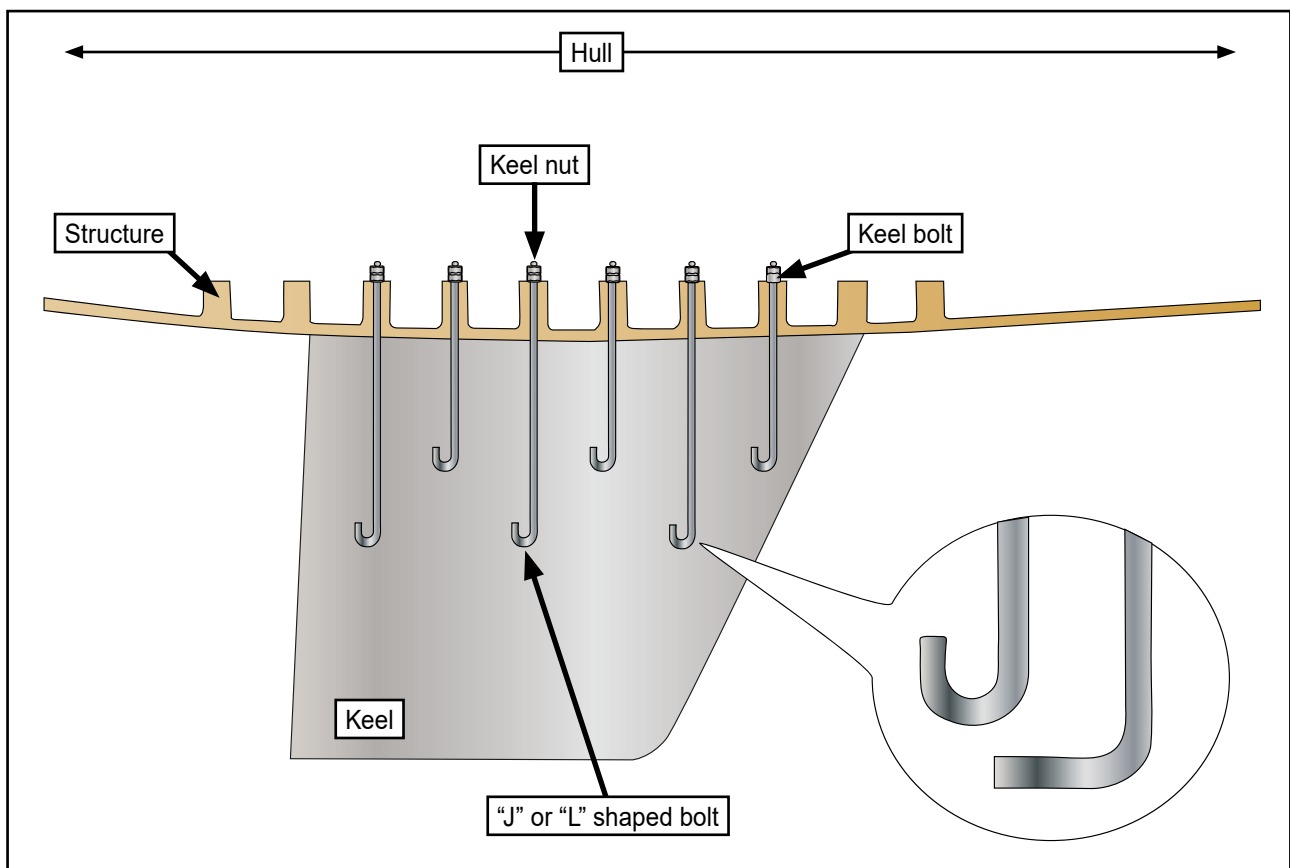
Figure 15: Traditional lead keel

The design of the Comar Comet 45S's shallow draught keel was very different to that of a traditional lead keel.

A traditional lead keel is cast around steel 'J' or 'L' shaped keel bolts, the ends of which are then bolted through a yacht's hull structure (**Figure 15**). The benefit of this simple design is that the condition of the hull-to-keel connection can be assessed by observing the keel bolts and ensuring that they are tightly secured with no signs of corrosion. Equally, the keel can be removed to make a more detailed examination of the keel-to-hull connection if required.
