Report A-008/2011

Accident involving a Bell 407
helicopter, registration EC-KTA,
on 19 March 2011,
in the municipality of Villastar
(Teruel, Spain)

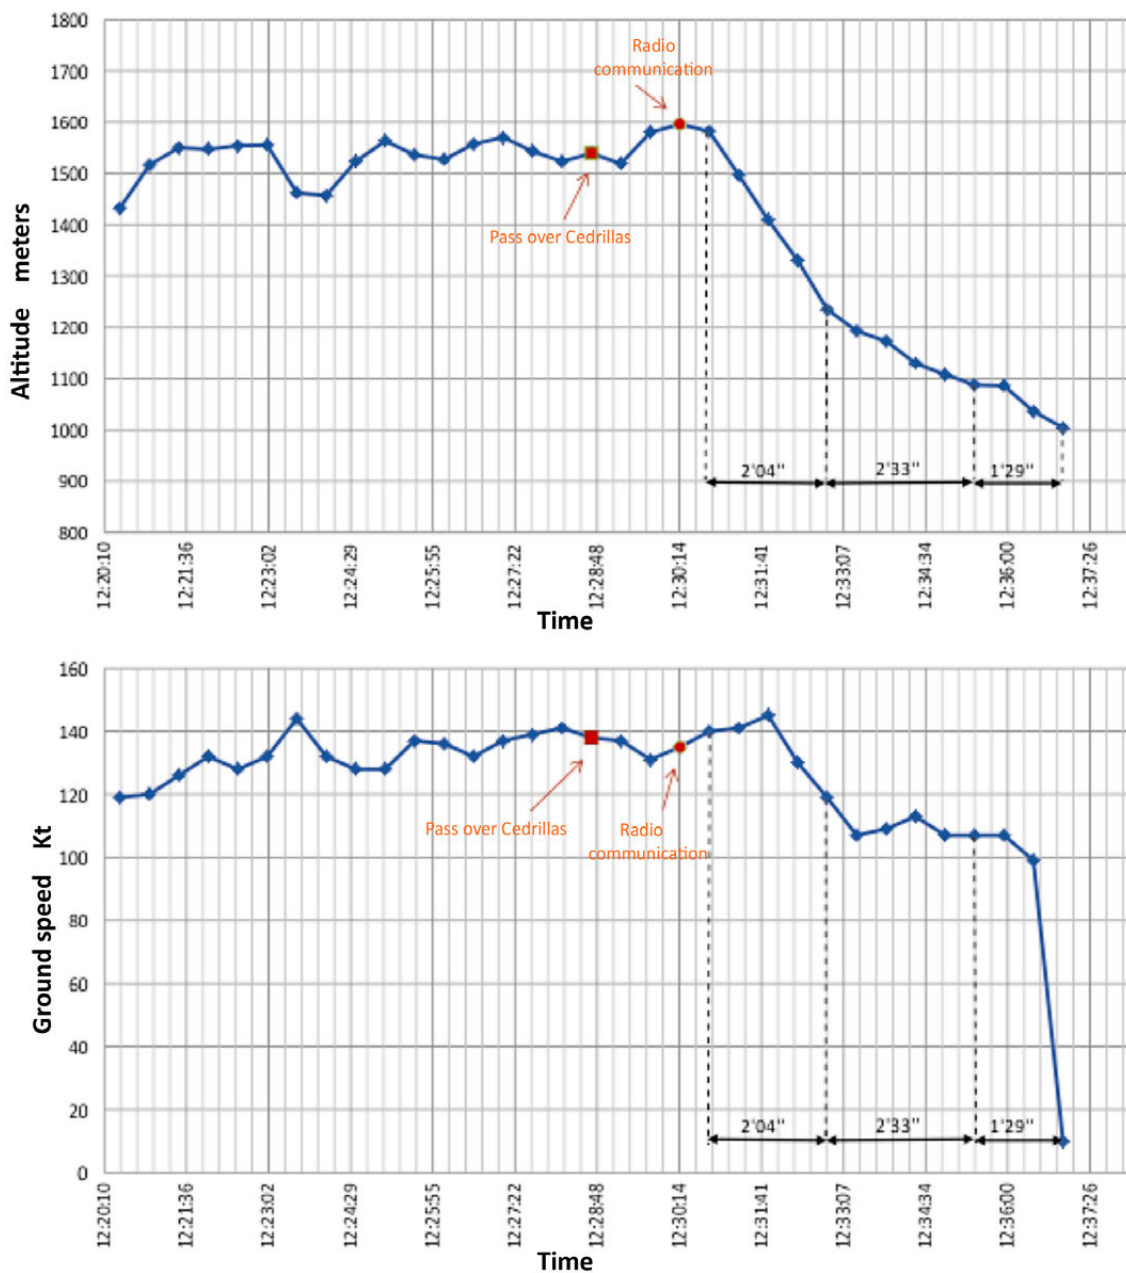
Figure 7. Data from the AVL-280 GPS positioning system

The helicopter's average altitude remained slightly above 1,500 m until 12:30:46, at which time the pilot started a descent at an approximate rate of 550 ft/min for about two minutes. The descent rate then dropped to about 190 ft/min for approximately two and a half minutes. On the last segment, lasting about a minute and a half, the altitude was initially constant, followed by a constant descent more pronounced than in the previous segment.

As for the speed data provided by the same unit, these indicate that the helicopter maintained an average cruise speed of nearly 140 kt until 12:31:48, when the speed started to drop gradually to values between 100 and 110 kt, which it maintained until 12:36:27.

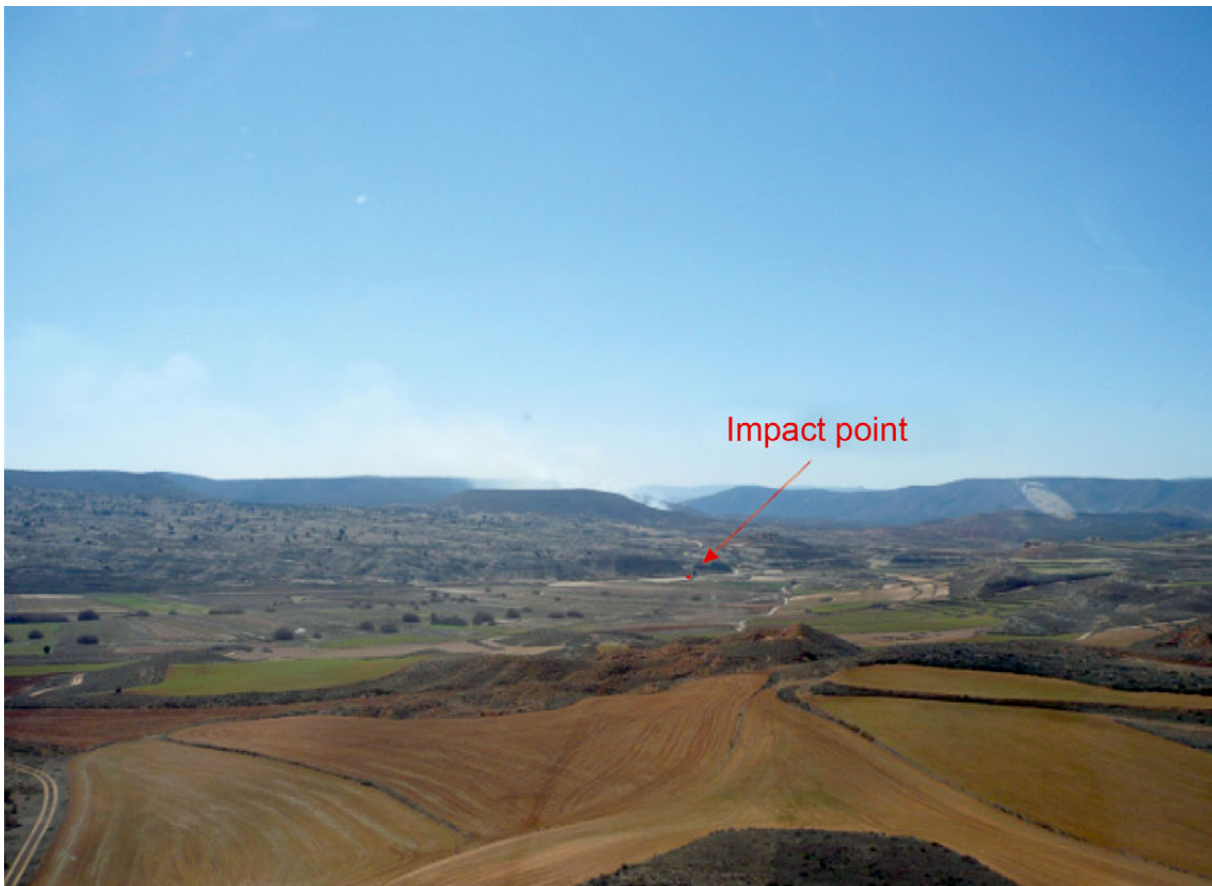
Figure 8. Panoramic view from the cockpit of the flight path and location of the impact point

This card contained six photographs taken looking out the front of the helicopter. They were taken over the course of the final four minutes recorded on the AVL280 positioning system. The photographs show different views of the ground to be flown over en route to the fire, visible as a plume of smoke rising in the background. The photographs reveal how the helicopter's altitude above the ground decreased gradually.

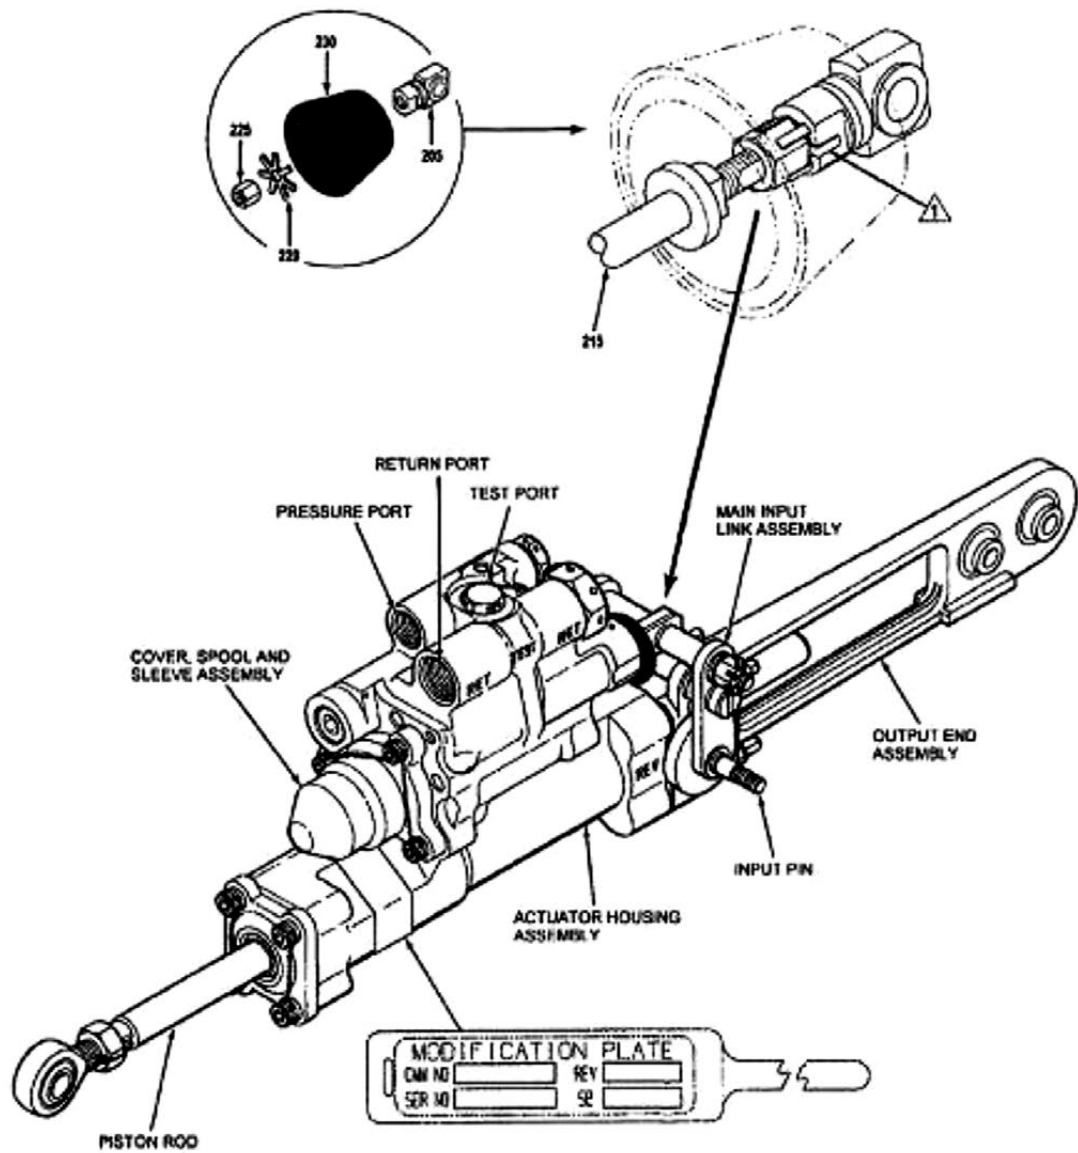
Clevis Assembly
 Figure 1

⚠ ACCEPTABLE CONDITION
 A MINIMUM OF ONE TAB SHALL BE IN LINE AND BENT FLUSH WITH THE NUT FLAT SURFACE AND A MINIMUM OF ONE TAB SHALL BE IN LINE AND BENT FLUSH WITH THE CLEVIS ASSEMBLY FLAT SURFACE

(1) Retract the boot depicted as "230" in Figure 1 of this AD:

(2) Applying only hand pressure, determine whether the nut, shaft, or clevis assembly, depicted as “225,” “215,” and “205,” respectively, in Figure 1 of this AD, turns independently. If the shaft turns independently of the nut or the clevis assembly, before further flight, replace the servo with an airworthy servo.

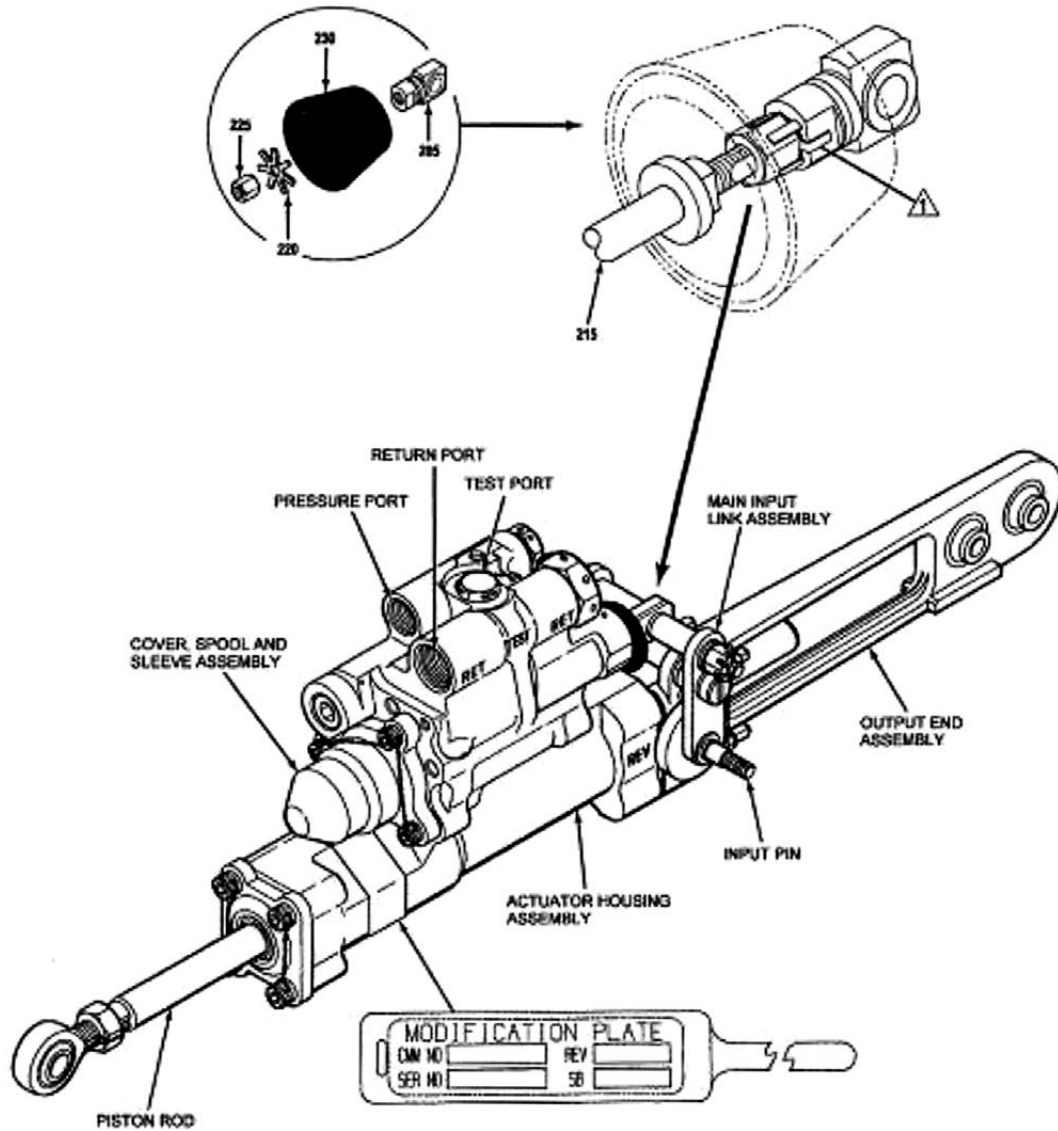
Clevis Assembly
 Figure 1

HR has discovered the possibility that the shaft (215) (refer to Figure 1) could be loose. The looseness is as a result of lock washer tabs (220), improperly bent over the flat surface of the nut (225) or the flat surface of the clevis assembly (205).

⚠ ACCEPTABLE CONDITION
 A MINIMUM OF ONE TAB SHALL BE IN LINE AND BENT FLUSH WITH THE NUT FLAT SURFACE AND A MINIMUM OF ONE TAB SHALL BE IN LINE AND BENT FLUSH WITH THE CLEVIS ASSEMBLY FLAT SURFACE
