A-040/1999

TECHNICAL REPORT

**Accident of aircraft Agusta A-109-E,
registration EC-GQX, in the municipal area
of Villarejo de Salvanes (Madrid), on 26th
July 1999**

AIR ACCIDENTS AND INCIDENTS INVESTIGATION COMMISSION

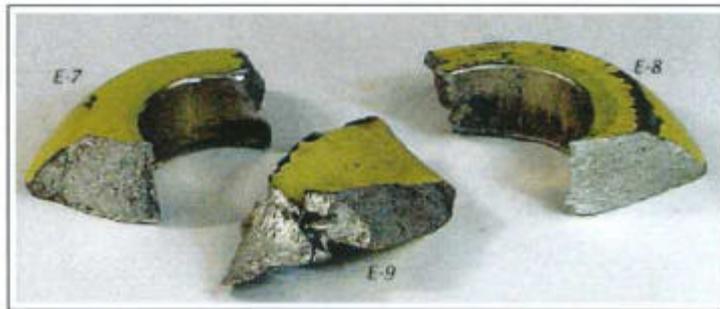
Fig. 13.- Fragmentos, dos procedentes de las orejetas de los tornapuntas (Fig. 9) y el tercero, no identificado

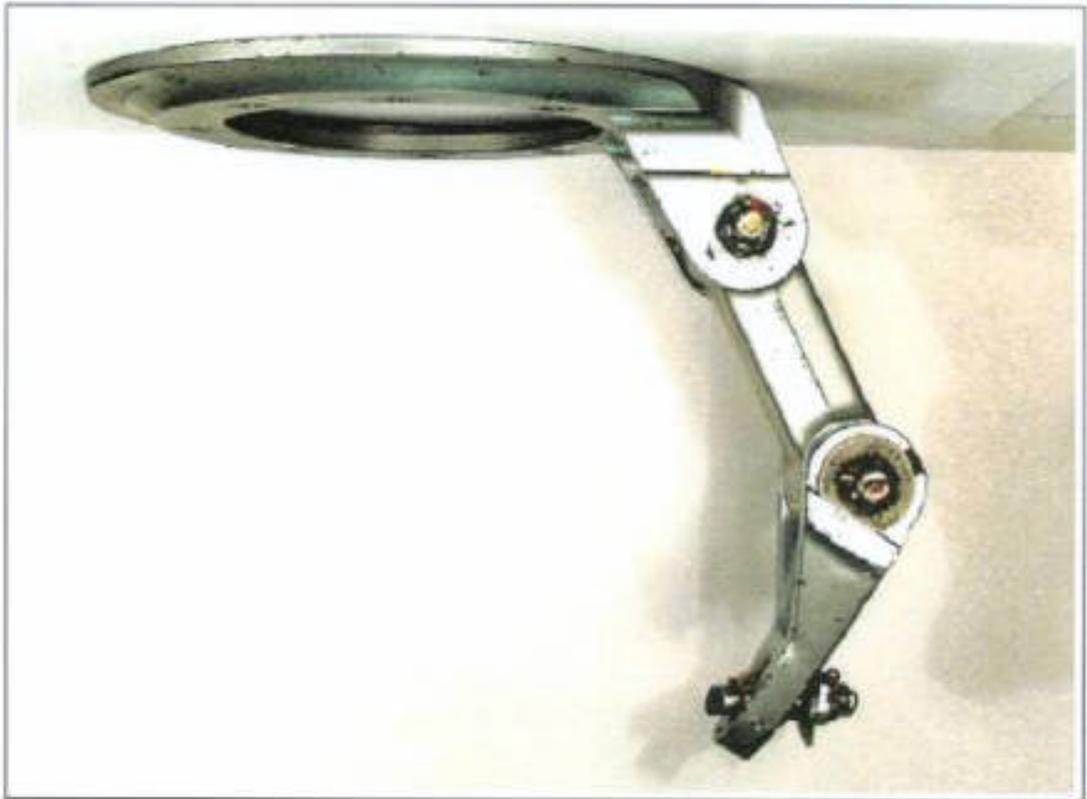
Fig. 1.1.- Tijera completa recibida

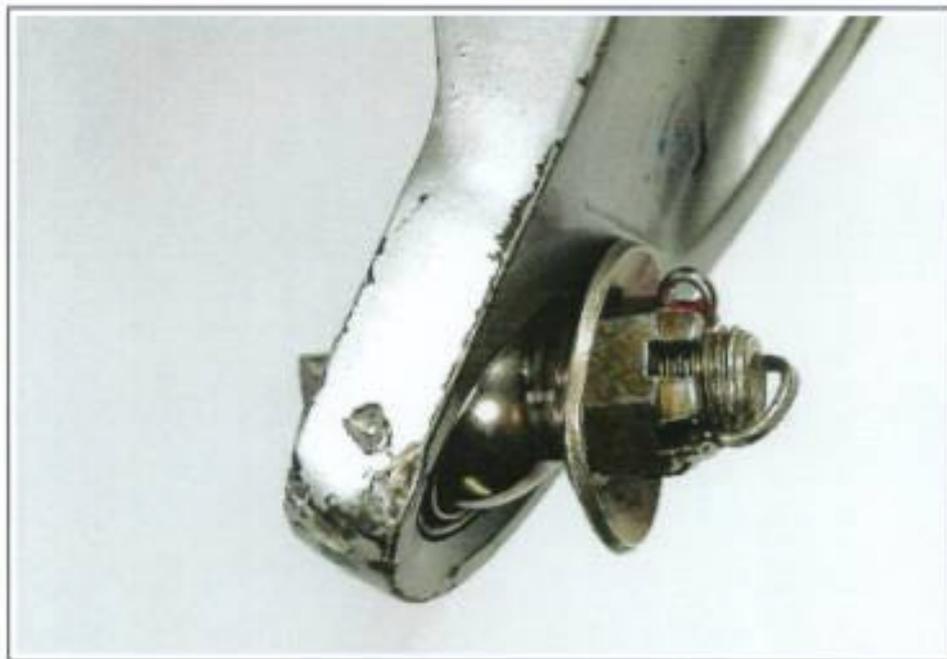
Fig. III.12.- Conjunto hueco-bulón en el brazo de la tijera

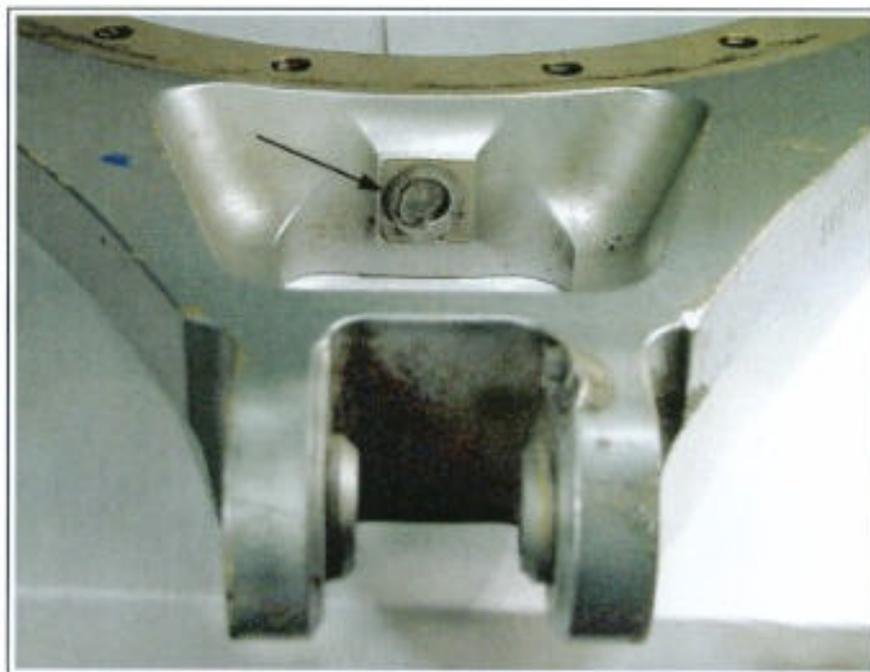
Fig. III.36.- Zona de empotramiento del bulón en el plato

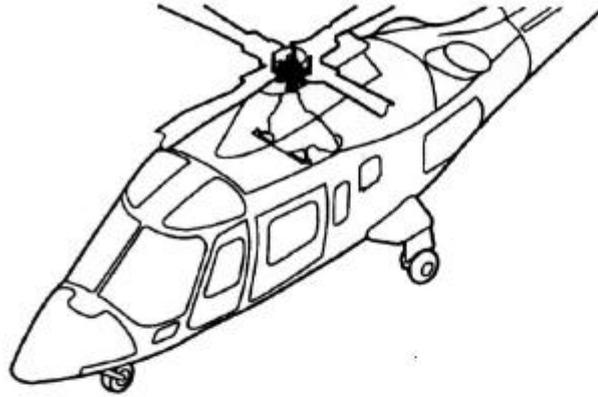
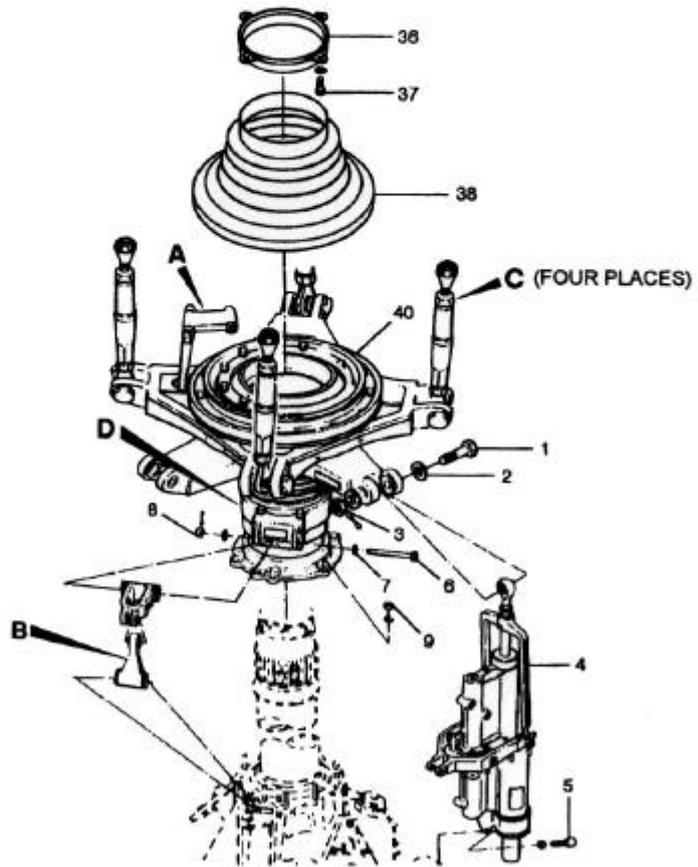
Figure 62-34. (Sheet 1 of 3) Rotating Controls

As stated in Section 1.17, the maintenance documentation which provided by figure 62-34 of the A109E-MM Maintenance Manual, including Revision 2 on 4-2-2000 (after the accident occurred), was ambiguous regarding the assembly instructions of the half-scissors assy, since the diagram's perspective did not clearly show towards which side it had to be assembled. Being a spherical bearing, physically it could have been assembled in both positions, as happened with the equivalent part of the A109A helicopters previously maintained by the operator. Neither were there written instructions on how to carry out this assembly.

Moreover, as it happens, the arrangement of the washers on both sides of the spherical bearing were correctly drawn in figure 62-34, but the bevelled washer was indicated as item 25, while in the text, when the installation procedure of the rotating scissors was described in writhing, it was mentioned as item 29. This could have led the maintenance staff to think that there was an error in the diagram, which, along with the fact that when assembling the lower scissors in the inverted position it was more logical to place the bevelled washer between the bearing and the swashplate, it probably meant that the washers were assembled as in figure INTA III.29B in Appendix D. Nevertheless, neither the bevelled washer nor the thin washer were found amongst the wreckage, and so it can not be definitively concluded whether they were installed or not when the part was assembled.

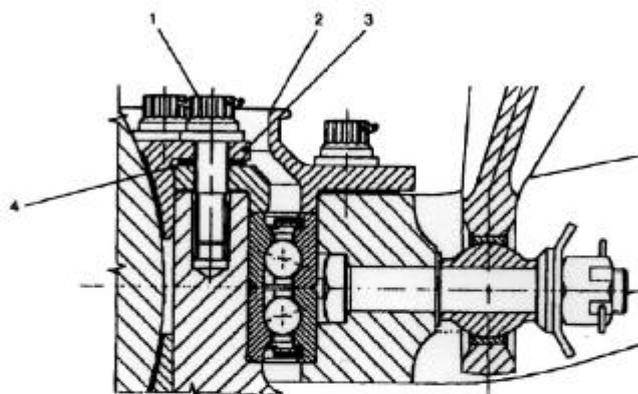
Figure 62-38. Swashplate Friction Adjustment

The Maintenance Manual did include the correct assembly in the diagram of figure 62-38, section 62-31-04 "Swashplate Friction Adjustment" (see Appendix E), but this figure, being part of another maintenance task, was not in the half-scissors assy section.

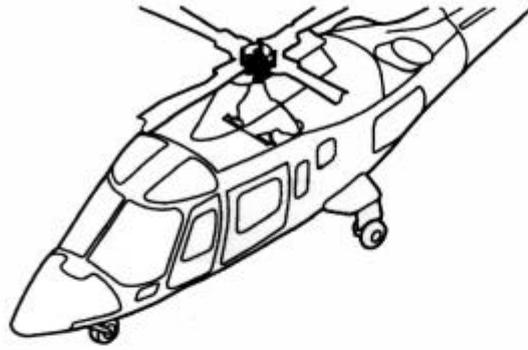
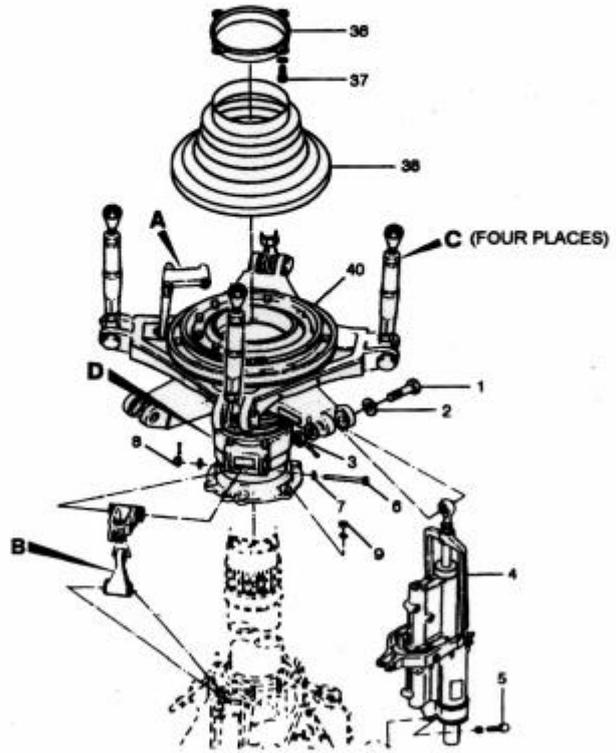
Figure 62-27. (Sheet 1 of 3) Rotating Controls

- The fig. 62-27, detail A, is clear and self explanatory for a correct installation of the parts. It is certainly expected that the maintenance personnel is asked to check the manual and the related figures before to performed the requested maintenance activity.

The installation figure in Maintenance Manual, if properly followed, is sufficient to preclude a wrong installation. In fact the figure showed the rotating scissor connecting bolts and the flanged sleeves on the same side so to be engaged on the machined shoulder of the link.

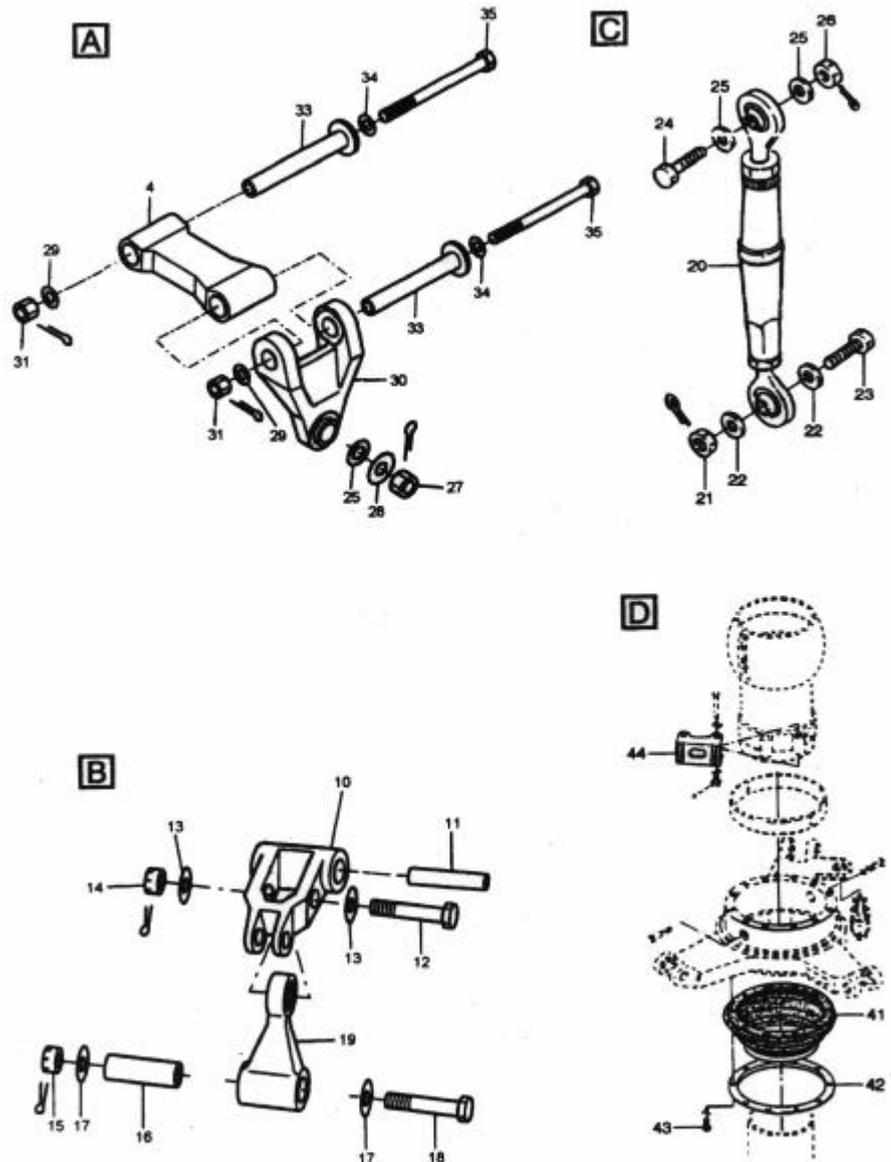
Figure 62-27. (Sheet 2 of 3) Rotating Controls

The washer identification P/N misprint noted in the fig. 62-27 (sheet 2 of 3) "A" is negligible due to installation instructions reported at par. 62-31-14 of the Maintenance Manual.

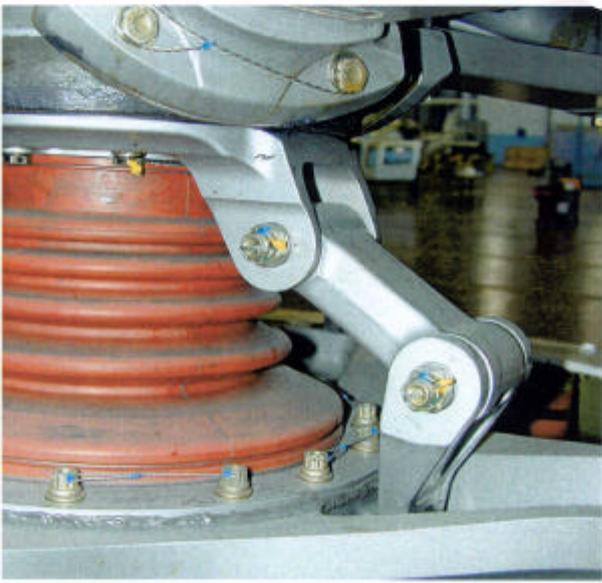
- The reverse installation of the lower scissor link (back to front) needs a consequently wrong positioning of the flanged sleeve. The installation that can be realized is clearly not consistent with the indication of the figure 62-27 A.

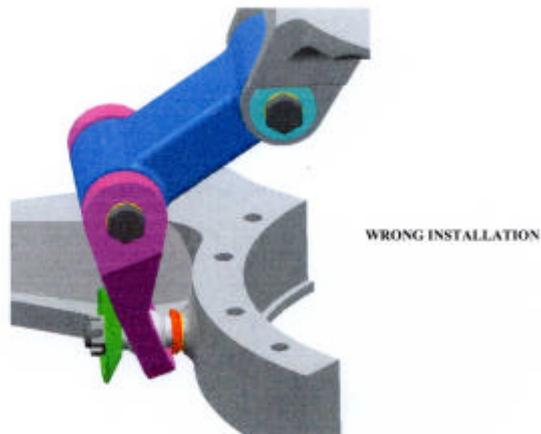
The following three dimension figures clearly show as appear a correct installation in respect to the wrong one. It is evident that a correct positioning of the two flanged sleeves preclude an incorrect installation of the scissors.

The operator installing the lower link in the reverse position (back to front) have consequently assembled also the flanged sleeve in the opposite direction. So doing it was realized an installation clearly not consistent with the indication of the figure 62-27 A.
