CIAIAC

Report A-064/2006

Accident involving a PIPER
PA-34-220T, registration
EC-HOL, on approach to
runway 02 at Jerez Airport
(Cadiz – Spain), on 15
December 2006

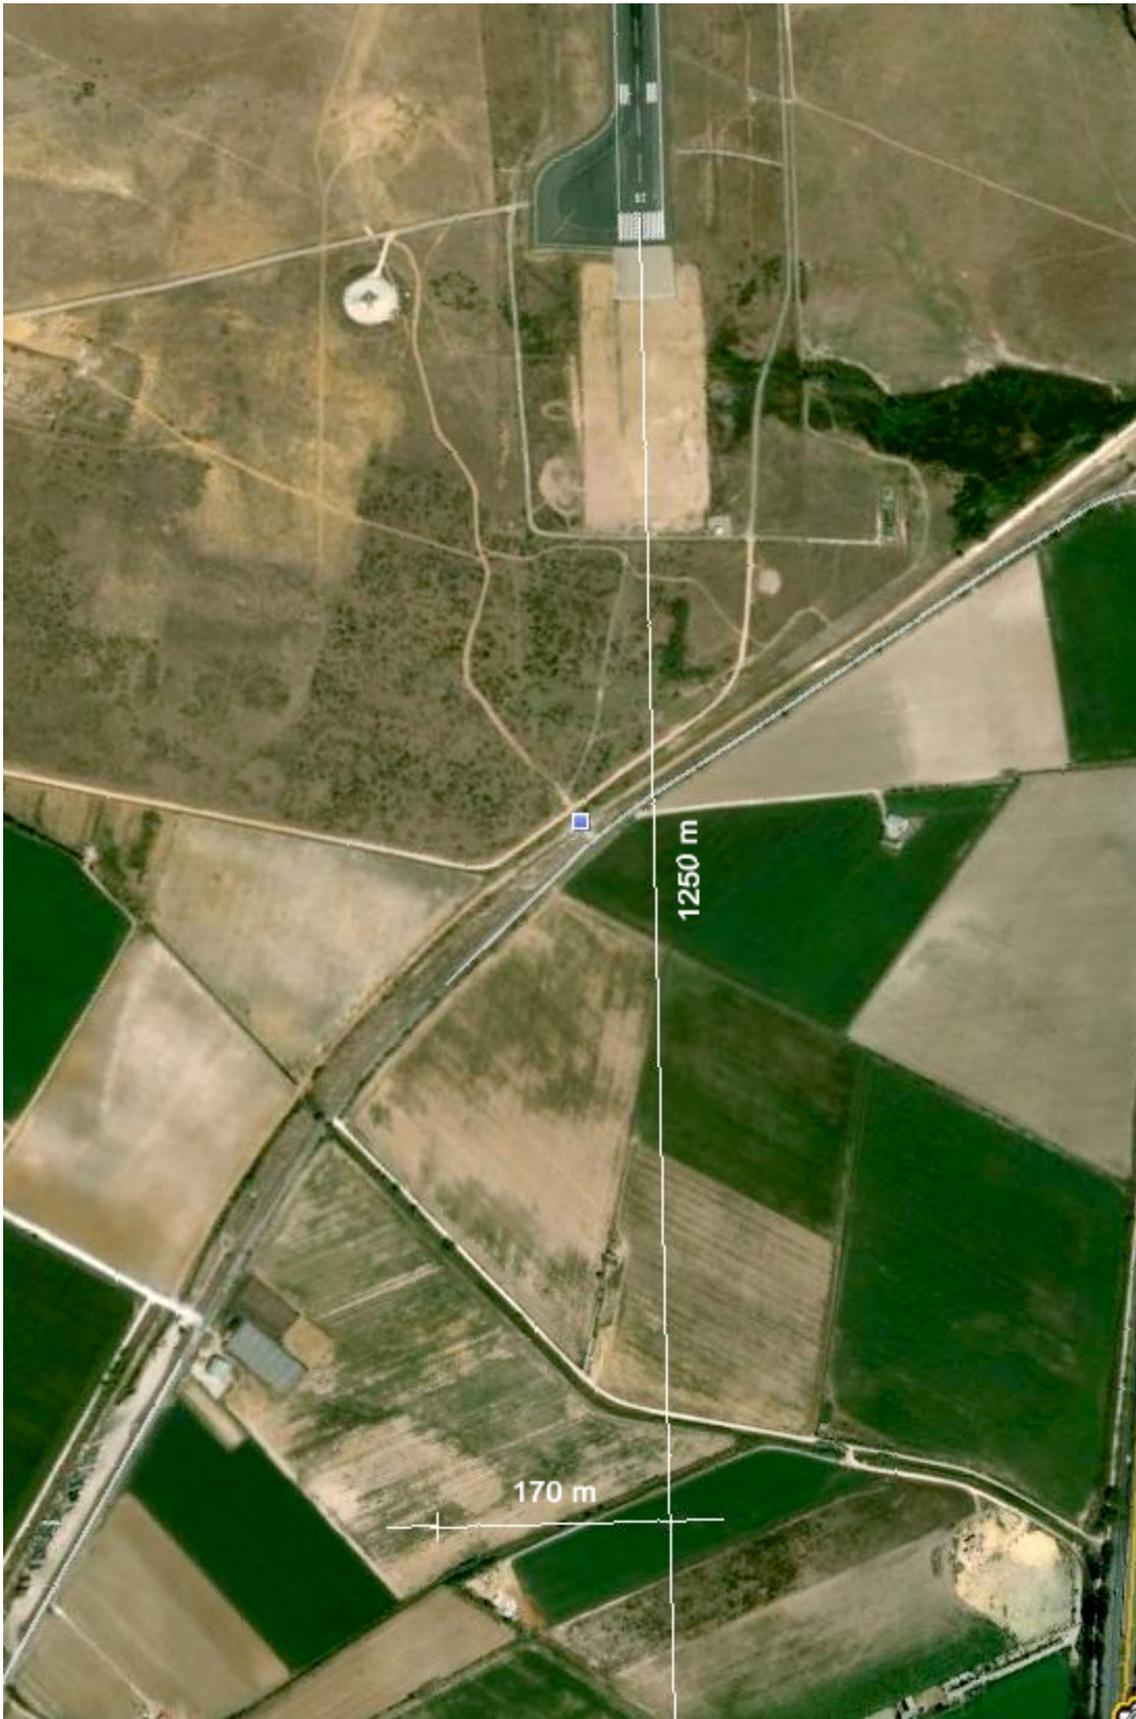
Impact site

- The crew did not declare an emergency, nor were any indications found that the engine stoppage could have occurred for operational reasons.
- The airplane stalled and went into a spin, turning one and a half times before impacting the ground.
