Interim Report A-019/2008

Accident involving
a PILATUS PC-6A
TURBO-PORTER aircraft,
registration EC-JXH,
in Lillo (Toledo)
on 30 May 2008

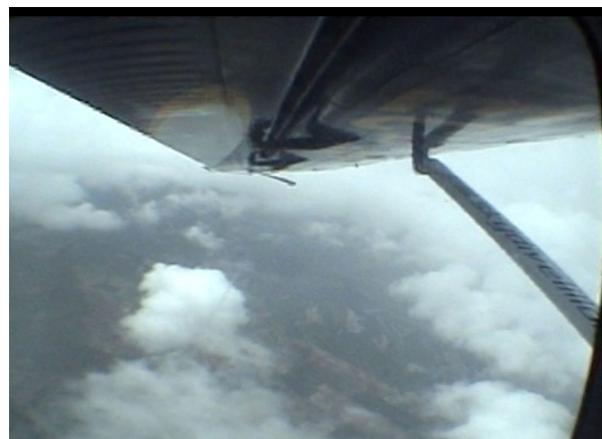
Figure 7. View from inside

One of the parachutists was recording during the climb on a camera mounted on his helmet (Figure 7). Later, during the fall, the camera turned on inadvertently when he hit his head as he was ejected from the airplane, so part of the fall was recorded (Figures 8 and 9). The footage shows the atmospheric situation described above, with abundant clouds and precipitation.

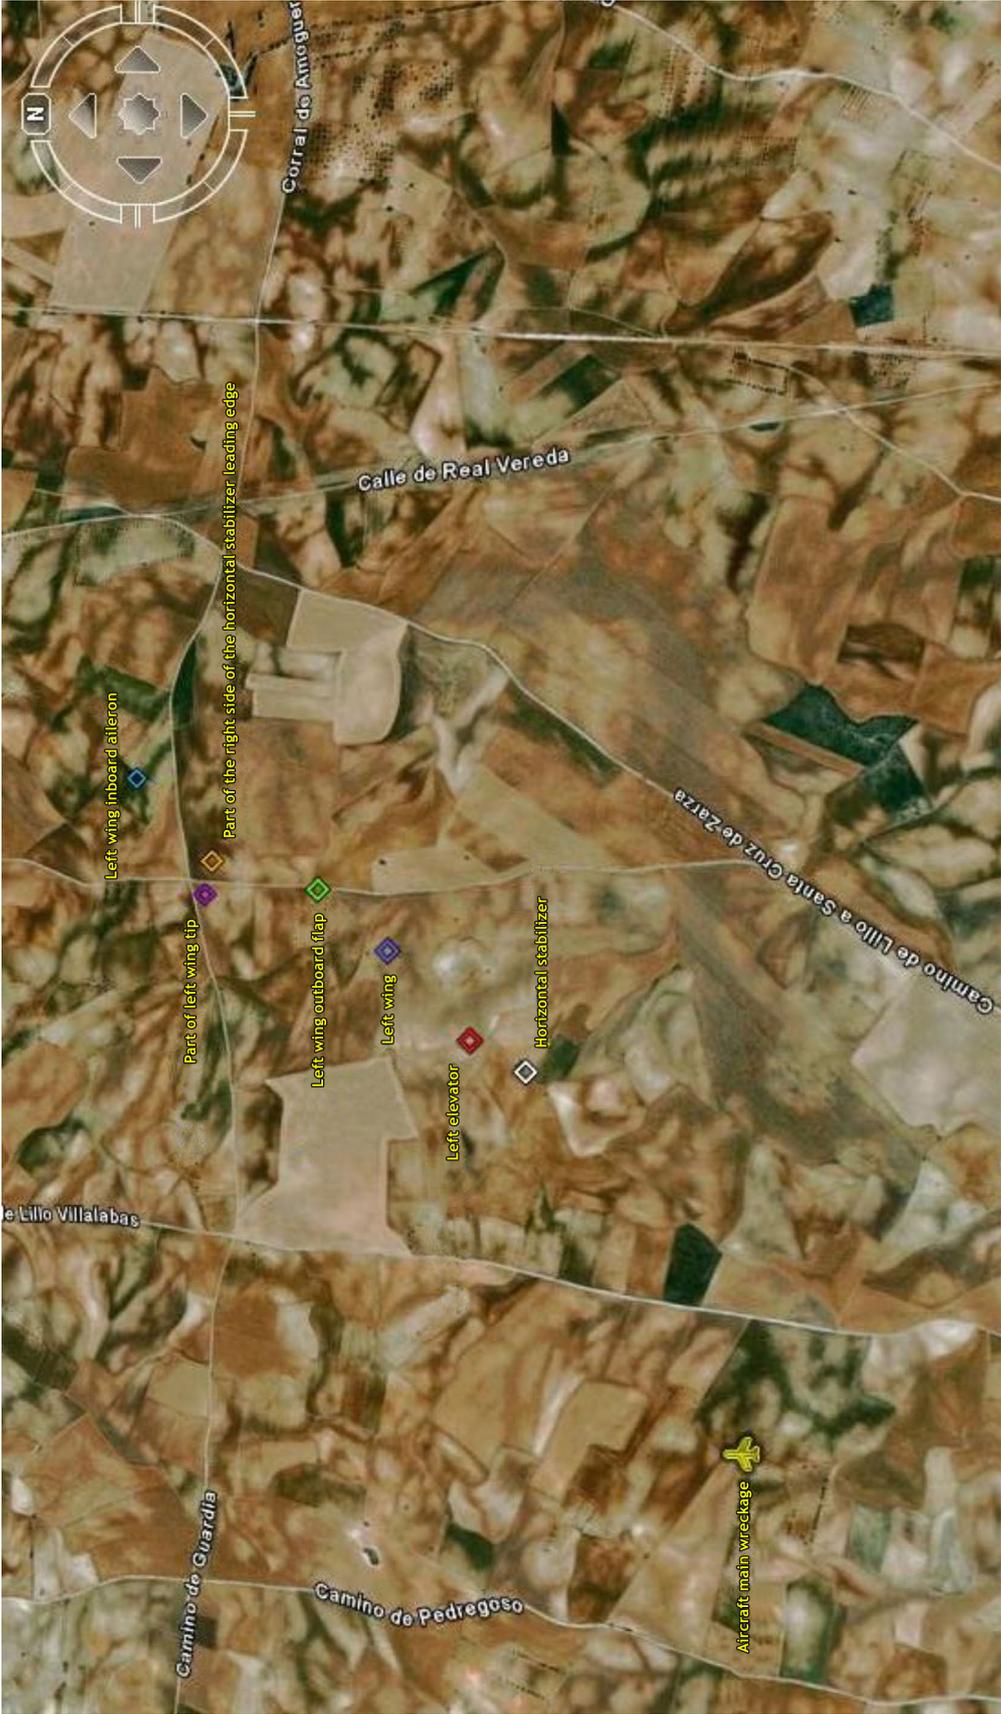
Wreckage distribution pattern

The airplane fell vertically and impacted in an inverted position at coordinates 39° 45' 25.56" N – 3° 18' 23.1" W, at an elevation of 688 m. Its longitudinal axis was at a 45° angle with respect to magnetic north. There were no drag marks. A part of the left wing spanning two thirds of its total length was missing. The part of the wing that remained attached to the fuselage had burned along with the main wreckage. A 1.10-m long section of the brace was still anchored. The inboard flap remained attached to the part of the wing that did not detach, and it was also charred.

The part that detached from the left wing was found alongside the Lillo-Villatobas road, in the segment that is known as the Cerrotraviesa trail, at coordinates 39° 46' 0.18" N – 3° 17' 10.8" W and an elevation of 680 m. It was oriented from east (part near the tip) to west (part near the root), and resting on its top surface. It was 5.75-m long measured along the spar closest to the leading edge. A 0.85-m long segment of the strut was still attached to it. The force of the impact had caused it to bend along its length such that it was convex along the top and concave along the bottom.

The left wing tip and a small part of the tail assembly were found together alongside the La Guardia-Corral de Almaguer road, at coordinates 39° 46' 16.8" N – 3° 17' 30.24" W and an elevation of 690 m.

Like the left wing, the horizontal stabilizer was also found near the Cerrotraviesa trail, at coordinates $39^{\circ} 45' 48.66''$ N – $3^{\circ} 17' 47.58''$ W and an elevation of 700 m. It was bent at the center in a U-shape (see Figure 11) and ripped from its fittings at the center. The left side was heavily damaged. It was missing the piece that had remained
