FINAL INCIDENT REPORT

Boeing B-737/300F

EC-KDJ

FINAL INCIDENT REPORT Nr. 07/INCID/2008

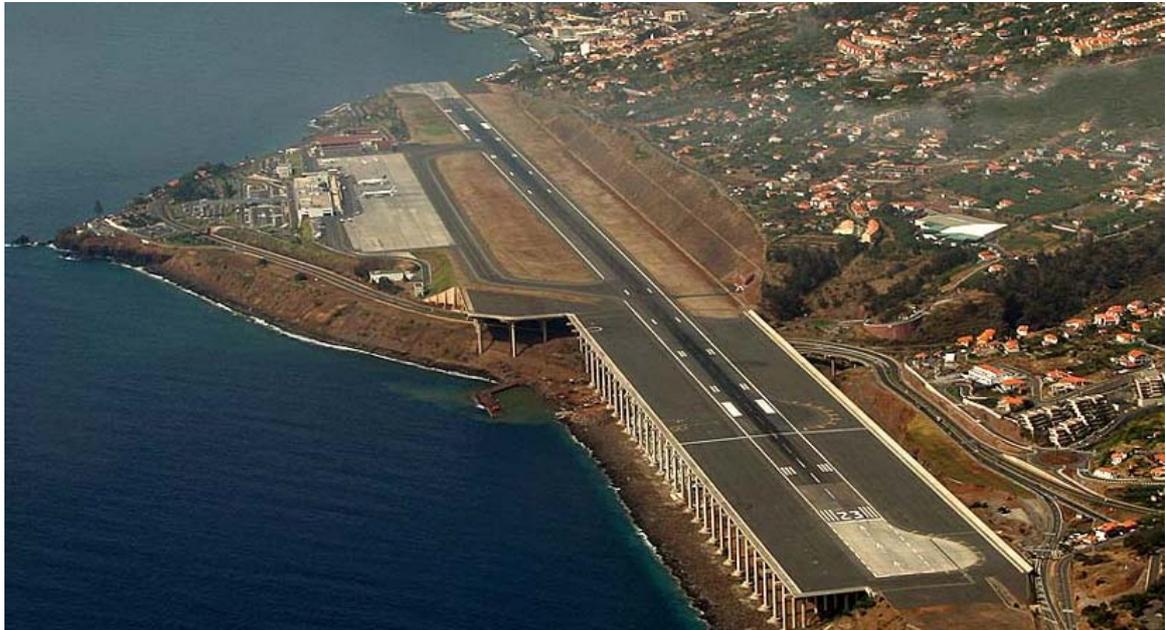
Picture Nr. 4

The Airport is located on a plateau on the east coast of Madeira Island (*picture nr. 4*). Except for the seaside, ground raises rapidly very closed to it. This fact generates, very often, wind variation and turbulence.

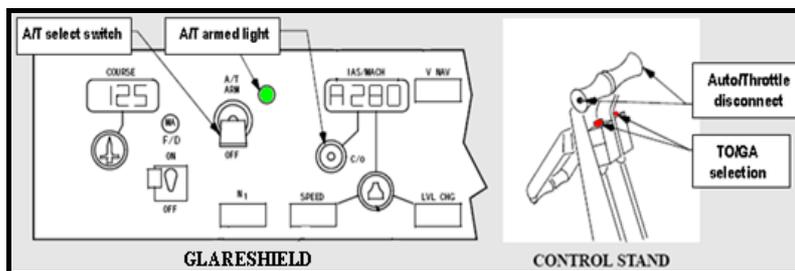
Picture Nr: 9

Pilot interface is made through A/T select switch, on glareshield, and disconnect and “TO/GA” switches, located on thrust levers (picture nr. 9).

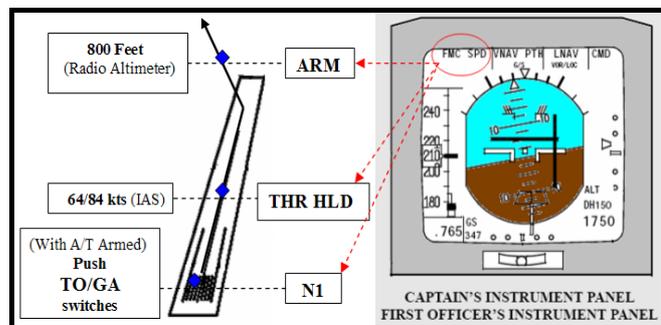
Picture Nr: 10

A/T status is indicated on top of Electronic Attitude Director Indicator (EADI), left column (picture nr. 10), on Captain & F/O instrument panels.

During take-off roll, after “TO/GA” engagement, thrust levers cannot be manually repositioned before reaching 84kts (64kts for older versions) and “THR HLD” mode be displayed, or on “ARM” mode (displayed after passing 800’ radio altimeter), unless the pilot disengages A/T.

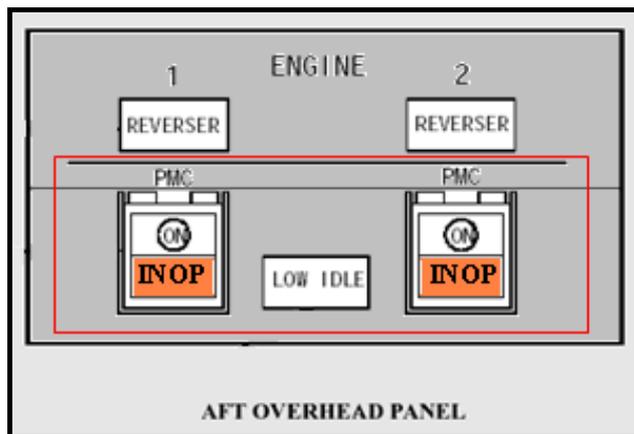
Picture Nr: 11

In case of malfunction of any PMC above 46%N2, or in case of PMC disconnected, an amber “INOP” light will come on, on after overhead panel (picture nr. 11).

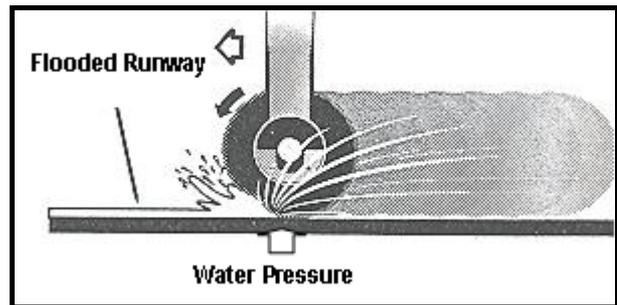
Picture Nr: 12

At high speeds, tire forward motion tends to displace great amounts of water from the tread contact area. This displacement action can generate sufficient water pressure to lift and separate part of the tire contact area from the runway surface. This phenomenon is known as **dynamic hydroplaning** (picture nr. 12).

Conditions 1 and 2 were missing.

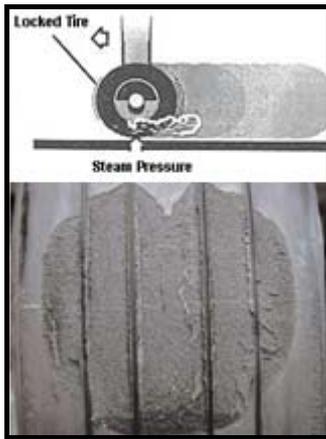
Picture Nr: 13

An accurate inspection to the tires showed no signs of wearing or melting rubber, characteristic of dynamic or reverted rubber hydroplaning phenomenon.

Another form of hydroplaning may occur when, even if there is some tread contact with the runway surface, the wheel is either locked or rotating slowly, with aircraft travelling at high speed. The friction produced by the skidding tire causes the tread material to become extremely hot. The resulting heat evaporates the water and generates steam in the contact area, providing additional upward pressure on the tire. The hot steam reverses the vulcanizing process and the tread rubber becomes irregular in appearance (gummy), resulting in a very low friction levels and braking capabilities (*picture nr. 13*).
