DATA SUMMARY

Date and time	Saturday, 24 September 2011; 11:44 h¹
Site	Near Almaraleja (Moura – Portugal)

Registration	EC-CZG
Type and model	CESSNA FR-172-J
Operator	Álamo Aviación

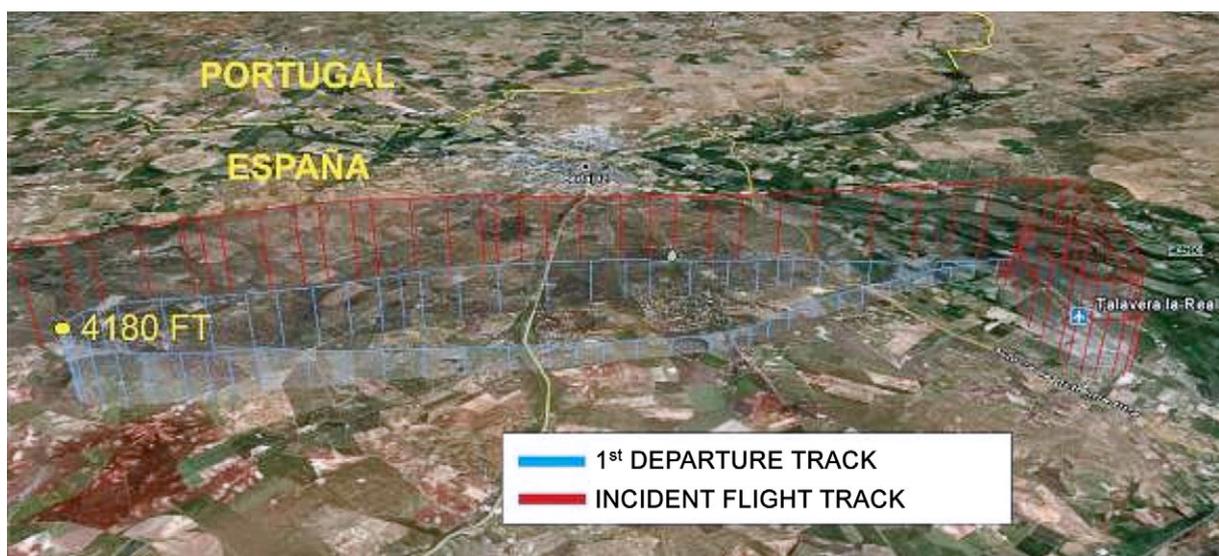
Figure 1. Flight paths of the first flight and initial segment of incident flight

At 09:19, the pilot reported to this airport's control tower that he was having problems with the airplane and returning to the airfield. When asked about the problem, he replied that he had a very low oil pressure indication and the engine was sputtering. He was cleared to proceed straight to the airfield at his discretion. When asked if he was declaring an emergency, he said not yet because, except for the oil pressure reading, everything was normal.

At the tower controller's request, at 09:21 the pilot reported being on the 211 radial and 8.4 NM away at an altitude of 3,300 ft. His intention was to conduct a right base leg for runway 13. Two minutes later he reported being 5.5 NM away on the same radial, and at 09:27 he was cleared to make the corresponding approach. One minute later he was cleared to land, which he did without incident at 09:29, after which he taxied to parking.

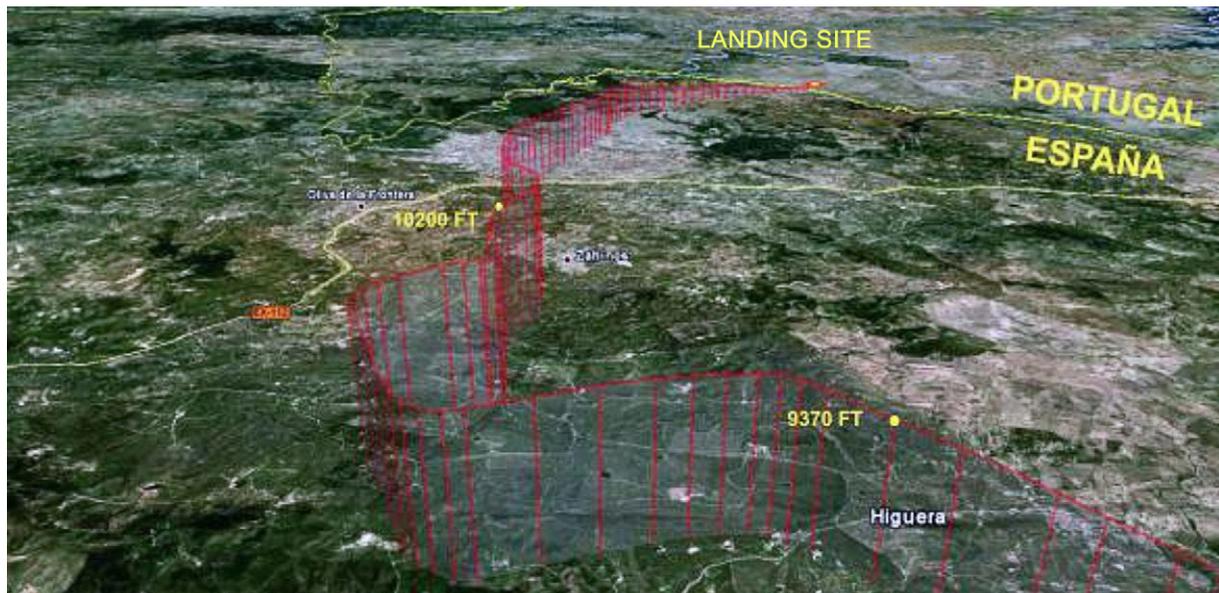
Figure 2. Final segment of the incident flight

After 40 minutes of flight, upon reaching an altitude of 12,000 ft, the pilot heard a strange sound coming from the engine, which was losing power. He decided to make an emergency landing. He reported his situation to the Badajoz Airport control tower and declared an emergency at 11:31. He gave his position and, realizing he could not reach an airfield, found a site where he could make an off-field landing.

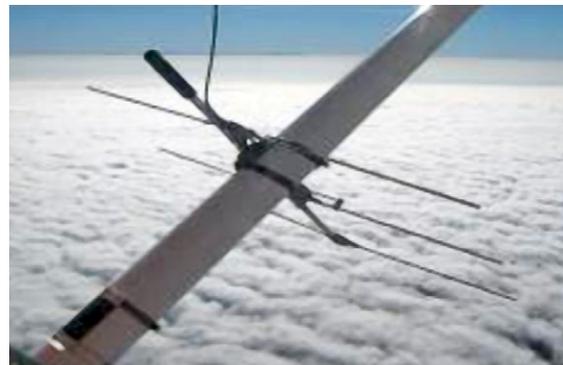
Figure 4. Antenna

The birds to be located were fitted with radio emitters in 148-152 kHz band. The equipment for detecting them included two sweeping scanners operated each one by the technician onboard the aircraft. On the outside of the airplane there were two antennas, one each on the two wing struts (see Figure 3 and close-up in Figure 4). The wires that carry the signals from the antennas to the scanners are inserted through ventilation holes on the underside of the wing and routed to the inside of the cabin.
