DATA SUMMARY

Date and time	Tuesday, 8 May 2012; 07:45 UTC¹
Site	Jerez Airport (LEJR) – Jerez de la Frontera (Cádiz, Spain)

Registration	EC-IOT
Type and model	PIPER PA-28-161 "Warrior"
Operator	Flight Training Europe (FTE) JEREZ

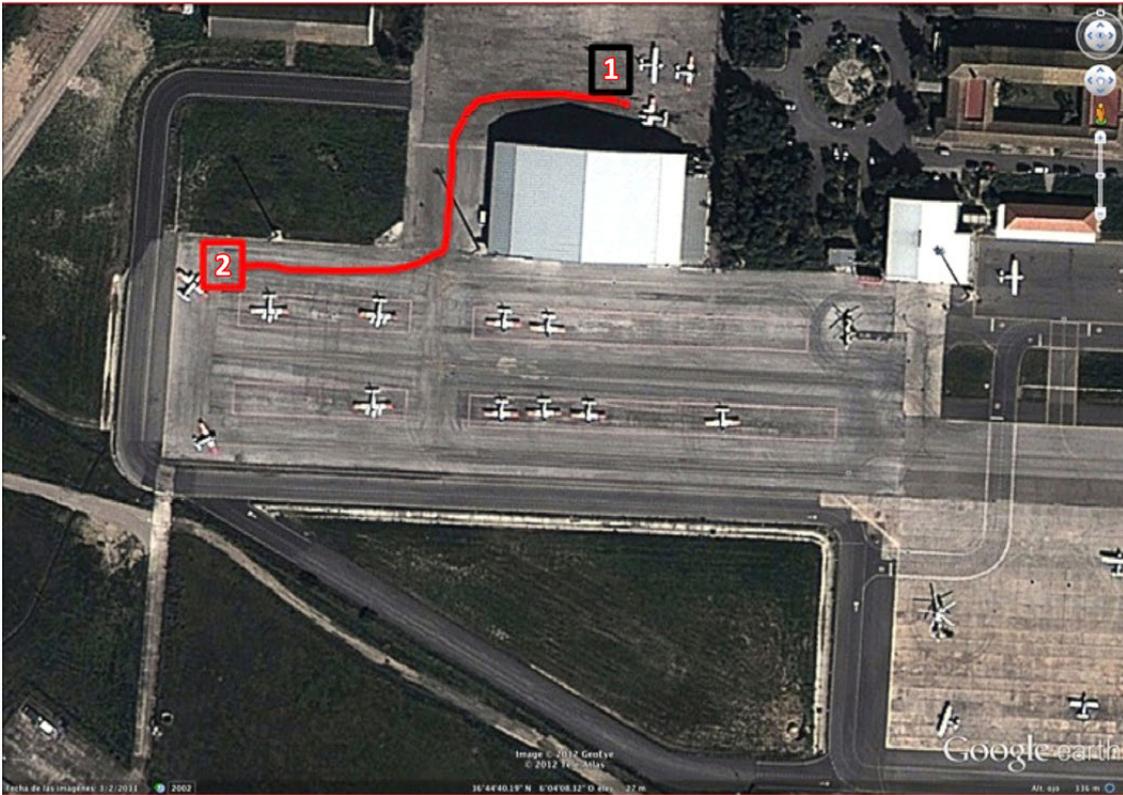
Figure 2. Route taken by the aircraft to conduct the engine test

The school’s aircraft park at point 1 and engine tests are normally conducted at point 2 (see Figure 2).
