FINAL ACCIDENT REPORT

AIR TRACTOR - 802A

EC-JLB

FINAL ACCIDENT REPORT Nr. 12/ACCID/2012

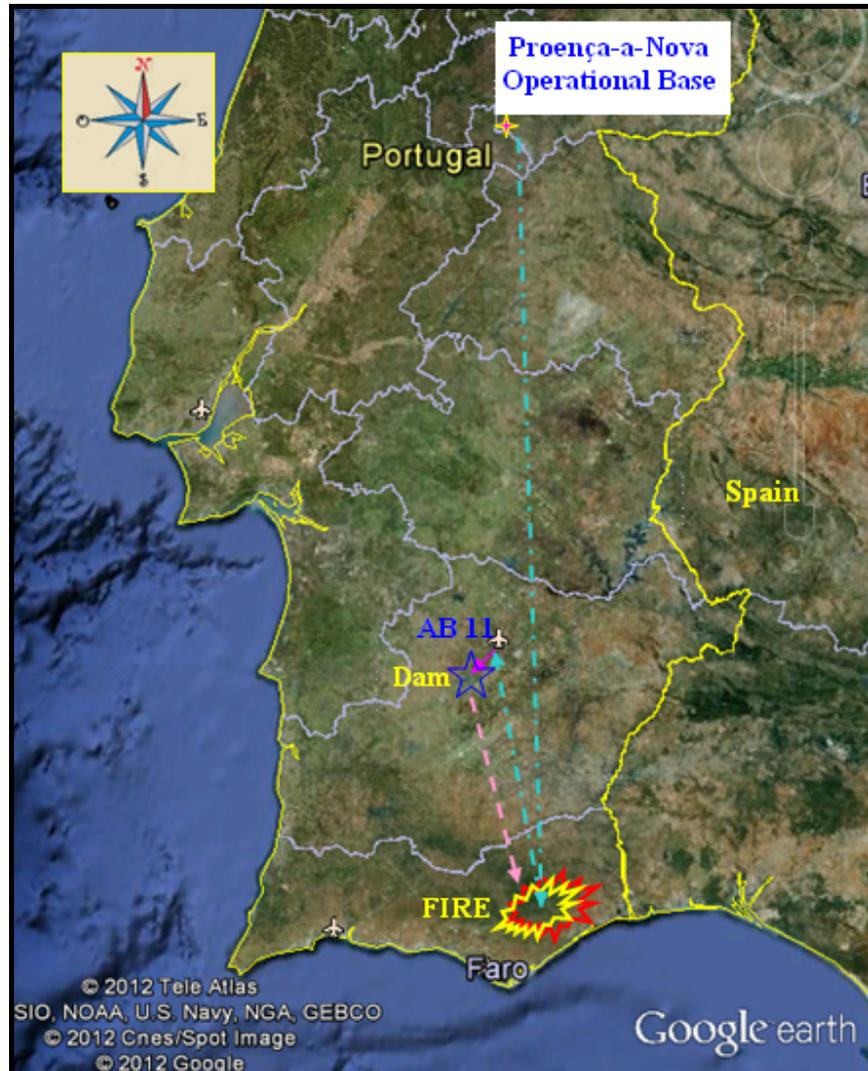
Picture Nr 1

By 12:10, both aircraft teams took-off in sequence, heading to "Roxo Dam", close to the aerodrome, where they expected to make water refuelling, prior to proceed to fire area again (*picture nr 1*).

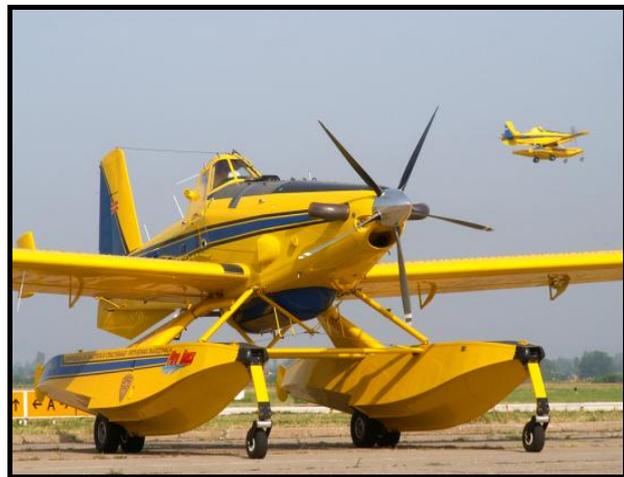
Picture Nr 4

The aircraft (*picture nr 4*) was a single engine, low wing and single pilot aircraft, specially prepared for wildfire fighting. Deriving from a previous generation of fire fighters, it was equipped with a water scooping system capable of scooping 820 USG of water in 30 seconds, for what floats had been installed, incorporating a wheeled undercarriage for land operation, becoming more versatile and efficient than his predecessor.

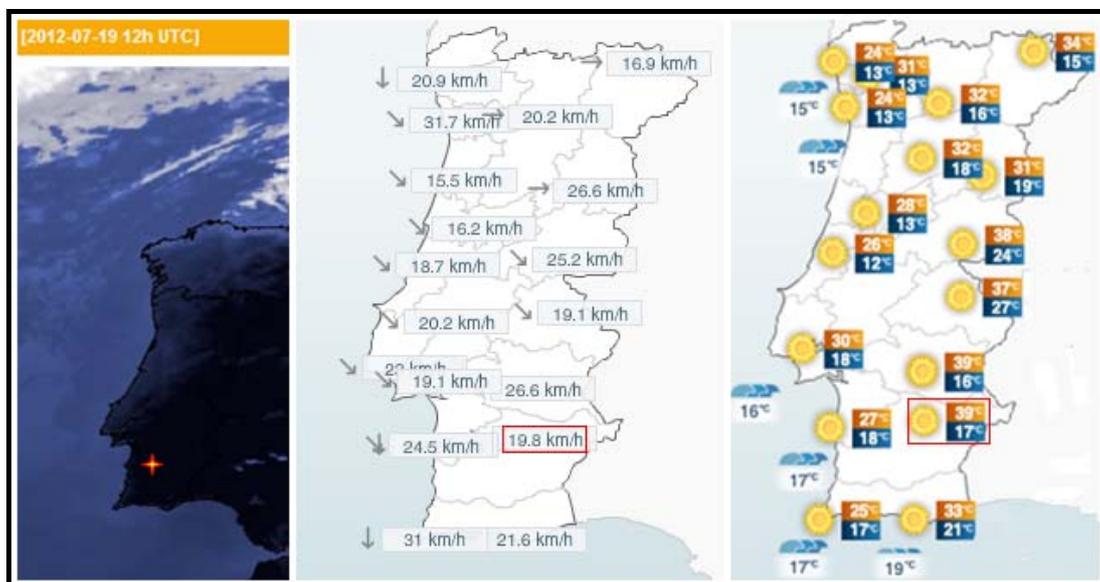
Picture Nr 5

The weather was fine, with clear sky, light to moderate North-westerly wind, high air temperature, capable of reaching 39°C (*picture nr 5*).

By accident time, the wind was blowing from 310° with 08kt and the temperature was 33°C, as meteo information from Beja military aerodrome (LPBJ) bellow.

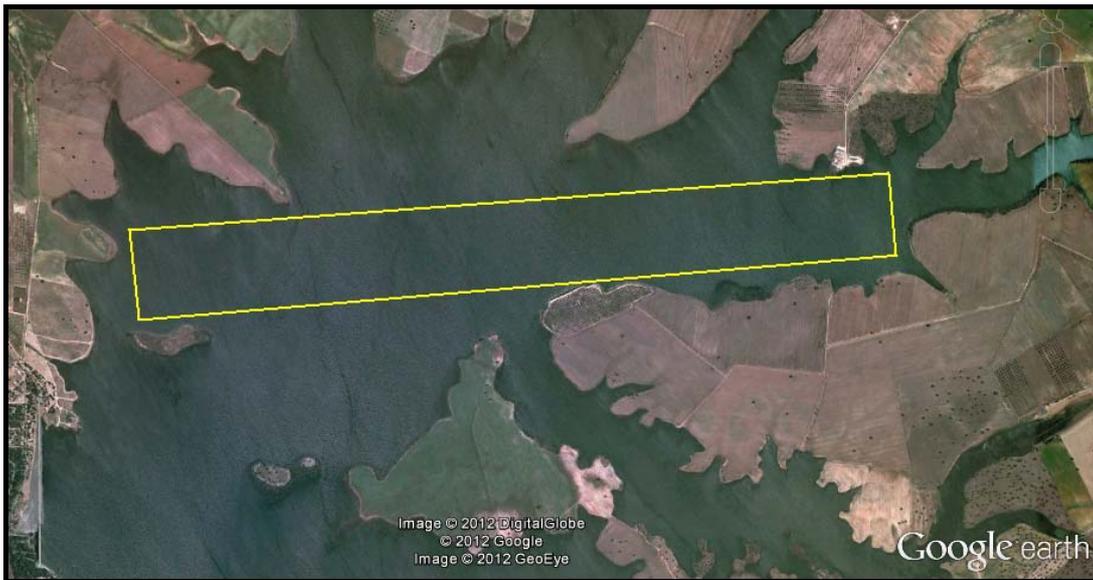
Picture Nr 6

Roxo Dam is located approximately 10NM Southwest of Beja military aerodrome and, at that time it was at a relatively high water level, which, given the absence of obstacles in its margins, no significant high grounds and no electric power lines in the zone, rendered it favourable for scooping operations. Taking a true heading of 265° (the wind was blowing from 310°), it was possible to draw a virtual runway with 13100ft X 1300ft (*picture nr 6*), well above the needs for this kind of aircraft operations.

After a sequential take-off, by 12:10, the four aeroplanes flew in group towards "Roxo Dam" and proceeded directly for scooping, always in group, on a true heading of 265° approximately, being that the best heading to grant the biggest and widest virtual runway available, more suitable for the group manoeuvre (*picture nr 6*).
