DATA SUMMARY

Date and time	Friday, 21 January 2012; 07:30 h¹
Site	San Sebastian Airport (Spain)

Registration	EC-HCG
Type and model	ATR-72-212A
Operator	Air Nostrum

REPORT

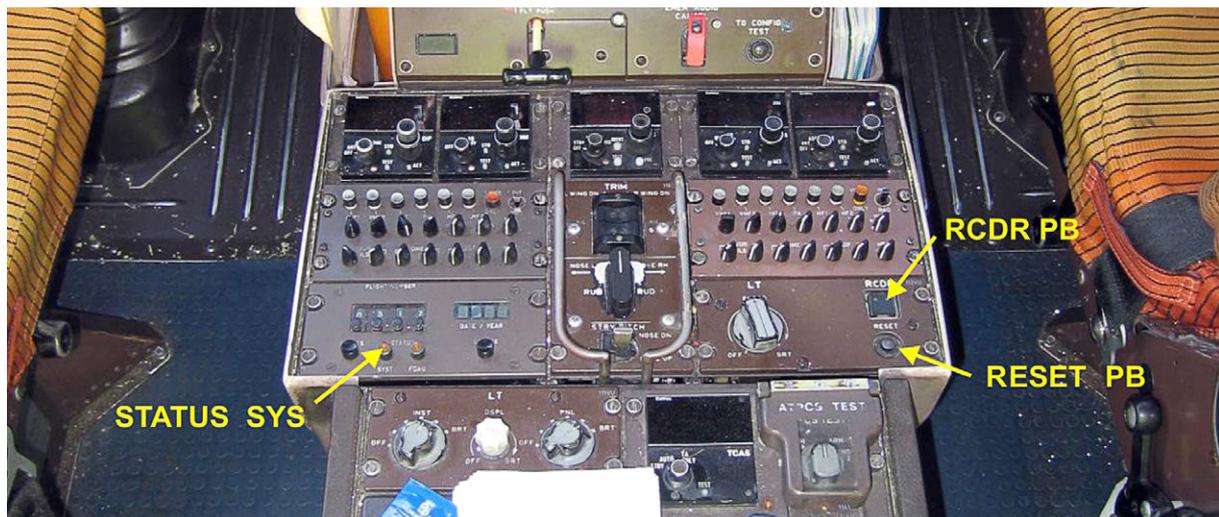
Figure 8. Aircraft pedestal

The flight crew did not report seeing this light energized in the cockpit. The checks made in the airplane revealed that the STATUS SYST light was not burned out, since when another recorder was installed, the light turned on when the FDR was deenergized, as expected.

- First, another FDR with the same part number was installed on the incident aircraft, and the MPC was replaced. No system status lights came on and the information was confirmed to have been correctly recorded on the FDR.
- The MPC in use in the aircraft on the day of the incident was then installed and the data verified to have recorded properly with no caution lights.
- Once the manufacturer confirmed the fault in the FDR's memory, the FDR was once again installed on the incident aircraft. Investigators confirmed that the STATUS SYST remained off even though the FDR indeed was not recording any information.

- Finally, with the FDR still installed on the incident aircraft, it was confirmed that opening the FDR feeder breaker caused the STATUS SYST light to turn on in the panel in the cockpit.
