## Report A-026/2016

Accident involving a PZL W-3AS  
aircraft, registration EC-LQA, operated  
by Hispánica de Aviación (HASA), in  
Villanueva de la Cañada  
(Madrid-Spain) on 17 July 2016

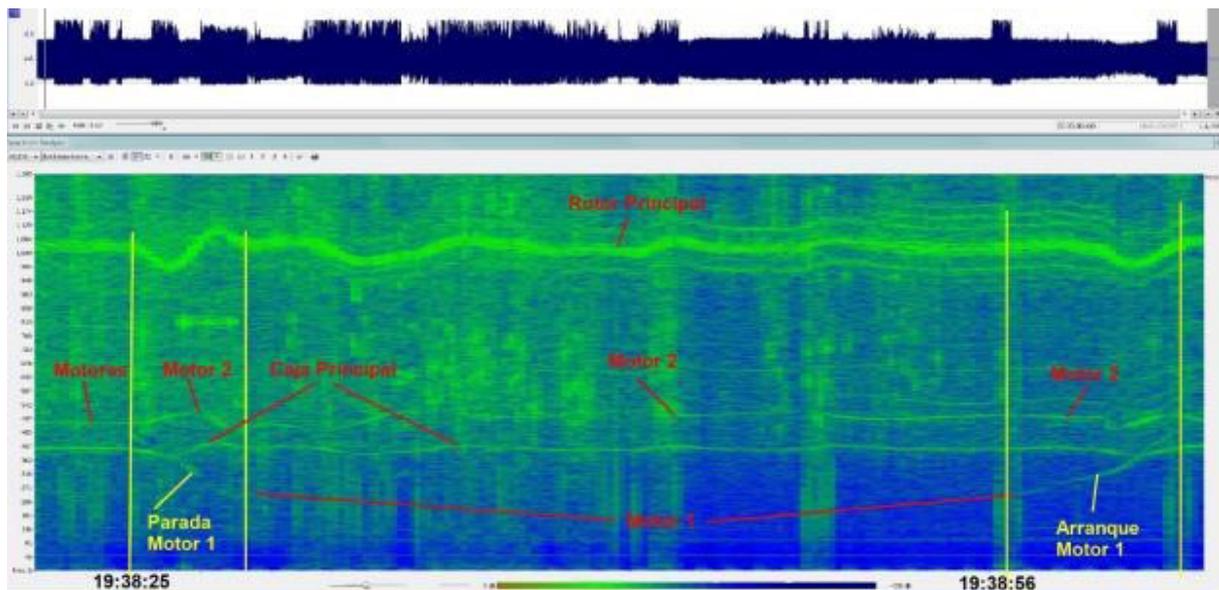
- 1029 Hz: corresponds to the normal operation of the main rotor (100%)
- 407 Hz: corresponds to the main gearbox, proportional to the main rotor.
- 497 Hz: corresponds to the accessory box, driven by the gas turbine and proportional to N1. This frequency line clearly shows a drop when the valve is closed and a subsequent increase in frequency once the crank, associated with N1, is commenced.

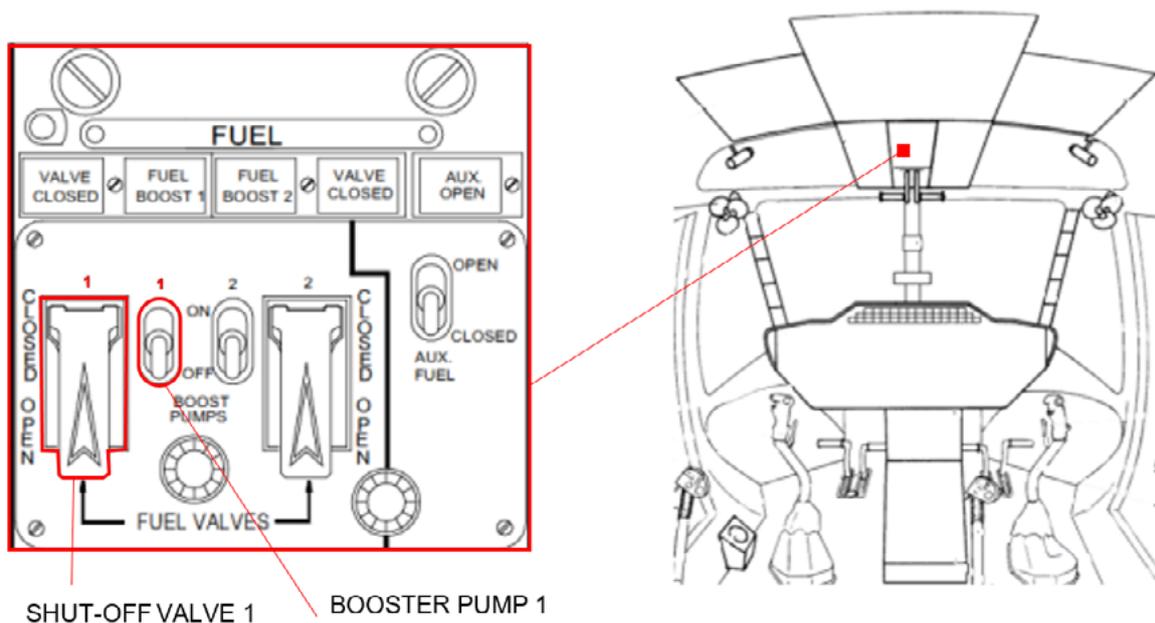
Figure 8. Location of fuel pump and shut-off valve controls for the engines

During operation, an imbalance can occur between the amount of fuel in the main forward and rear tanks. This imbalance is allowed up to a certain limit, and the emergency procedure in the Flight Manual for restoring the balance in the tanks (Excess of Fuel in Either Engine Group of Cells) specifies the following:

- When the quantity in the main (rear) tank supplying the 1 (left) engine exceeds the forward tank that supplies the 2 (right) engine by 200 l, turn off the booster pump for the tank with more fuel (BOOSTER PUMP 1 to OFF), and turn it on again when they equalize.

- When the quantity in the main tank for the 2 (right) engine exceeds the tank for the 1 (left) engine by 300 l, turn off the booster pump for the tank with more fuel (BOOSTER PUMP 2 to OFF), and turn it on again when they equalize.

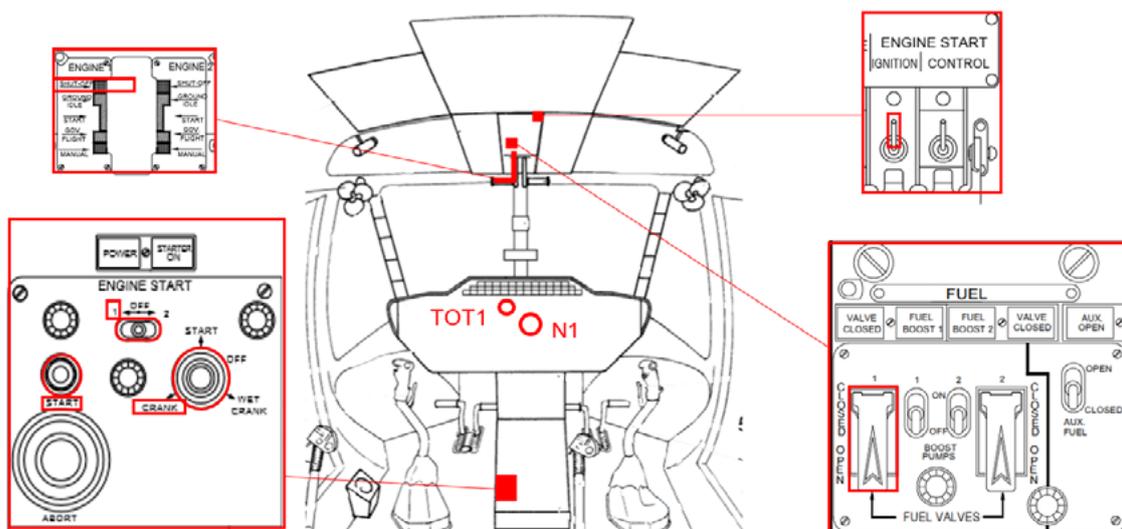
Figure 9. MOTORING THE ENGINE (CRANK) procedure

(motor the engine) before starting whenever any of these conditions exists: TOT above 270° C, failed start, maintenance of the lubrication system or if the engine was wet motored. Since the procedure is included in the engine start section, the engine power lever is in the SHUT-OFF position as a consequence of the “Before starting engines” procedure. Therefore, of the six steps required in the procedure, one is not included as it is a condition of the previous sequence, and two are included in parentheses before the procedure proper. The procedure as contained in the Flight Manual is shown in figure 9.

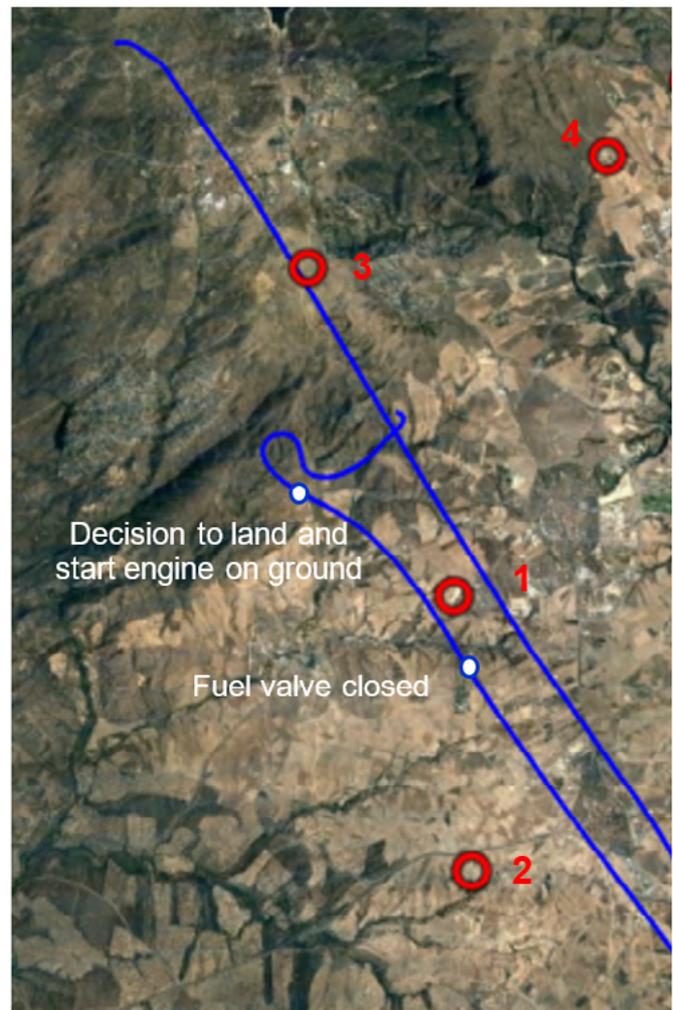
Figure 10. Alternate fields along flight path

- (1) Aerodrome of Villanueva de la Cañada.  
Cross runways 200 m and 160 m long.  
3.2 km away  
2.5 min away at 41 kt (1.5 min at 65 kt)
- (2) Aerodrome of Brunete:  
370-m runway  
6.5 km away  
5.3 min away at 41 kt (3.2 min at 65 kt)
- (3) Private aerodrome:  
250-m runway  
3.4 km away  
2.6 min away at 41 kt (1.7 min at 65 kt)
- (4) Aerodrome of Villanueva del Pardillo:  
Cross runways 360 m and 160 m long  
7.5 km away  
5.9 min away at 41 kt (3.7 min at 65 kt)
