## A-004/2017

Accident involving a Socata TB-20 Trinidad aircraft, registration D-ECJP, in Sierra de Tejada, Canillas de Aceituno (Málaga) on 29 April 2017

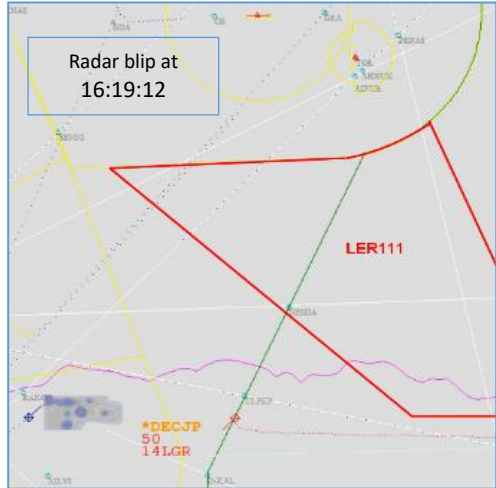
16:18:55	DECJP	<i>DECJP squaking 6303 we are VFR flight from LEMU to LEGR presently 5000' inbound PTM<sup>9</sup>, request to cross airspace and 5000' via PTM, LEAX, S from LEGR inbound for LEGR</i>
At <b>16:18:55</b> , the crew of the aircraft contacted LEMG APP and after identifying itself as a VFR flight on route to point PTM at 5000 ft, they requested to cross the airspace at 5000 ft via PTM, LEAX, point S for LEGR and LEGR.		
Remarks:		
<ul style="list-style-type: none"> <li>The phraseology used and the data provided by the crew of the aircraft in their report conform to the communication standards for VFR<sup>10</sup>.</li> <li>The crew are aware that VFR rules apply.</li> <li>The crew know the points they are flying, indicating they have available to them a navigation chart (identified in the wreckage).</li> <li>The crew anticipate entering class-D airspace and contact ATC to request crossing the airspace.</li> <li>The aircraft started a right turn during the transmission, as shown by the radar track, in order to stay at an altitude of 5000 ft.</li> </ul>

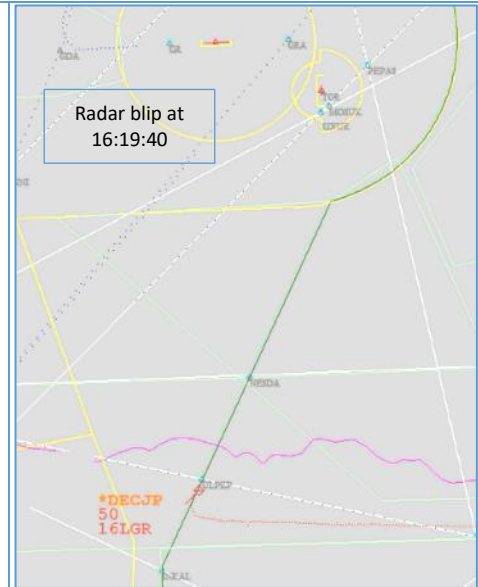
- Since the controller makes no reference to the altitude, the crew seek clarification by trying to determine if they can continue to point PTM, the first point listed on the route, at 5000 ft.
- The crew of the aircraft are uncertain about their current altitude and the altitude they should be at in order to cross the airspace.
- The aircraft continues turning right while holding at 5000 ft during the conversation.

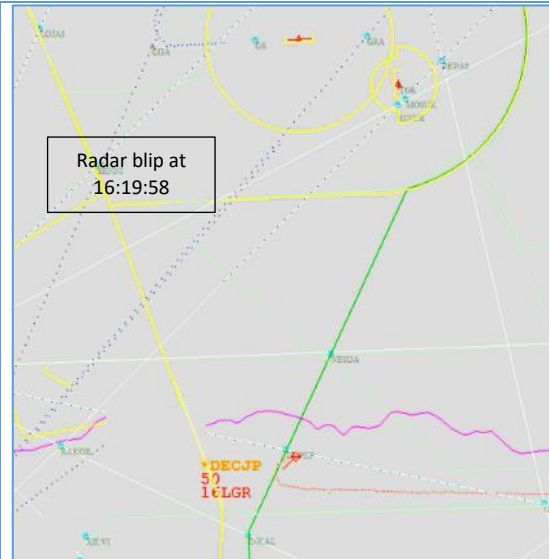
- The use of the term “confirm” in its communication means that the crew are confirming the climb to 5500 ft and the route to LEGR point S.
- The confirmation is used to verify that the correct altitude is 5500 ft, since the altitude is the only change made during the messages exchanged.

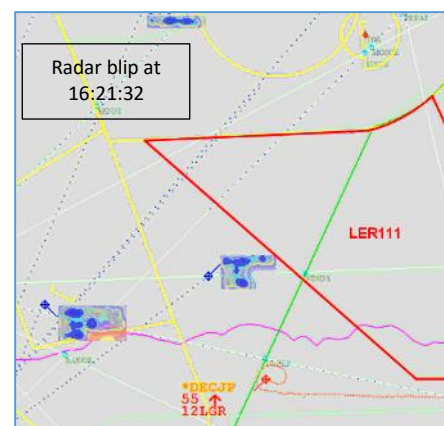
At **16:21:32**, the crew reached 5500 ft while still turning.
