Report

A-037/2018

Accident involving a Piper PA-28R-200, registration EC-HSZ, at the Cuatro Vientos Airport (Madrid) on 4 September 2018.

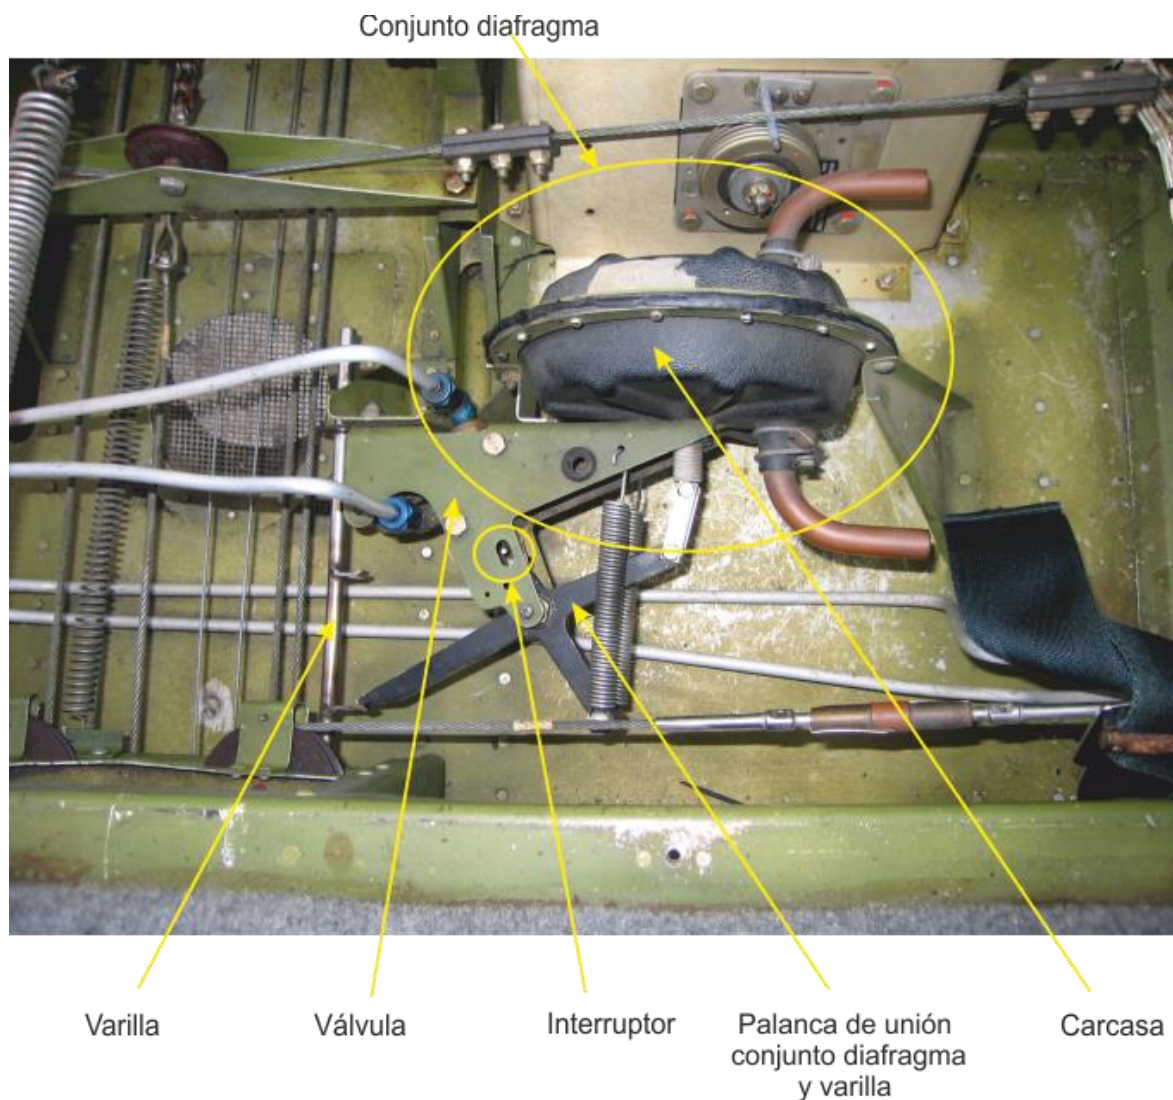
As described in the Pilot's Operating Handbook, this system is controlled by differential air pressure across a diaphragm that is mechanically joined to an electric valve and a switch that turns the electric-hydraulic pump on. The system that provides static and ram air pressure to this diaphragm is located on the left part of the fuselage, above the wing. Any blockage of the orifices could cause the gear to lower.

Fig. 3.- Automatic gear extension system

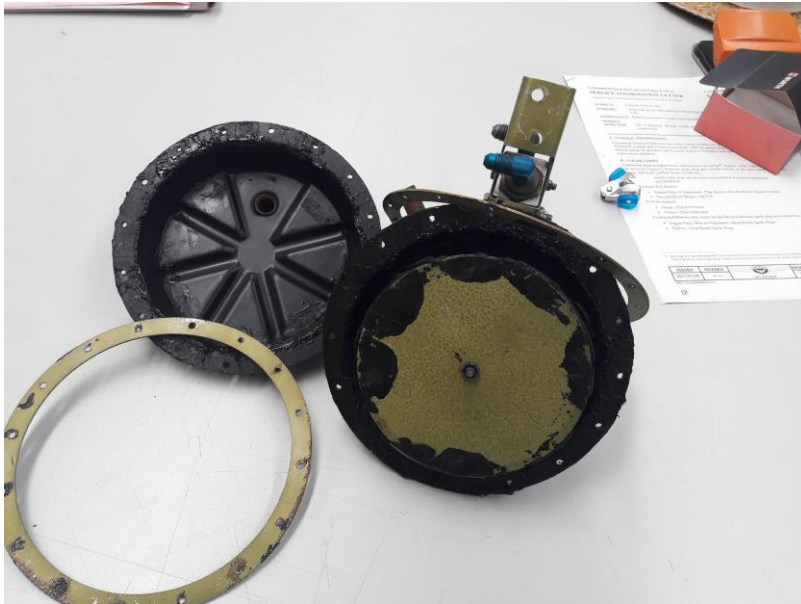
As for the pressure sensor mechanism, once opened it was found to be blocked because the diaphragm assembly, consisting of a membrane and circular metal supports, was stuck to one of the sides of the casing that housed it, which prevented it from moving.

Fig. 9.- Pressure sensing assembly

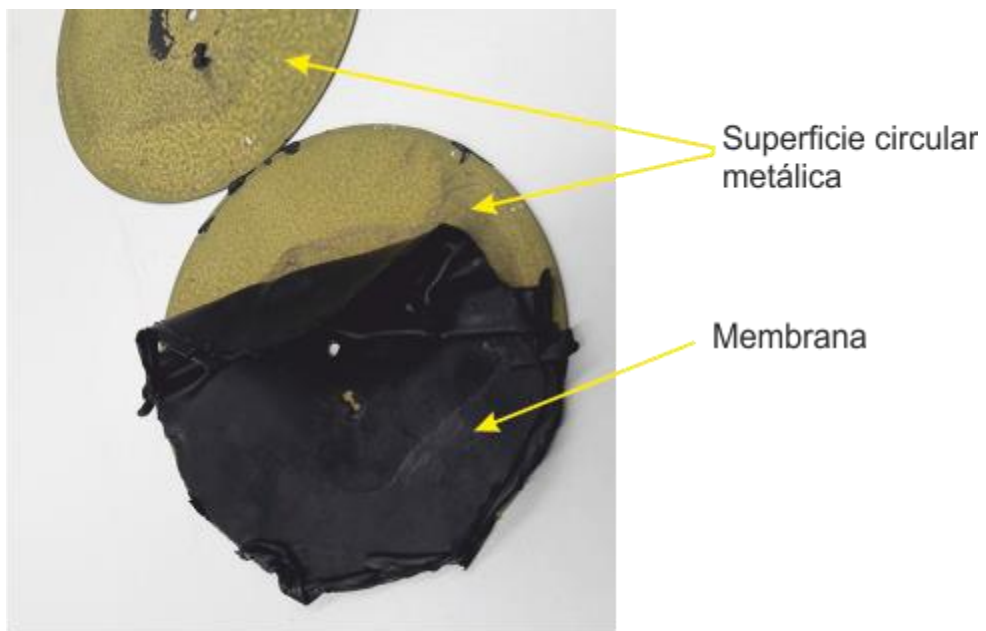
Fig. 12.- Internal view of diaphragm assembly

Opening the casing that contained the diaphragm revealed that the membrane had deteriorated and stuck to one side of the casing (see Fig. 8), precisely in the position where it would be when the lever is in the topmost, or override, position, which disarms the automatic gear extension system. As a result, the rod was only able to move as far as the distance between its two tabs – which push the diaphragm – a distance that, as the diagram/photo show, is insufficient to change the condition of the landing gear mechanism (see Fig. 3).
