Arab Republic of Egypt
Ministry of Civil Aviation
Aircraft Accident Investigation

Final Report

Air Balloon Burning and falling Accident

Registration SU-283

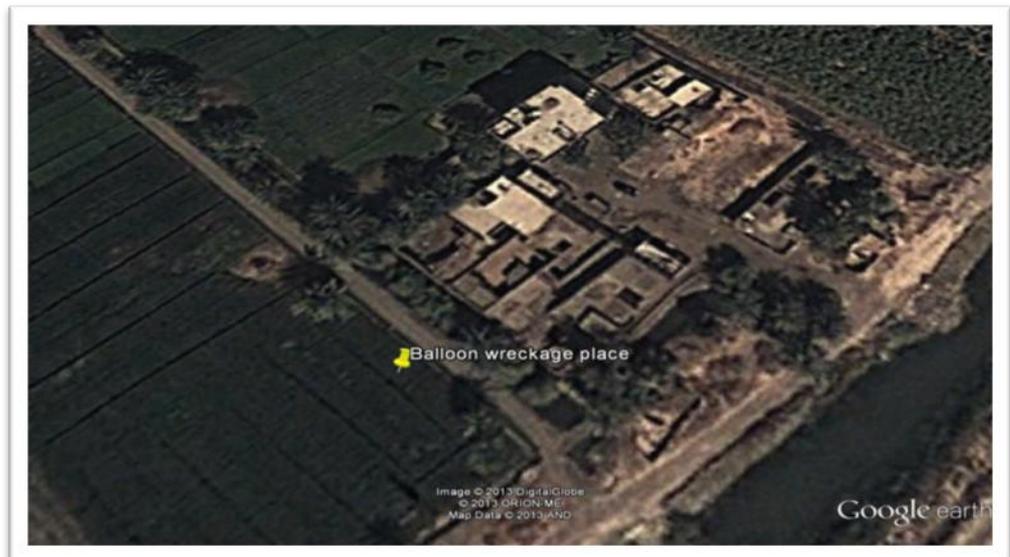
- The balloon fell down on an agriculture land in the side of “Hager El Dabeyyah”. This land was cultivated with wheat. The wheat height was almost 60 cm. The coordinates of the area center is almost N 25°40’55”, E 32°33’50”

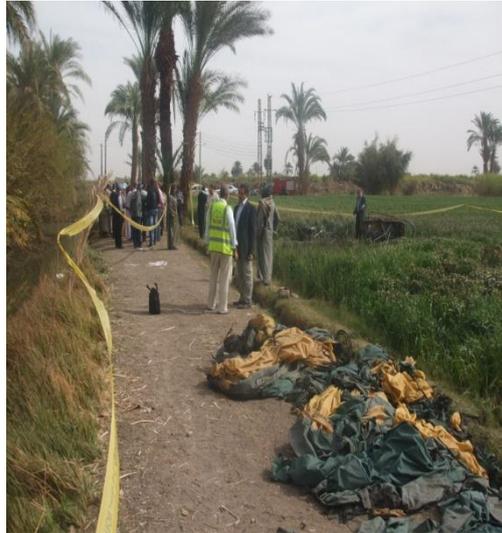
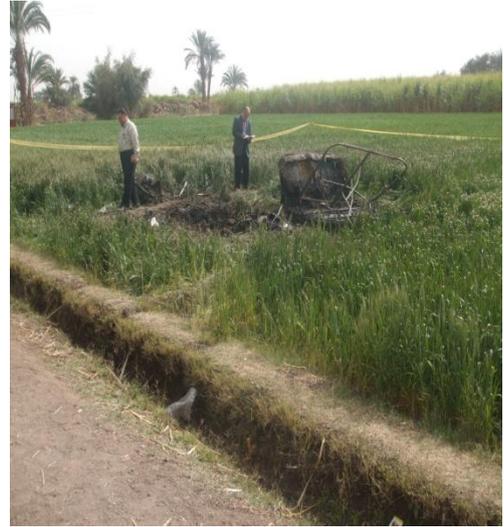
- The balloon falling down site is surrounded from the South Western side with low tension cables.
- The site is surrounded from the Northern Western side, with an unpaved road and then a canal with a width of almost 8 meter.

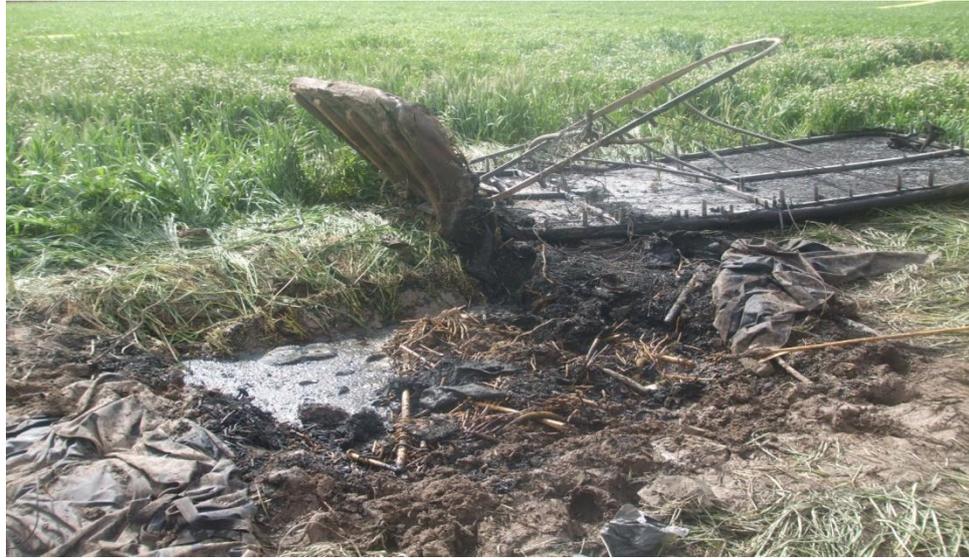
- The site is surrounded from the North eastern side with some palm trees, and an irrigation canal (Merwa) with the width of ½ meter, then an unpaved road of a width of three meters, followed by a small canal of a width of another three meters, followed by palm trees with a house of four stories behind the trees.
- It is surrounded from the West side agriculture lands
- The impact of the balloon resulted in a rectangular pit of almost 2.2 meter length, 1.8 meter width and about ½ meter depth.

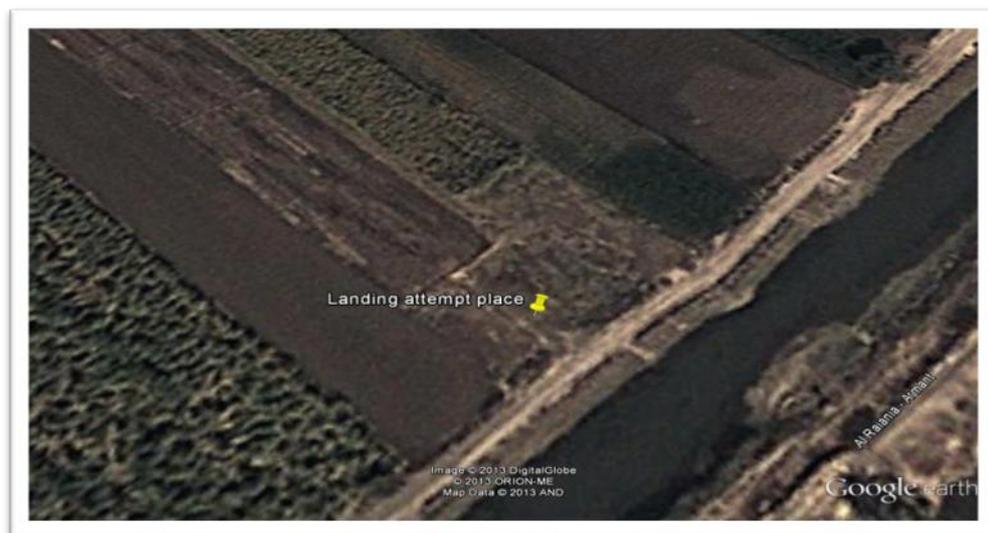
- The balloon captain selected a clear land of 15.3 meter by 30 meter dimension near the sugar cane fields at the side of “Hager El Dabeyyah” for landing. The coordinates of this area center are N 25°41’00” , E 32°33’56”

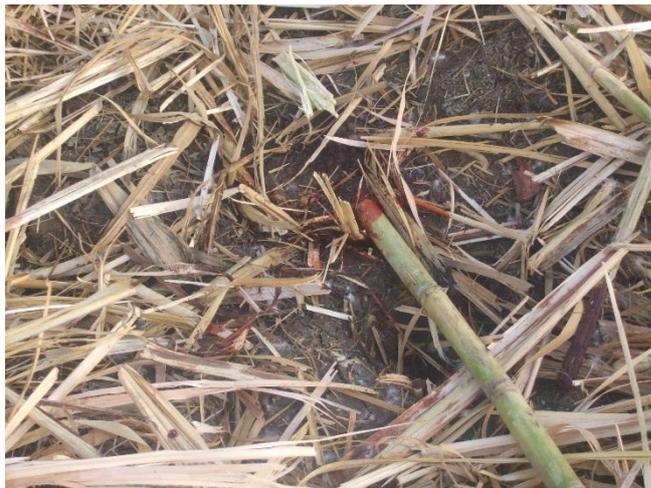
- The area was surrounded from the western side by sugar cane fields and a house of four stories, then the site for the fallen wreckage.
- Some traces of fire were observed in the sugar cane fields as a result of the victim falling inside them

- Some traces of bloods were also observed at the locations of victims falling.

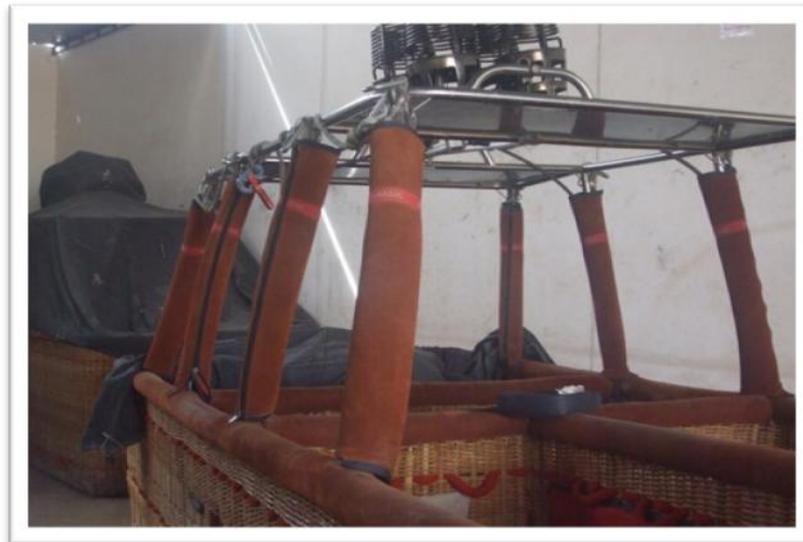
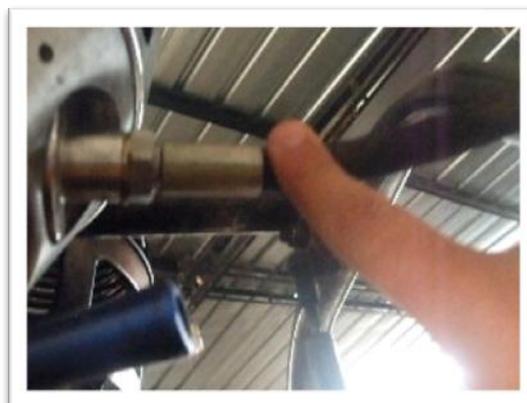
- The investigation Committee has examined a balloon of a similar type as the event balloon (Ultramagic- N425) in the store of one of the balloon company, the following was observed:
 - The fuel hoses were fixed on four beams on the balloon metal frame and covered with a jacket of the rubber cloth.

- Bents were visible in the hoses, in the upper part before connecting the hoses with the burners

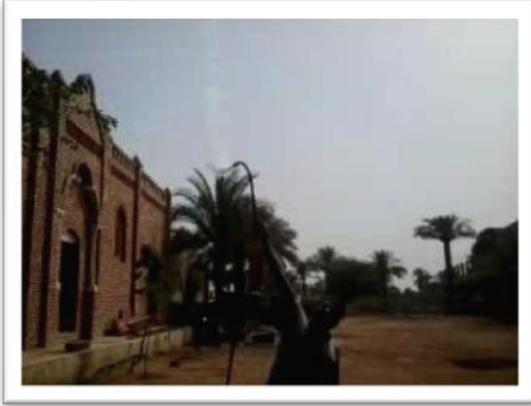
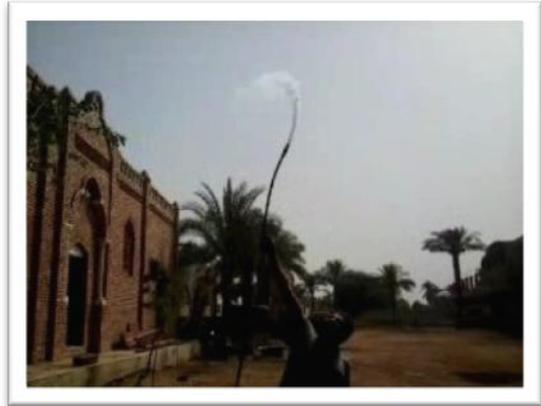
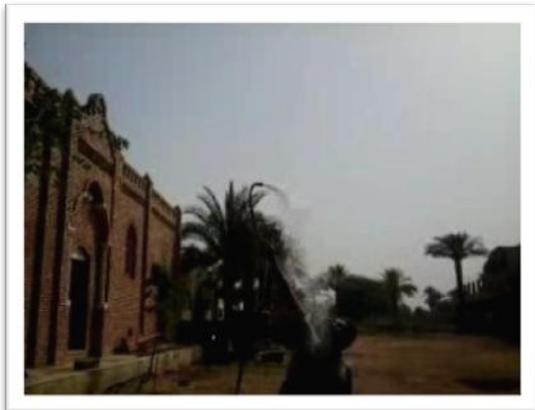
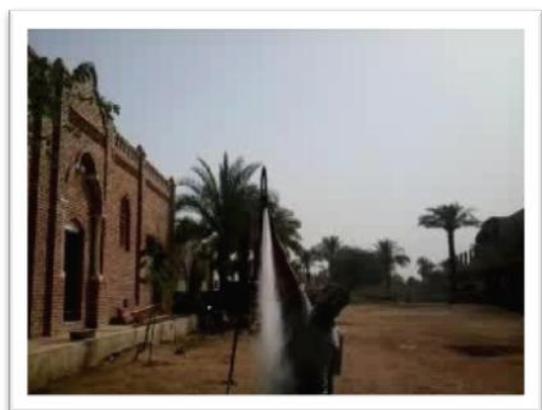
- The hose moved strongly to the right and left of the position where the one performing the experiment was holding the hose.
- The gas was going out as a white liquid spray.
- A loud noise was heard when the gas was going out the hose.

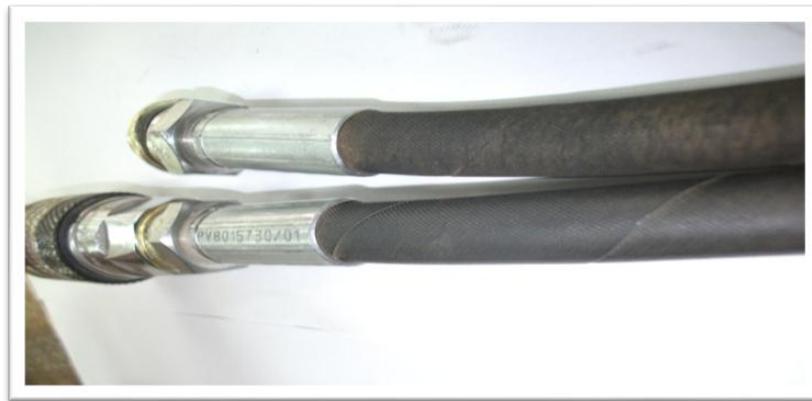
- The start of the influence of the heat and the environmental conditions at the adjacent part of the igniters at the part near to the quick connection connectors (TEMA) were easily observed, this can be identified through the dissimilar colors.
- Cracks were visible at the part adjacent to the burners, its intensity increasing as it becomes more near to the igniter, it decreases as it becomes more far from it, until it almost disappears

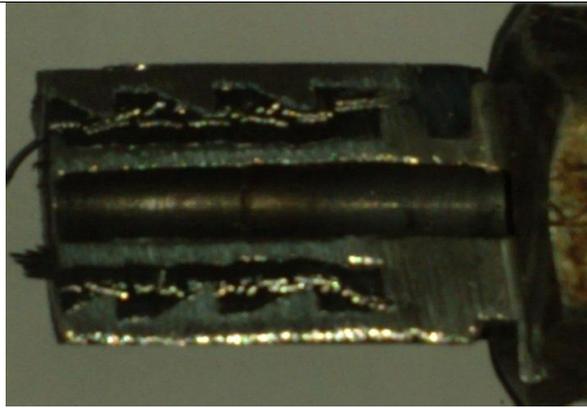
Longitudinal cross section of connector 191

It was noticed that the hose contains two areas still covered with rubber. The rest of the hose was burned showing the internal fiber steel reinforcement with an average diameter 12 mm.

The approximate length of the hose is 275 cm.

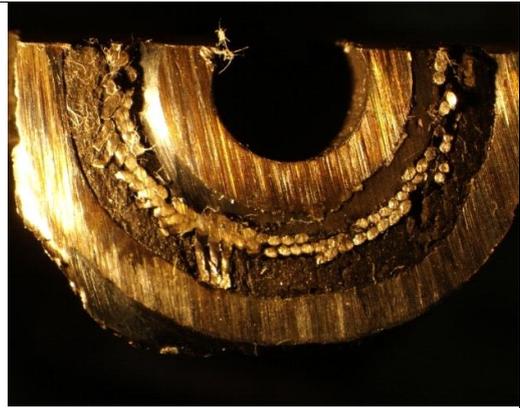
Diameter sector cross section of connector 191

After longitudinal cutting of connector to burner 191, it was noticed that the inner as well as the outer tubes contains teeth that bite the rubber layer of the hose. Biting continues to the fiber steel reinforcement.

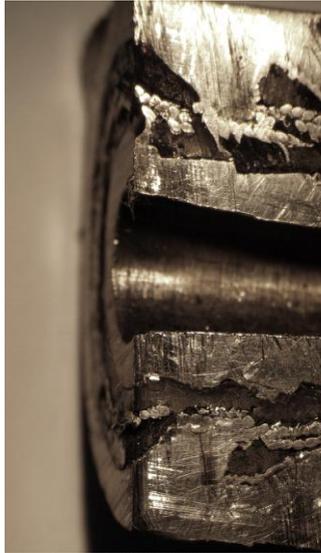
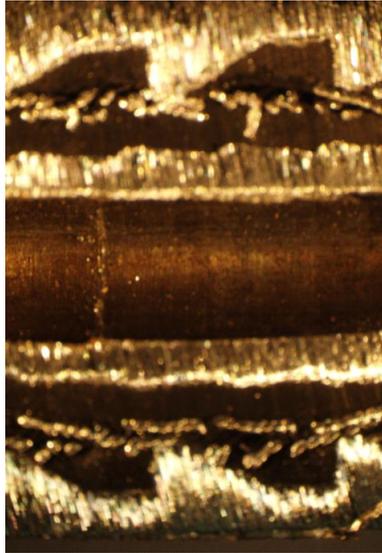
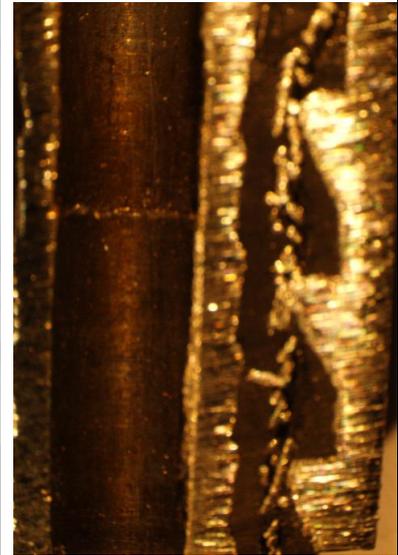
Longitudinal cross section of connector to burner 191

The biting mechanism clearly shown in the following photos suggest it is a remote possibility that the hose could release from its connector under normal circumstances unless it is subjected to an external pulling force.

Inner tube teeth

Outer tube teeth

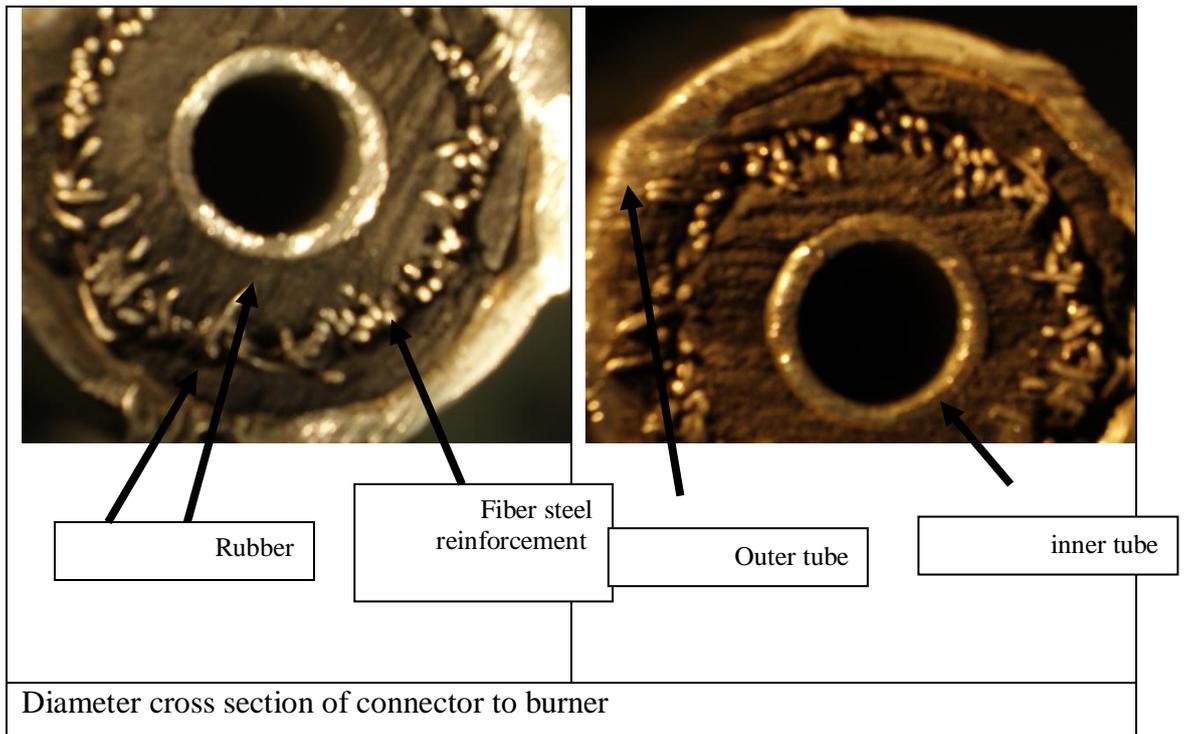
The following photos show that the connector to burner contains rubber hose between the inner and outer tubes. The fiber steel reinforcement is clearly impeded in the rubber layer.

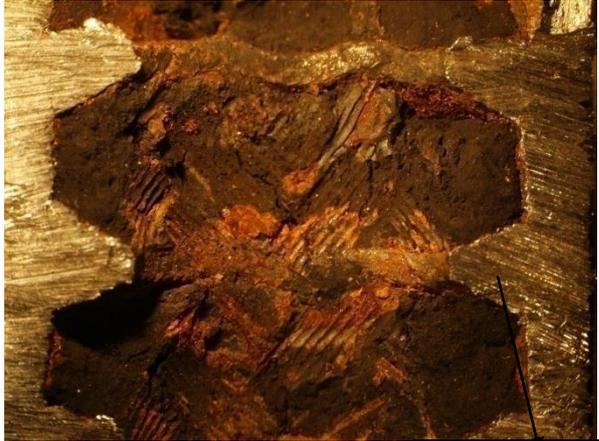
Rubber ash traces

Outer tube of the connector

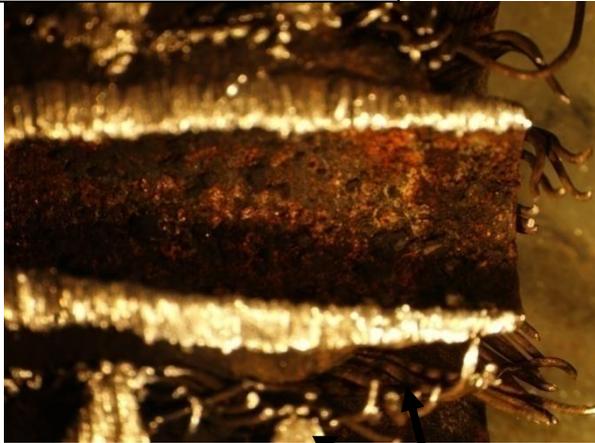
Rubber ash traces

Fiber steel reinforcement

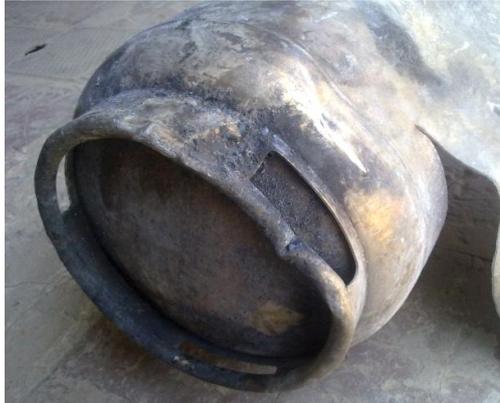
Lower seam welding lines
Edges of the failed wall of the cylinder move outward

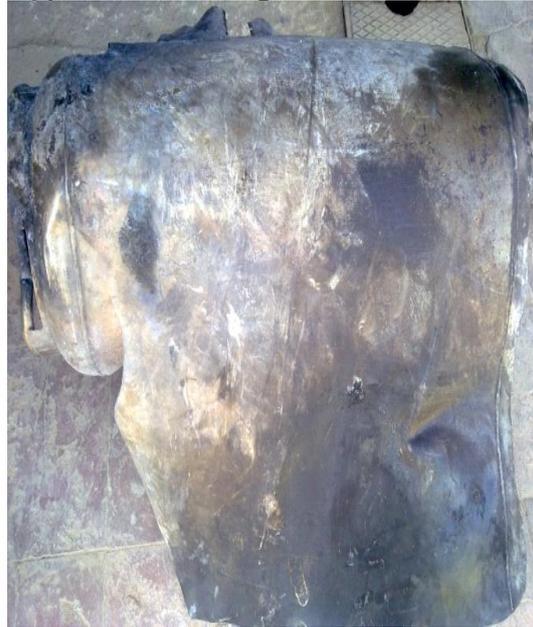
Loss of surface coat painting
Upper seam welding lines

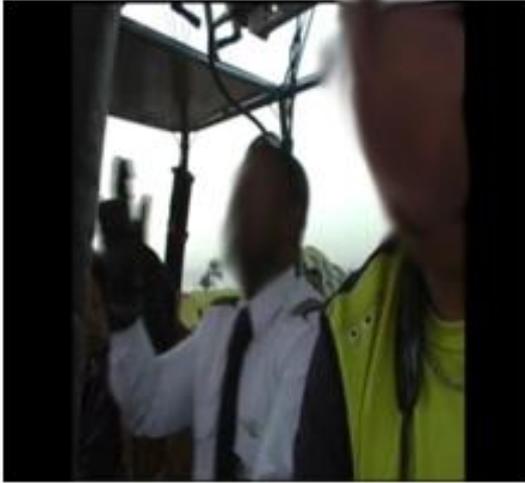
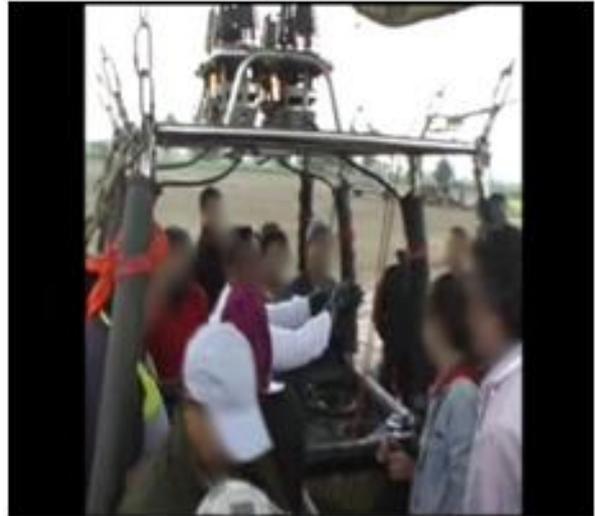
- The wires attaching the envelop to the basket Appearance of the metallic cover above the basket and below the burners. It seemed to be in good condition.

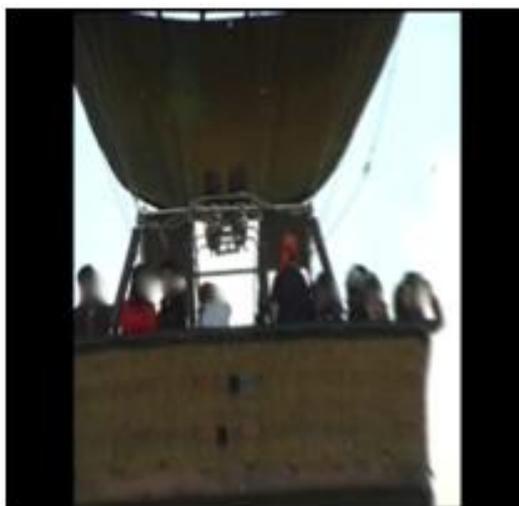
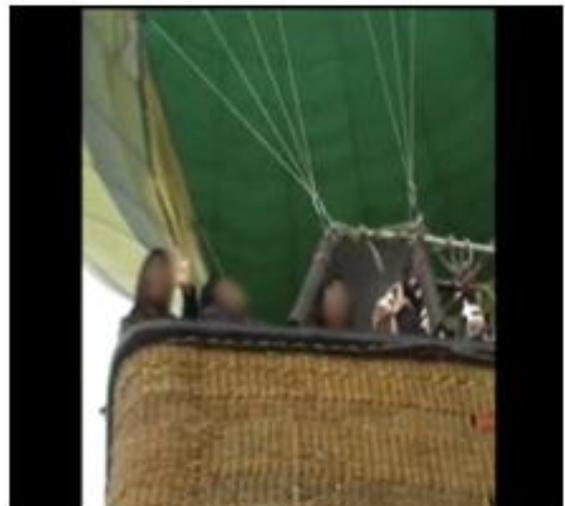
- Appearance of the metallic cover above the basket and below the burners. It seemed to be in a good condition.
- The ignition in only two burners out of the four burners was visible (Left forward and aft)
- The Drop line appeared attached to the basket pulling rope with the car.

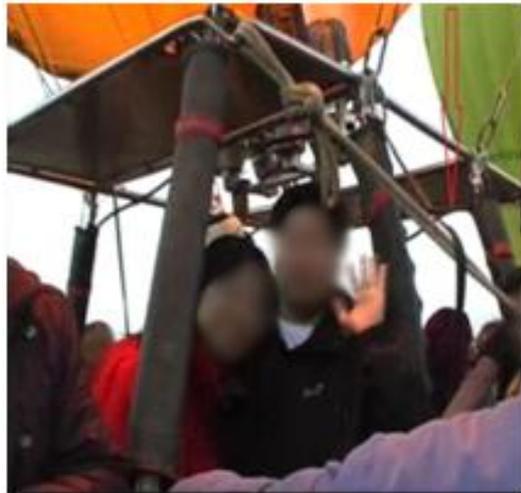
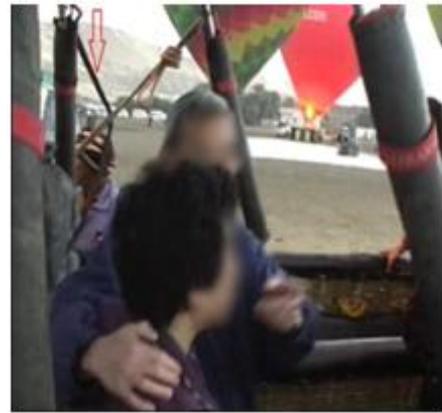
- Appearance of the four covers on the four hoses connected to the burners.

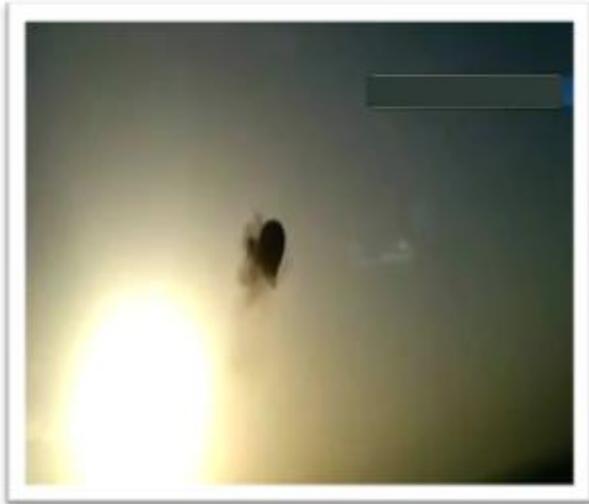
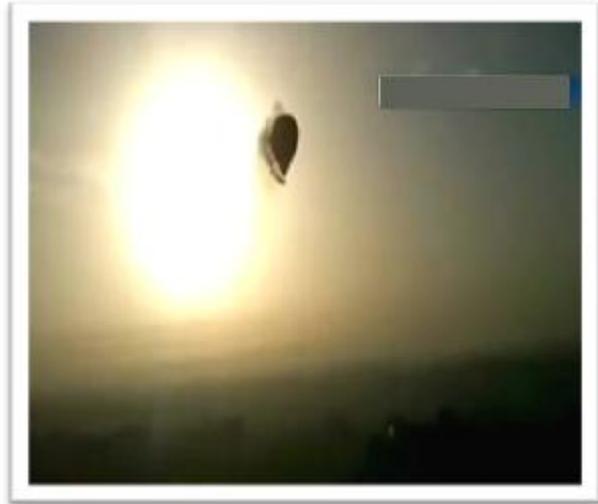
- The appearance of black smoke started at the left side of the balloon and the continued growing.
- The balloon height was increasing with smoke growing.
- The smoke was severely growing until both the envelop and the balloon totally changed to a heavy smoke flame.
- The balloon and its parts fell down on the ground

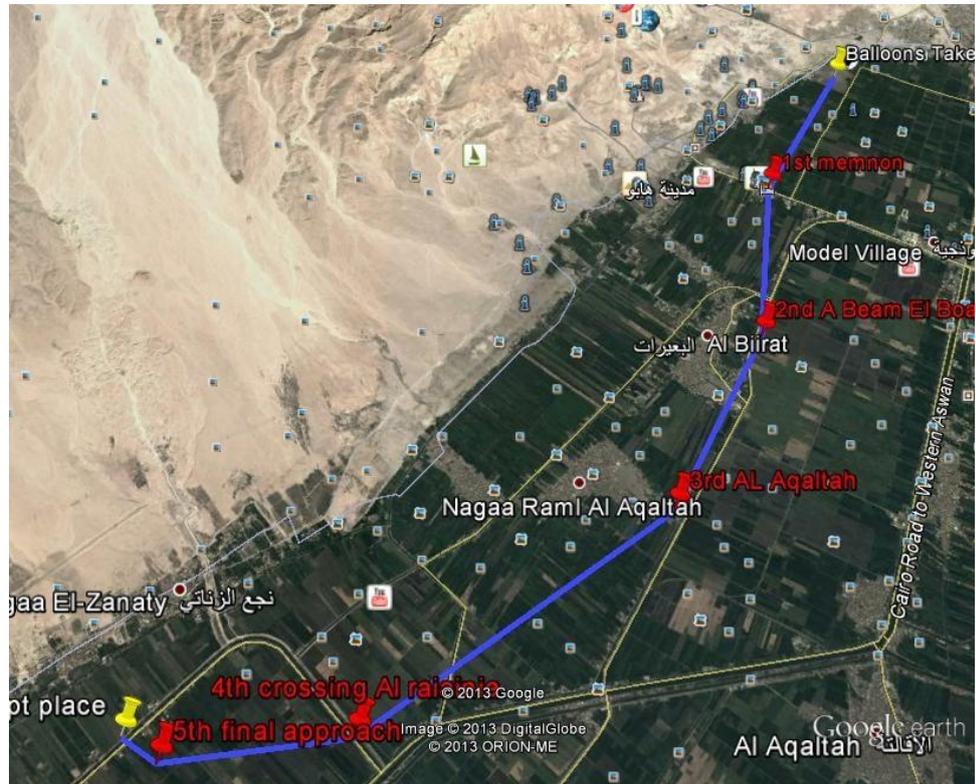
Photo showing the estimated flight path of the accident flight

- The balloon took off in a normal way from the area assigned for departure.
- The balloon continued flying normally for about 35 minutes.
- The balloon captain selected an open area for landing the balloon
- The distance between the take off site and the first landing attempt site is about 8.27 km. Considering that the flight, including the beginning of the landing procedures by the captain took about 40 minutes, the average balloon speed was about 12.4 km/ hr.
- Communication was made between the balloon captain and the ground crew leader to inform him about the selected location for landing the balloon.
- The balloon captain crossed the electric wires and then the water canal, directing the balloon to the selected site for landing
- The balloon captain dropped the “Drop line” rope to the ground crew.

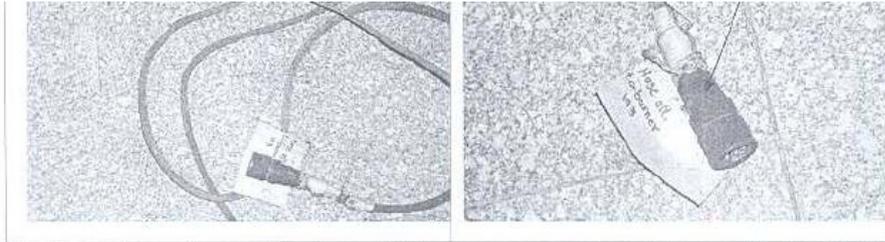
By visual inspection to the hose which was connected to burner 193, the TEMA was found connected to the hose.

The connector to the burner wasn't connected to the hose.

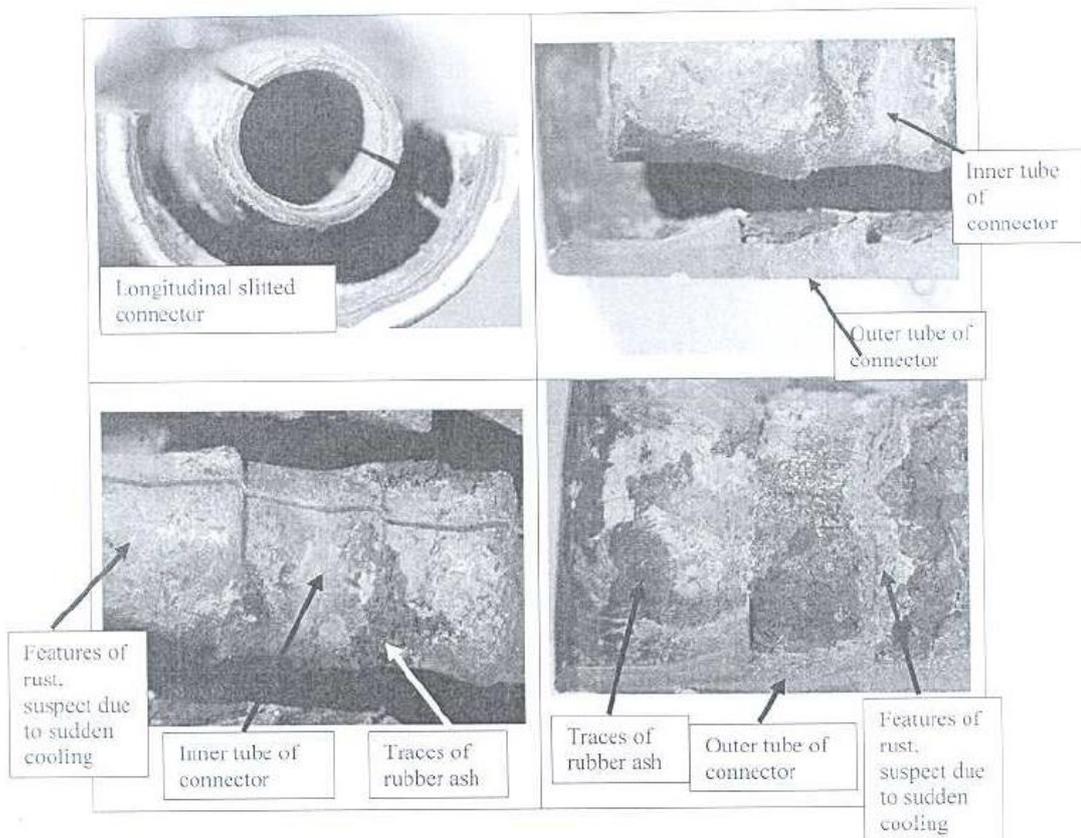
Connector to burner 193 was found unconnected to its hose.
The connector is extensively investigated by slitting into longitudinal cross section by wire cutting to avoid contamination of the inner contents.

The following photos shows the details of the connector to burner 193 (item #2)

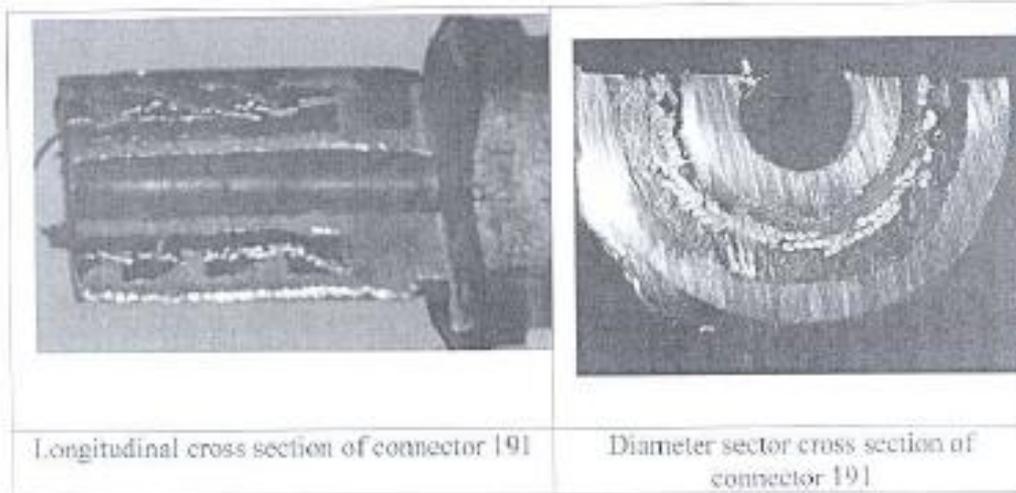
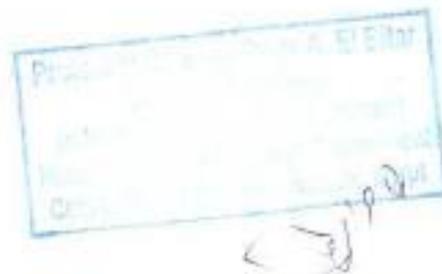
The following photos represent both longitudinal and diameter sector cross sections of connector to burner 191.

After longitudinal cutting of connector to burner 191, it was noticed that the inner as well as the outer tubes contains teeth that bite the rubber layer of the hose. Biting continues to the fiber steel reinforcement. The biting mechanism clearly shown in the following photos suggest it is a remote possibility that the hose could release from its connector under normal circumstances unless it is subjected to an external pulling force.

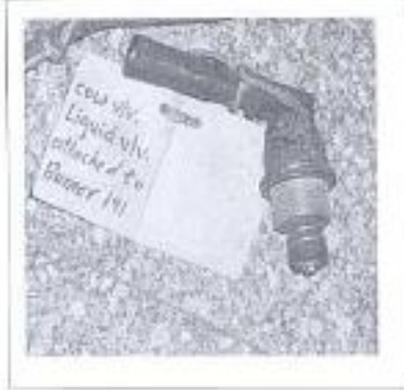
Item #5: Cow vlv. attached to burner (191)

The cow valve attached to burner 191 was found in a right situation (undamaged).

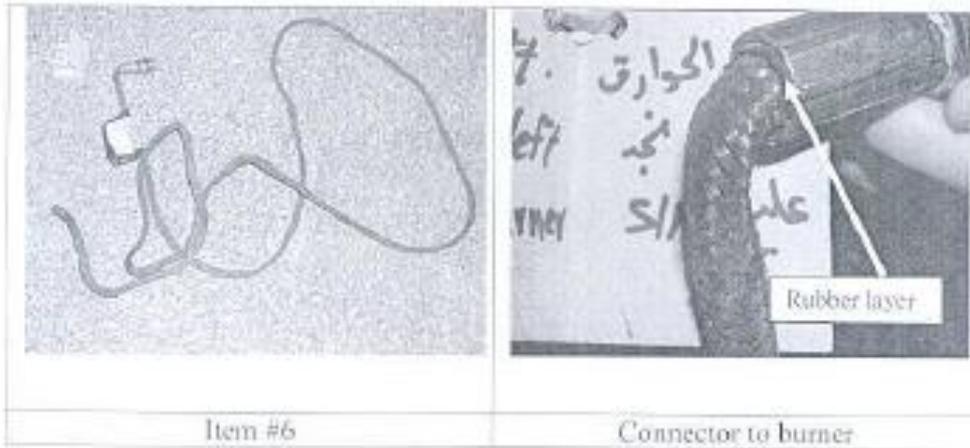
Item #6: Hose of one of the two unidentified burner serial no. (left front side)

It is also noticed that there is great variety between the hose diameter (8.9 -12.7 mm) as a result of a pulling force.

The following photos describes the situation of item #6

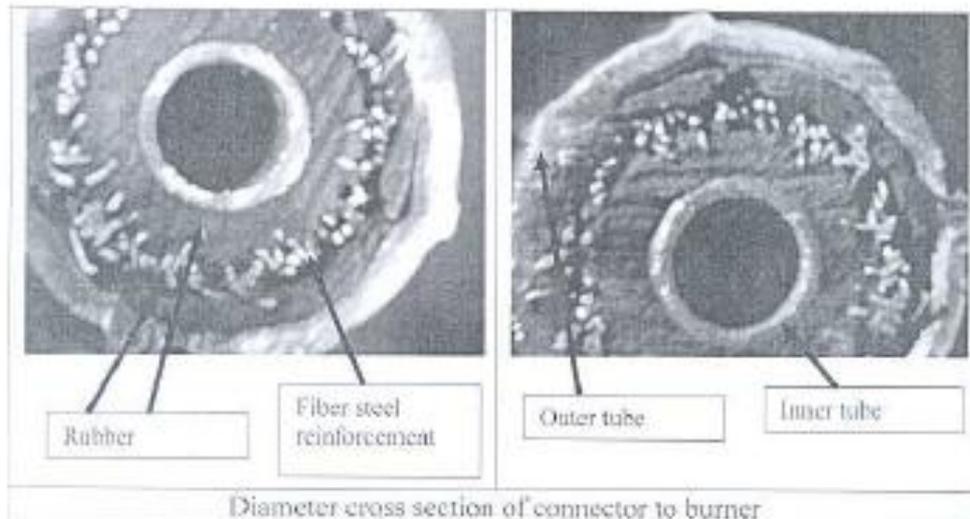
The following photos show that the connector to burner contains rubber hose between the inner and outer tubes. The fiber steel reinforcement is clearly impeded in the rubber layer.

6. the connector to hose of the unidentified burner (item #6) contains the rubber hose between the inner and outer tubes. The fiber steel reinforcement is clearly impeded in the rubber layer.

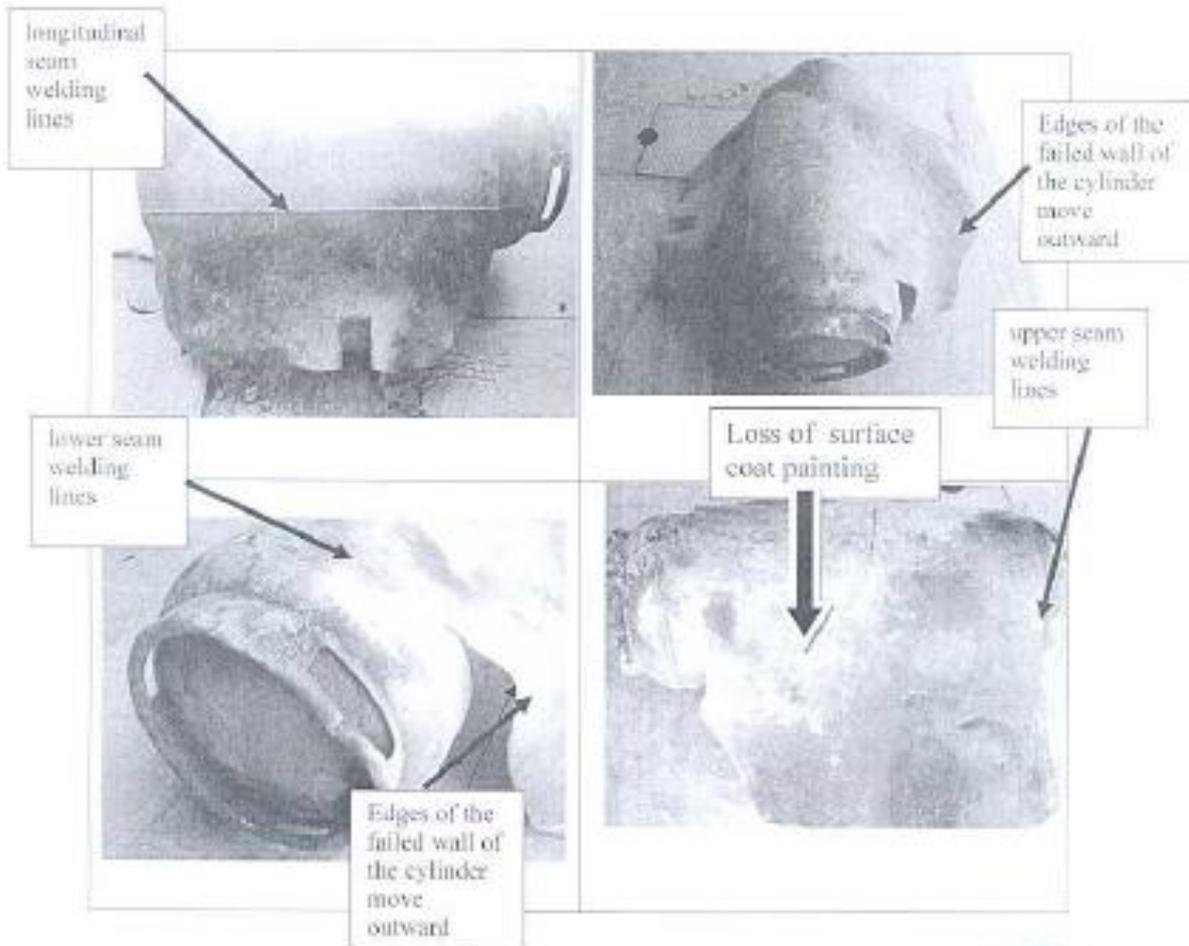
- An outburst happened from inner to outer of the cylinder, where the edges of the failed wall of the cylinder move outward.
- According to the general law of gases, increase of gas temperature is leading to increase of volume and consequently gas pressure. It is supposed that the gas cylinder was subjected to fire as its clear on the upper part of the wreckage of the cylinder surface. It was found that the opposite side of the failed edges lost the feature of the surface coat painting.
- Lower, upper and longitudinal seam welding lines still in a right way situation and were not subjected to any failure.

The following photos show different positions of the gas cylinder (item #10)

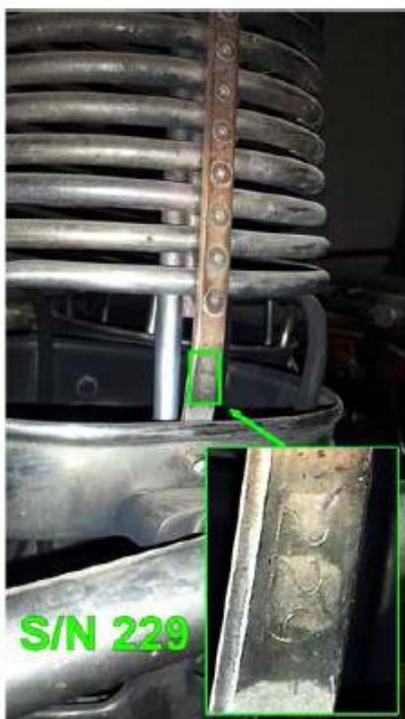
PICTURE 1

- Up to S/N 250 approximately, a unique S/N was engraved on one of the three brackets of the burner/vaporization coils (see picture 1).

VAPOURIZATION COIL OF A BURNER UNIT
INSTALLED ON A DOUBLE BURNER ASSEMBLY
WITH S/N 229 AND 230.

S/N LOCATED ON THE COIL BRACKET

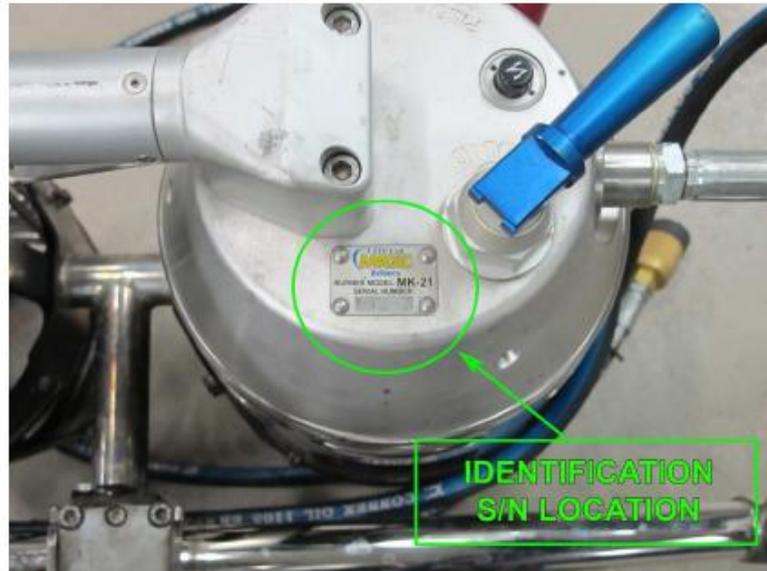
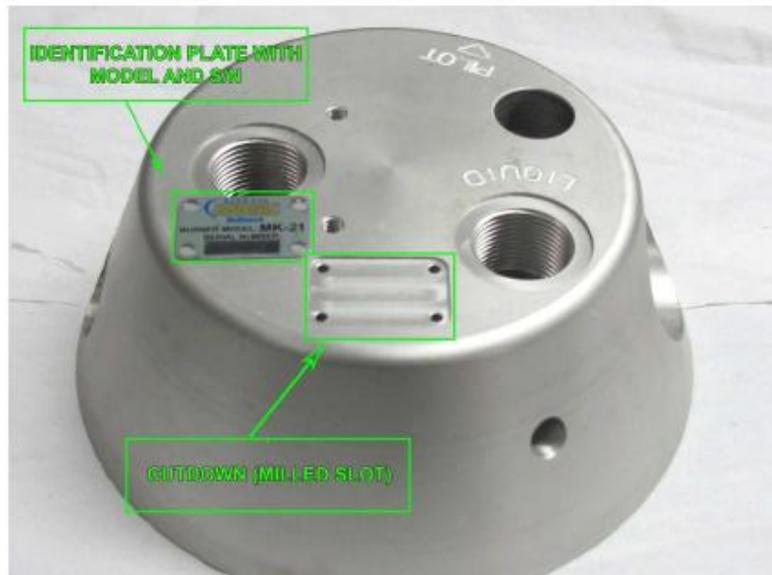
PICTURES 2 & 3

- For units from S/N 250 and above, the S/N is solely engraved on a plate riveted to a cutdown (milled slot) machined on the lower part of the burner block. (see pictures 2 & 3).

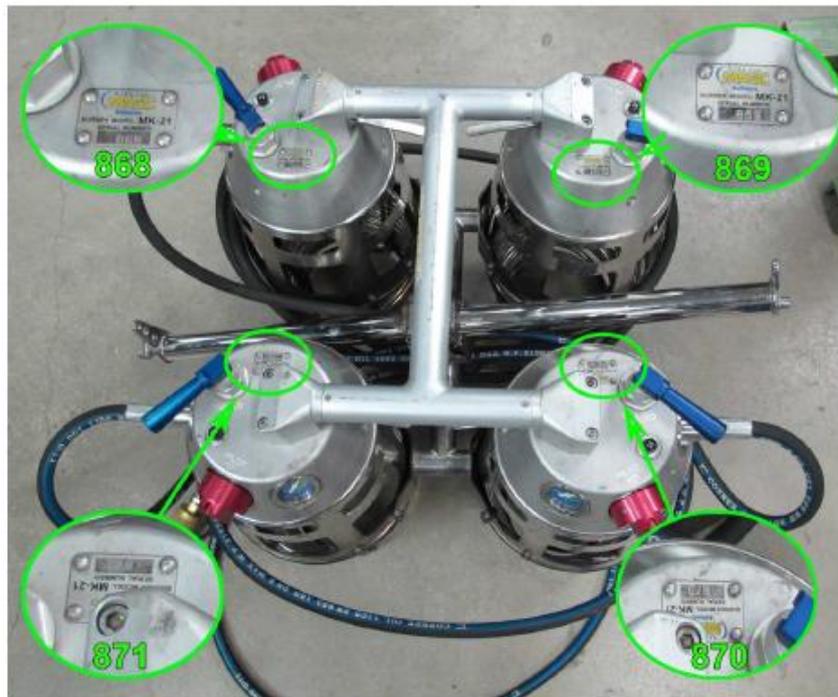
PICTURE 4

Besides, the CIAIAC's investigation also confirmed that Ultramagic has always marked with consecutive numbers each and every burner unit that make up a burners assembly which will be then installed on a balloon (like the quadruple assembly in this case), this also ensuring that the S/N of all the burner units of any assembly are always marked in the same location during production (see picture 4).

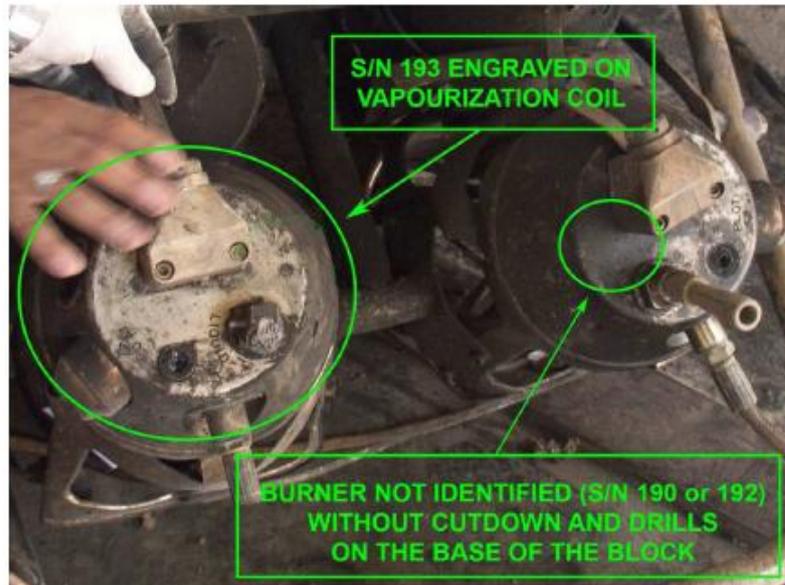
PICTURE 5

The burners assembly installed in the event balloon showed two burner units with S/N's under 250 (specifically 191 and 193) which were engraved on the brackets of their vaporization coils. However the other two burner units (presumably 190 and 192 according to the original documents by the manufacturer) did show no S/N at all, either on their vaporization coils or their blocks. These two burner units did not either show any cutdown (milled slot) on the lower part of the block (see picture 5), what also confirms, without a doubt, that said burner units were modified after the balloon was sold by Ultramagic.

The referred modifications were not recorded by the Operator's maintenance personnel, and even, according to the Operations Manager's statement, there were other burner units with dual S/N engraved or with S/N not concurring with the ones on the logbooks.
