Report on the investigation of
of the fatal crush accident
on the general cargo vessel

Karina C

at Seville, Spain

on 24 May 2019

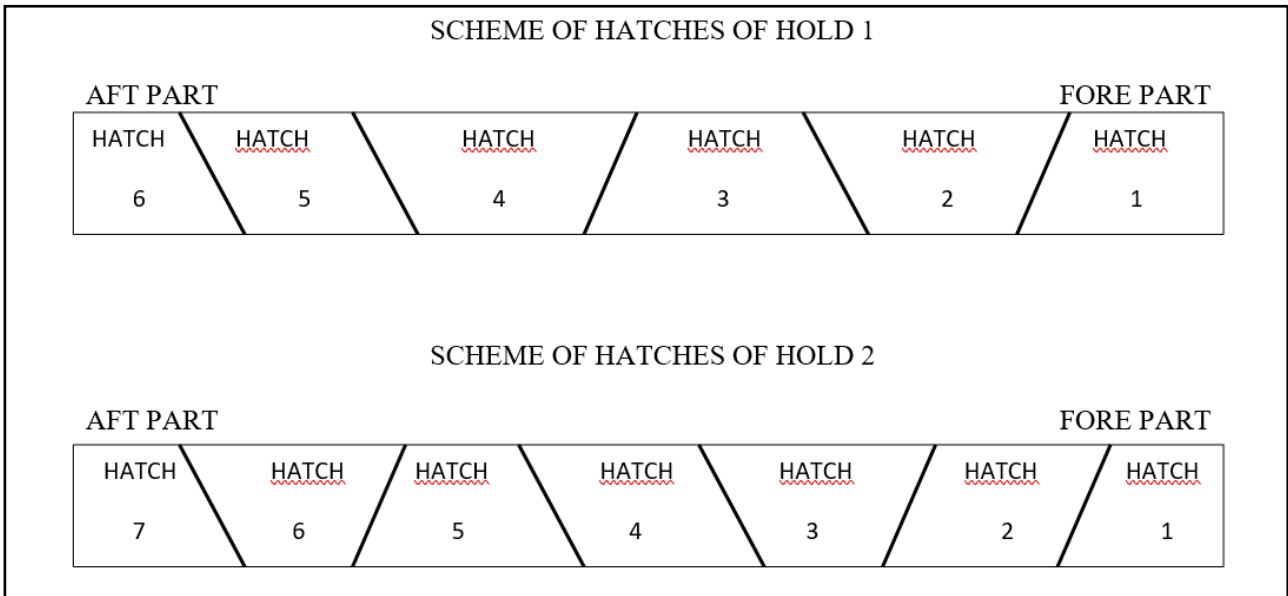
Figure 7: Cargo hold hatch cover scheme – all covers were unique

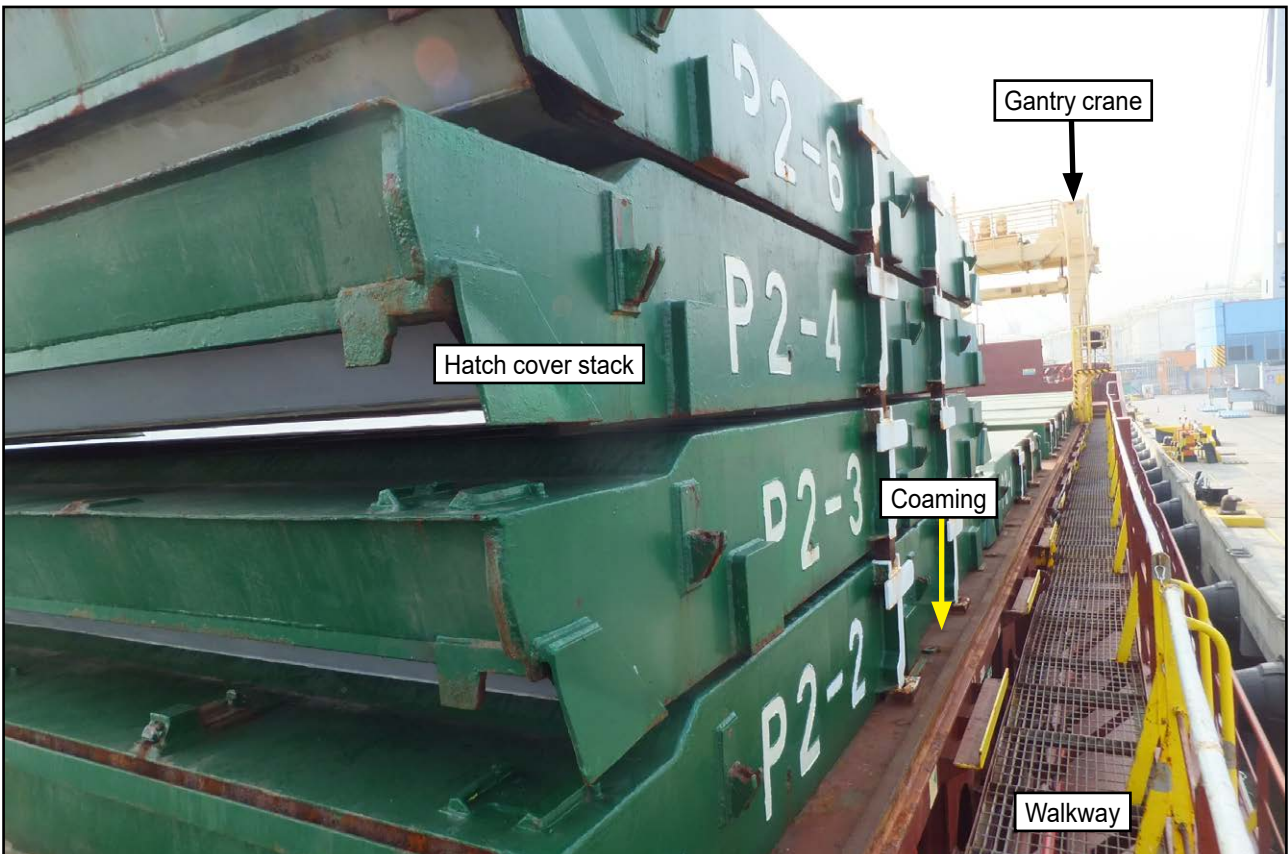
Hold access routes and ventilation ducts were located in the space between the two holds. Raised walkways, 1.67m from the main deck, ran along the length of the two holds on either side of the cargo hatch coamings (**Figure 8**).

Figure 8: Starboard walkway showing stack of hatch covers and gantry crane

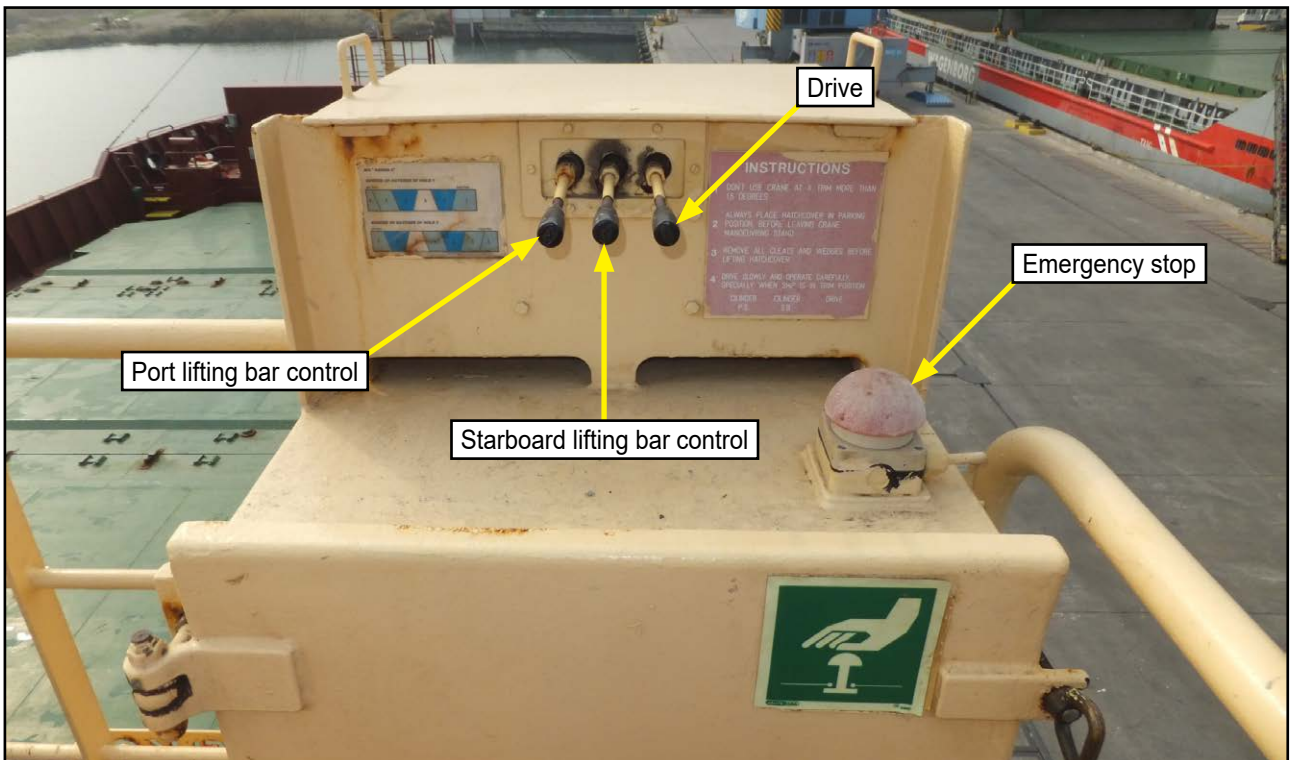
The crane had three control levers: two for operating the lifting bar through hydraulically-operated cylinders and wires, and one for driving the crane forward or aft (**Figure 10**). The drive lever had three positions: forward, stop and reverse. The crane speed was variable depending on the position of the drive lever; at the extreme end position of the lever, the crane reached a speed of 20m/minute. Bringing the drive lever to stop applied brakes on the two forward wheels.

Figure 10: Gantry crane control panel

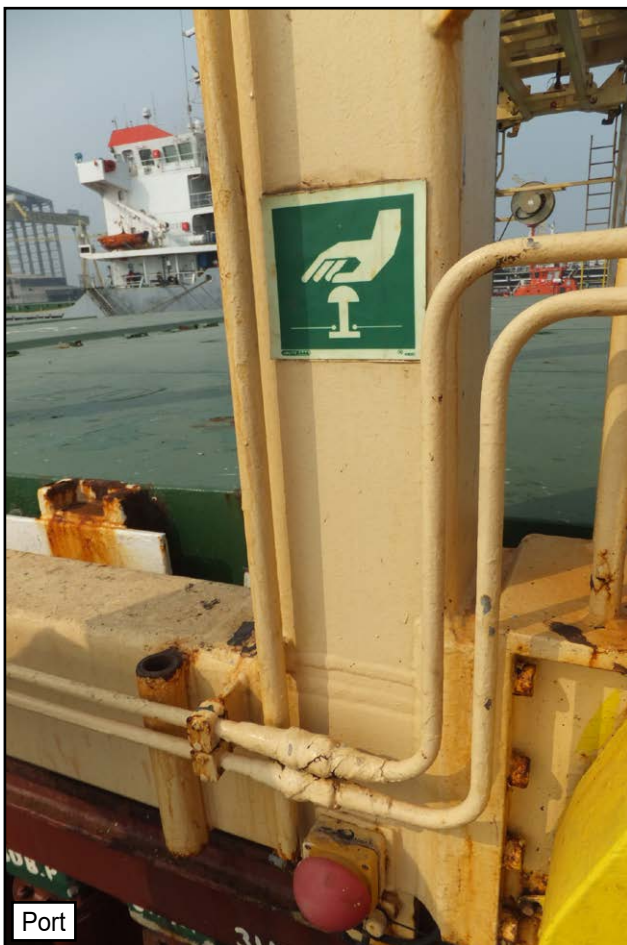
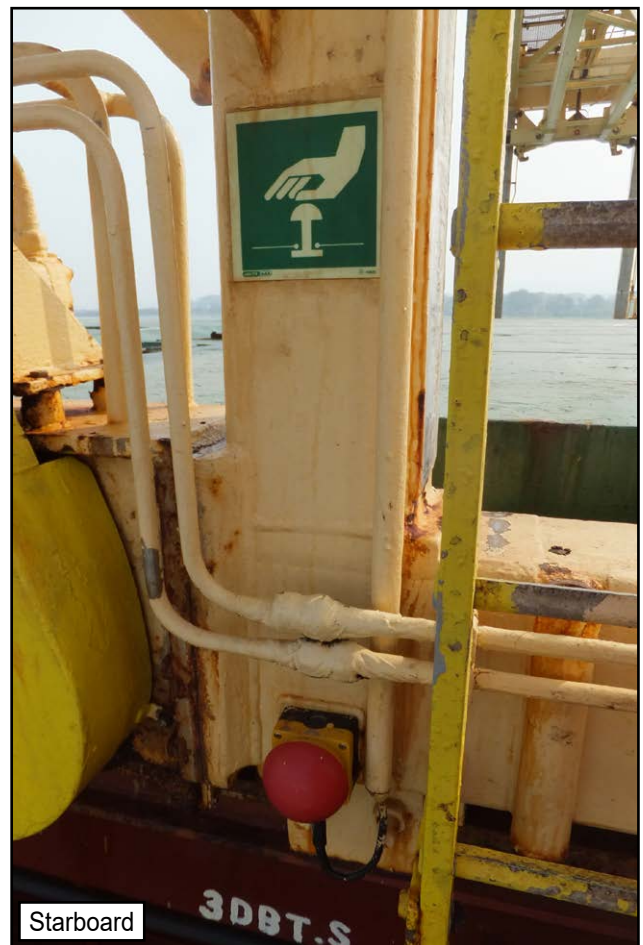
Figure 11: Gantry crane emergency stops

The crane had three emergency stops; two at walkway level on the outboard sides of the port and starboard aft crane legs (**Figure 11**) and one at the driving position (**Figure 10**). To operate the port or starboard emergency stops, a crew member needed to be stationed on the outboard side of the crane between the crane and the walkway guardrail. The gap between the crane and the guardrail was about 350mm wide (**Figure 12**).
