Report on the investigation into the capsizing of the  
fishing vessel

**Z 582 ASSANAT**

off the British coast near Margate with the loss of two lives  
on 27 December 2016

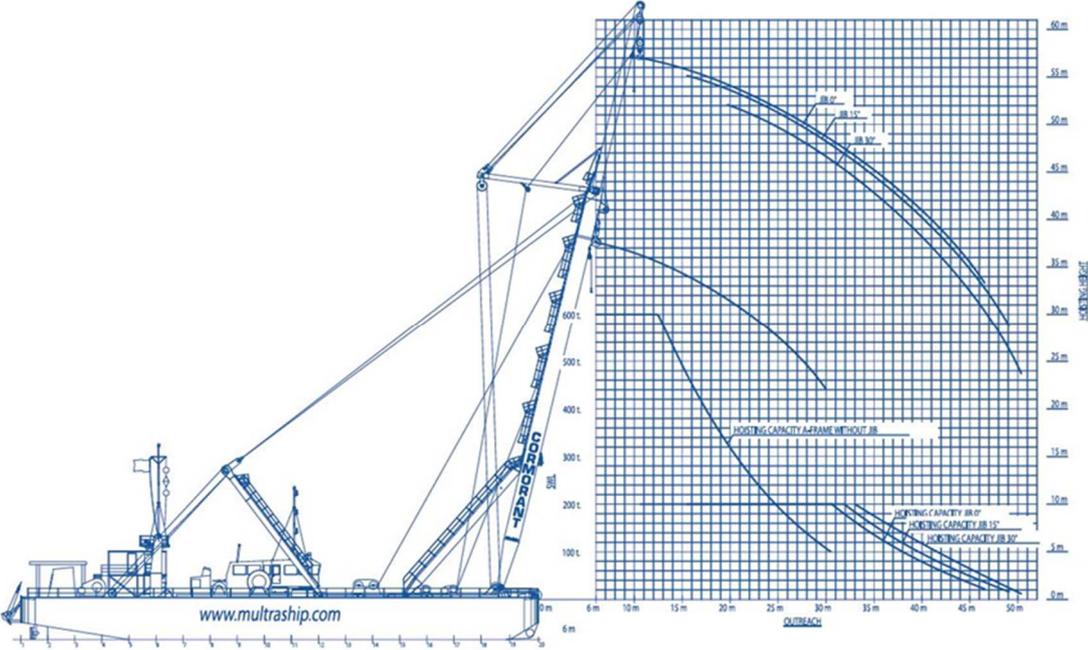
Figure 6 – crane barge CORMORANT and lifting capabilities

During the turning right side up of the fv Z582 ASSANAT, the bulwark of the vessel got damaged by the hoisting cables of the crane barge.

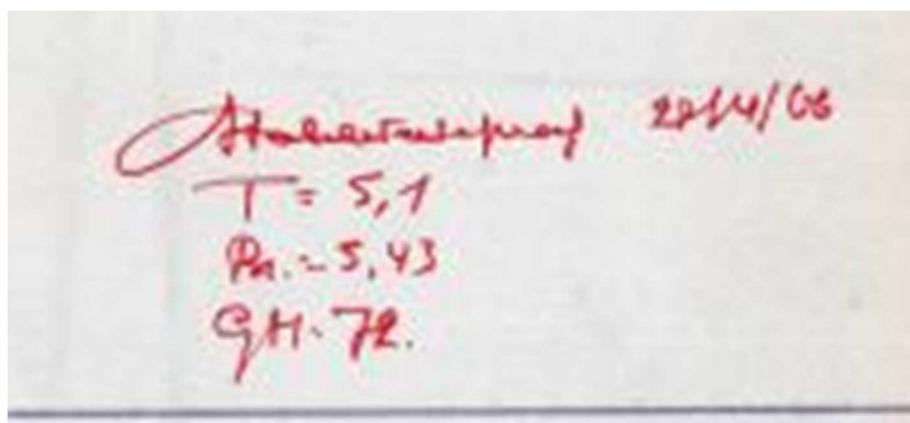
On Figure 11 on page 19 a handwritten note from 1966 was found indicating that the initial GM was 72 after an inclining test. No unit was indicated, however, it was assumed to be in centimetres. The origin of said values could not be determined.

Figure 13 – Close up of note indicating GM

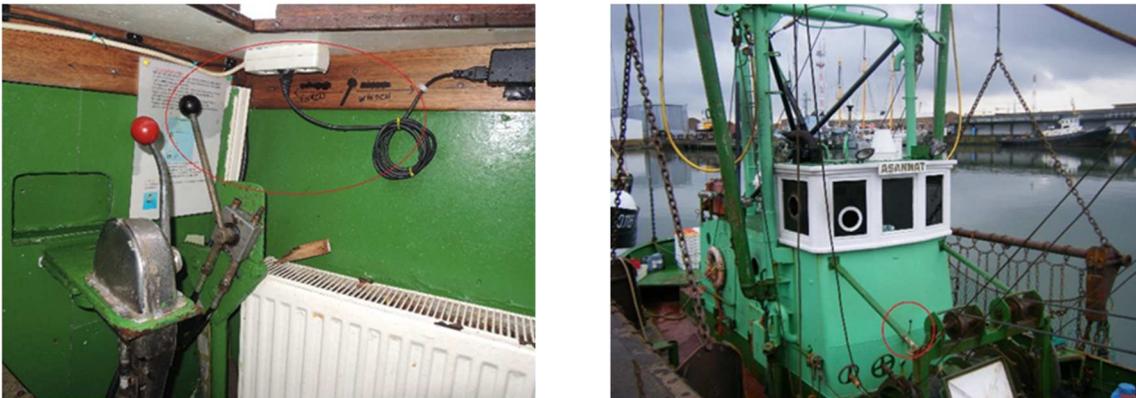
On board the fv Z582 ASSANAT, the flow was regulated by means of hand operated valves. One was placed in close vicinity to the winch on the facing of the superstructure, one was placed inside the wheelhouse as seen in Figure 17 on page 25.

The valves operated in parallel, meaning that the speed of the winch motor could be regulated from either valve.

*Figure 17 - winch control valves inside the wheel house and on facing of superstructure of fv Z582 ASSANAT (archive pictures)*

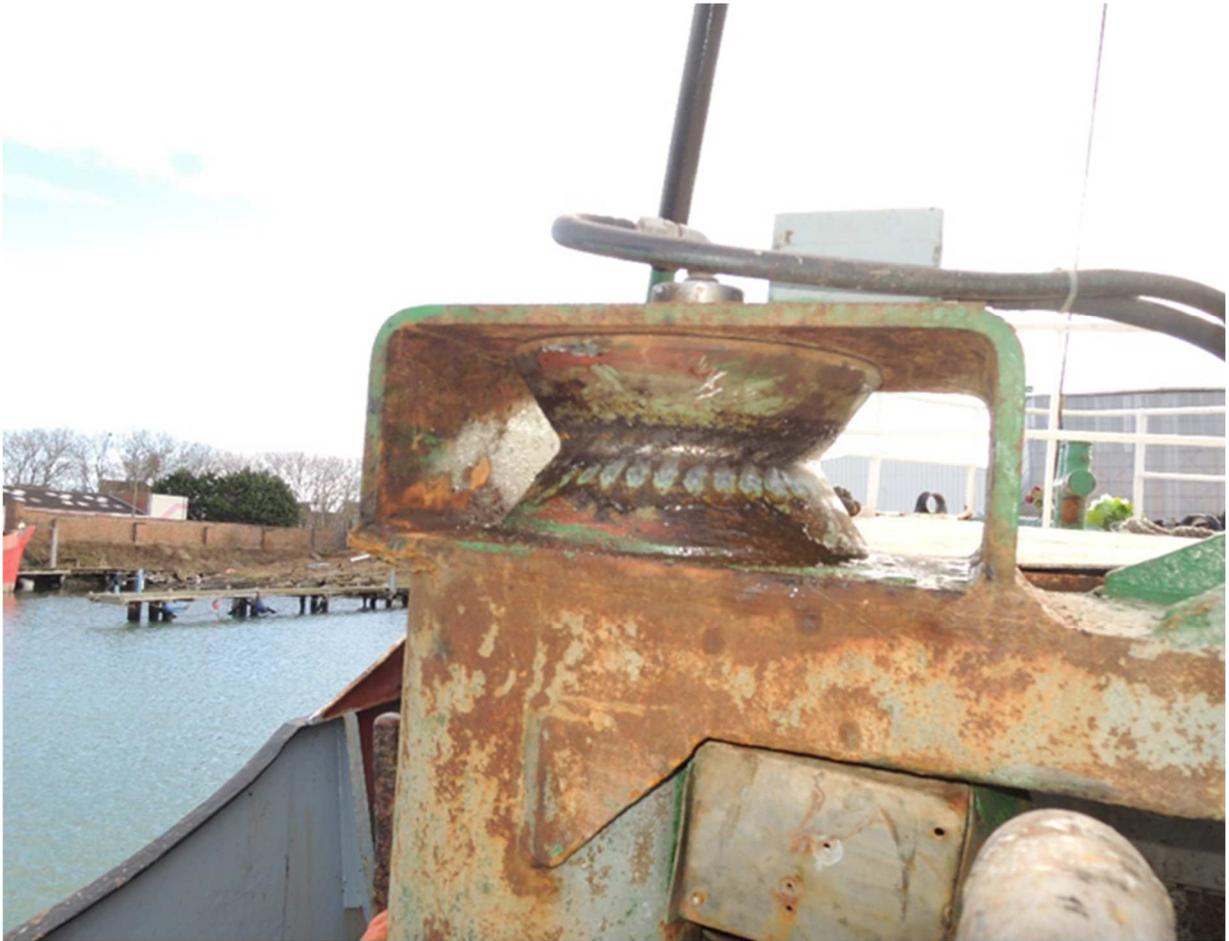
Fairleads on deck, through which the warps of the fishing nets were rigged were equipped with a patented length of line and force meter as an indicator for when the nets would be entangled with objects on the seabed as seen in Figure 18 on page 26.

The system did not foresee in letting go of the nets or automatically reducing the revolutions of the main engine in case of entanglement of the fishing nets.

*Figure 18 - fairlead through which the net warp was rigged  
equipped with hydraulics to measure line length of the warp and forces on the warp*

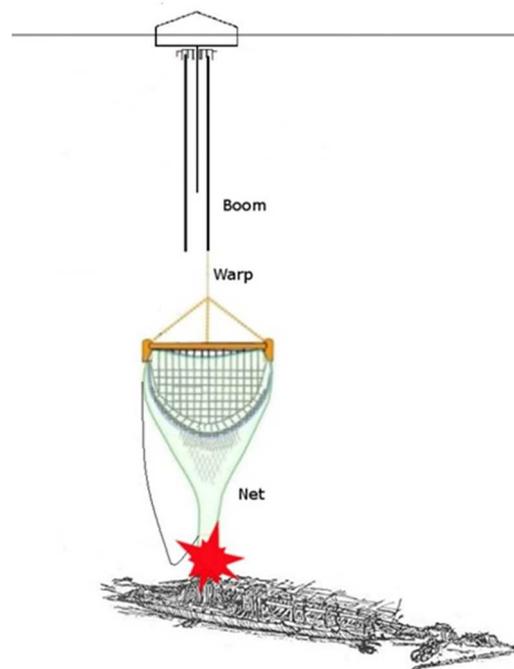
The skipper of the rescue craft, that had towed the overturned derelict of the fv Z582 ASSANAT to a rendezvous point with the crane barge CORMORANT, had declared that during the tow, the speed had been reduced a few times by external factors. Considering the length of the fishing net and the boom, and the water depth and the presence of several wrecks on the bottom of the sea, there was a possibility that the net had been damaged during the tow from the place

where the derelict of the Z582 ASSANAT had been fastened to the rescue craft to rendezvous point with the crane barge CORMORANT as seen in Figure 32 on page 46.

*Figure 32 - Pictorial representation of net being entangled during tow  
(not to scale)*

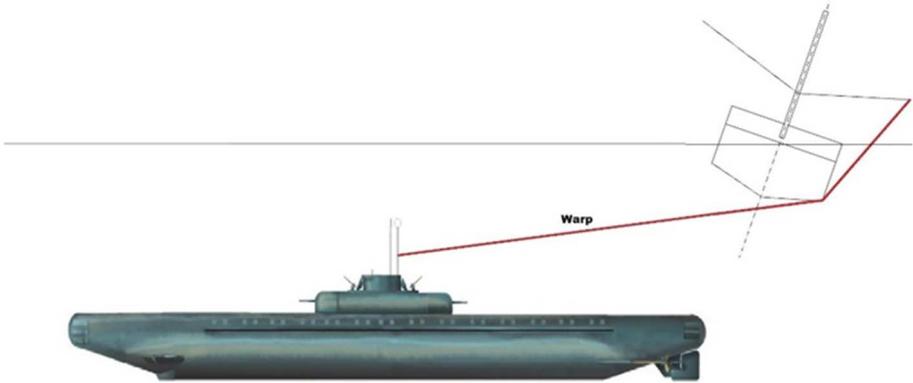
The submersible snagging the starboard net would have created a situation as in Figure 33.

Figure 33 - Pictorial representation of submersible snagging fishing net  
(not to scale)

The hypothesis whereby a submersible snagged the starboard net of the Z582 ASSANAT, and created enough torque to turn the Z582 ASSANAT upside down in the water would have been as in paragraph 7.1.3 Forces acting on booms during beam trawling when fishing vessels run off course on page 32 whereby the component  $V$  increased to such extent that the initial stability of the fv Z582 ASSANAT is lost. The underwater velocity of the submersible would also have had an increasing effect on the torque necessary to turn the fv Z582 ASSANAT upside down.

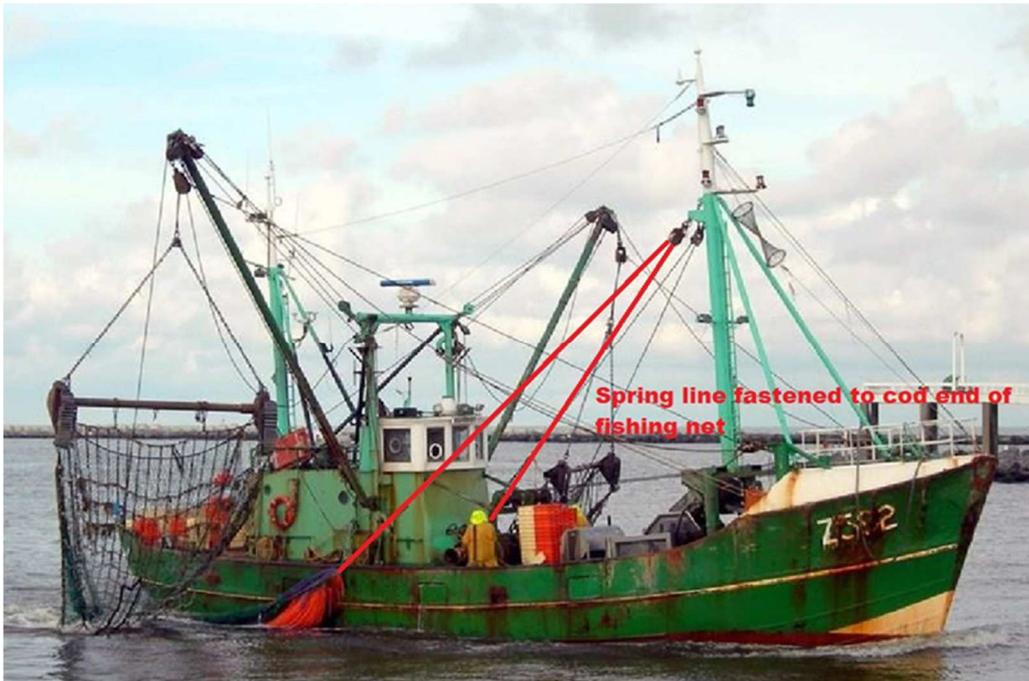
After the nets are symmetrically hoisted to water level, crewmembers fastened a spring line, a natural fibre rope, to the lazy tackle of the starboard net allowing them to hoist the cod end over the bulwark, by running the spring line on the turning warping head of the winch.

The spring line was rigged through a pulley that was attached to the mast of the fv Z582 ASSANAT at approximately 10 metres above the base of the vessel as seen in Figure 35 on page 50.

*Figure 35 – spring line (coloured red) fastened to starboard fishing net on board the Z582 ASSANAT archive picture)*

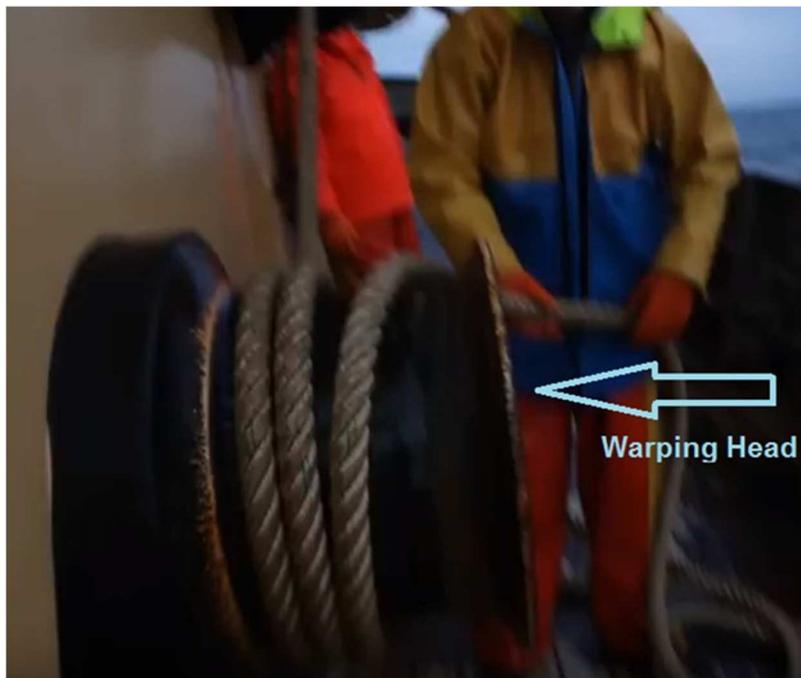
*Figure 36 - Running a spring line over a turning warping head of a winch*

When the hoist reached the desired height, the crewmember running the spring line over the warping head of the winch slacked the spring line over the turning warping head, whilst another crewmember manipulated the cod end on deck.

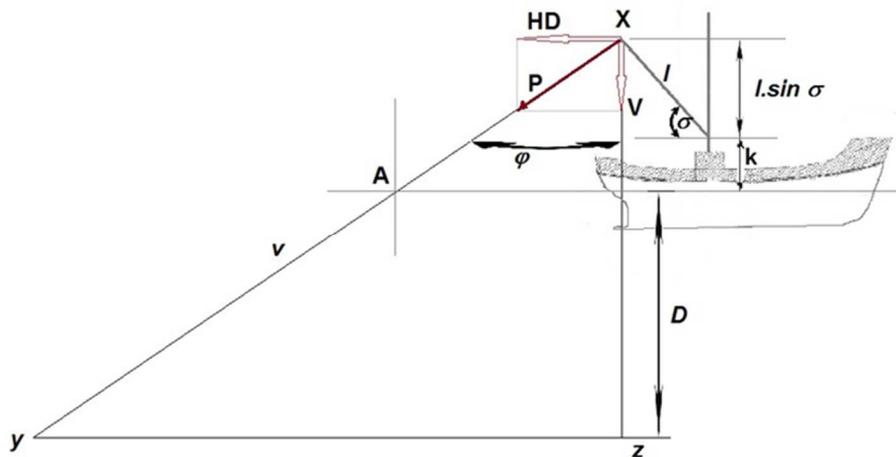
Figure 39 - forces acting upon booms when trawling

The vertical component V causes the ship to list

From Figure 39 we learn that:

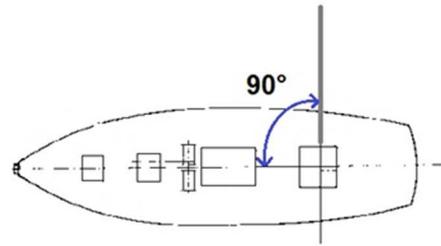
Figure 41 - Angle between boom and keel

The arm of the torque equals  $l * \cos\sigma$ . It is assumed in this equation that the angle in the horizontal plane between the boom and the keel is  $90^\circ$  as in Figure 41 on page 75.
