Report ULM A-021/2018

Accident involving a TECNAM
P-92 aircraft, registration
EC-GR6, at the aerodrome of
Benabarre (Huesca) on 22
December 2018

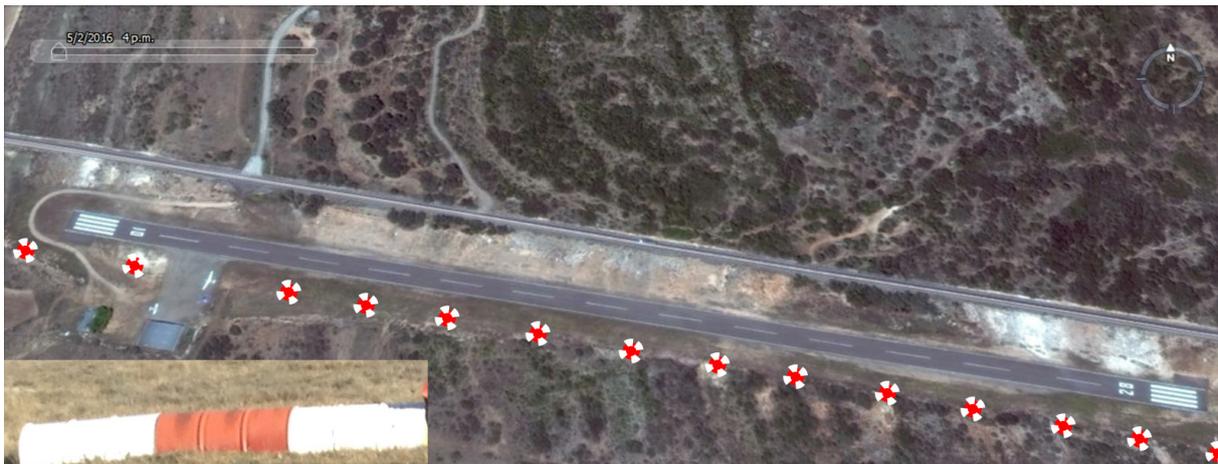
Figure 5. Location of the markers, and close-up of one

During the landing he veered off the runway to the left and the left main gear leg impacted a marker at the edge of the runway, causing the leg to detach. The airplane stopped 10 m beyond the broken marker, next to an embankment.

The marker detached and was found next to the embankment, behind the airplane.

There are 15 markers on the north edge, located at the same positions as on the south edge and spaced some 60 m apart.

Each marker consists of several drums cut in half lengthwise and joined at the base. They have an alternating red and white paint scheme.
