CIAIM-34/2014 REPORT

Loss of control, grounding and complete loss of cargo ship LUNO
on the breakwater of the outer harbour of Bayonne (France) on 5
February 2014

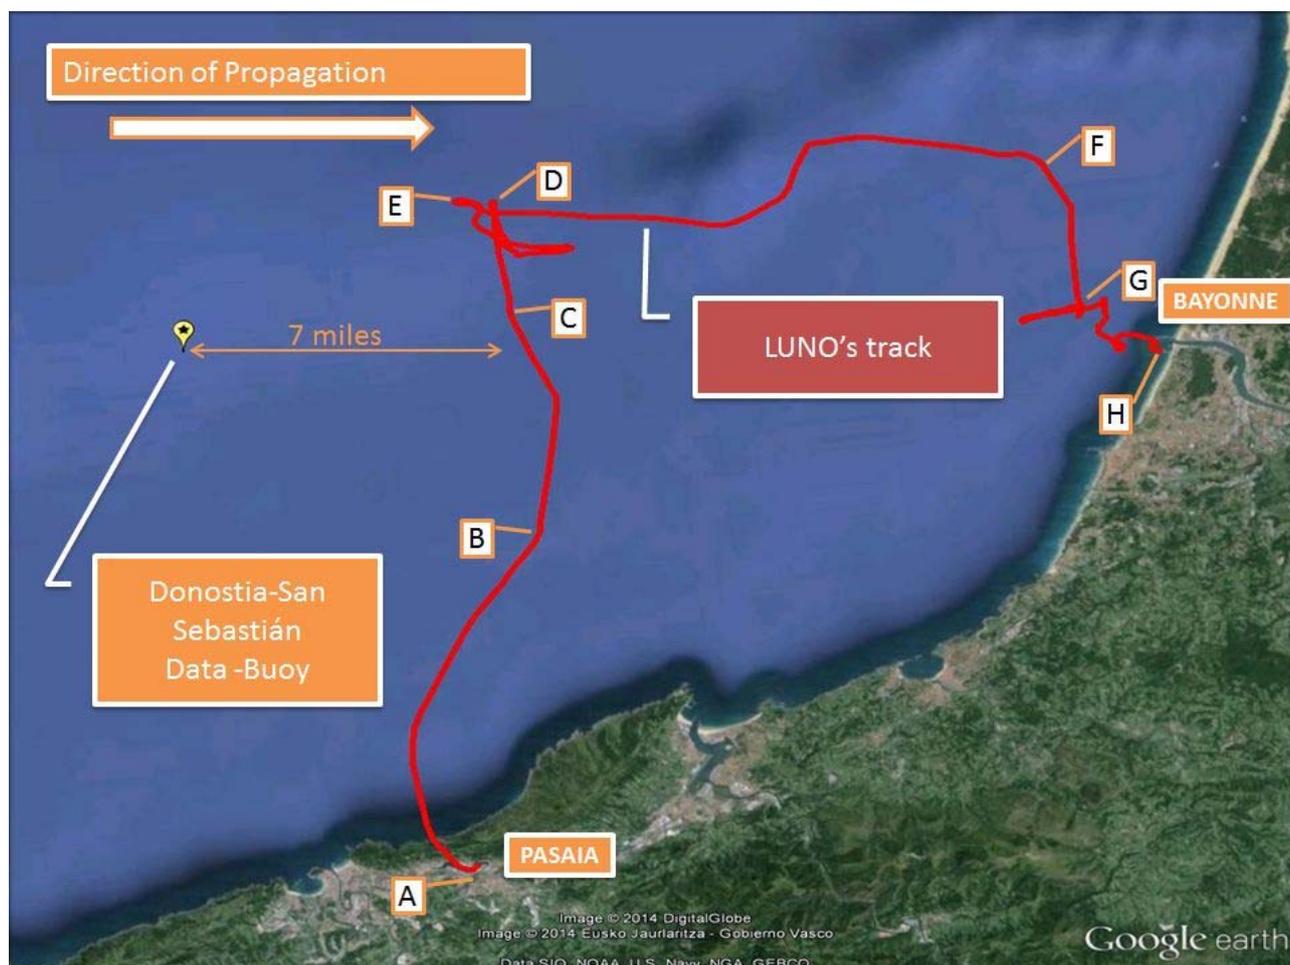
Figure 5. Position of San Sebastián Data Buoy with respect to LUNO's Track

Figure 5 shows:

- LUNO's track from the Port of Pasajes on the 4th at 19:18 hours (waypoint A) until she ran aground on the 5th (waypoint H) at 10:36 hours.
- Combined sea and wave main direction and significant height from 3 to 4 m, maximum wave height from 4.3 m to 5.5 m, mean wave period of 9.5 s and direction of wave propagation to west.
- Location of deep water data buoy in San Sebastián. The data this buoy gathered are considered to show the real sea conditions LUNO withstood until her arrival nearby Bayonne at 07:00 a.m.
- Relevant waypoints where track and/or speed were changed are assigned to consecutive letters B to G.

At approximately 20:35 hours (waypoint B), the ship's speed decreased below 6 knots and her track was altered in two segments towards portside. The final average course was then 343°.

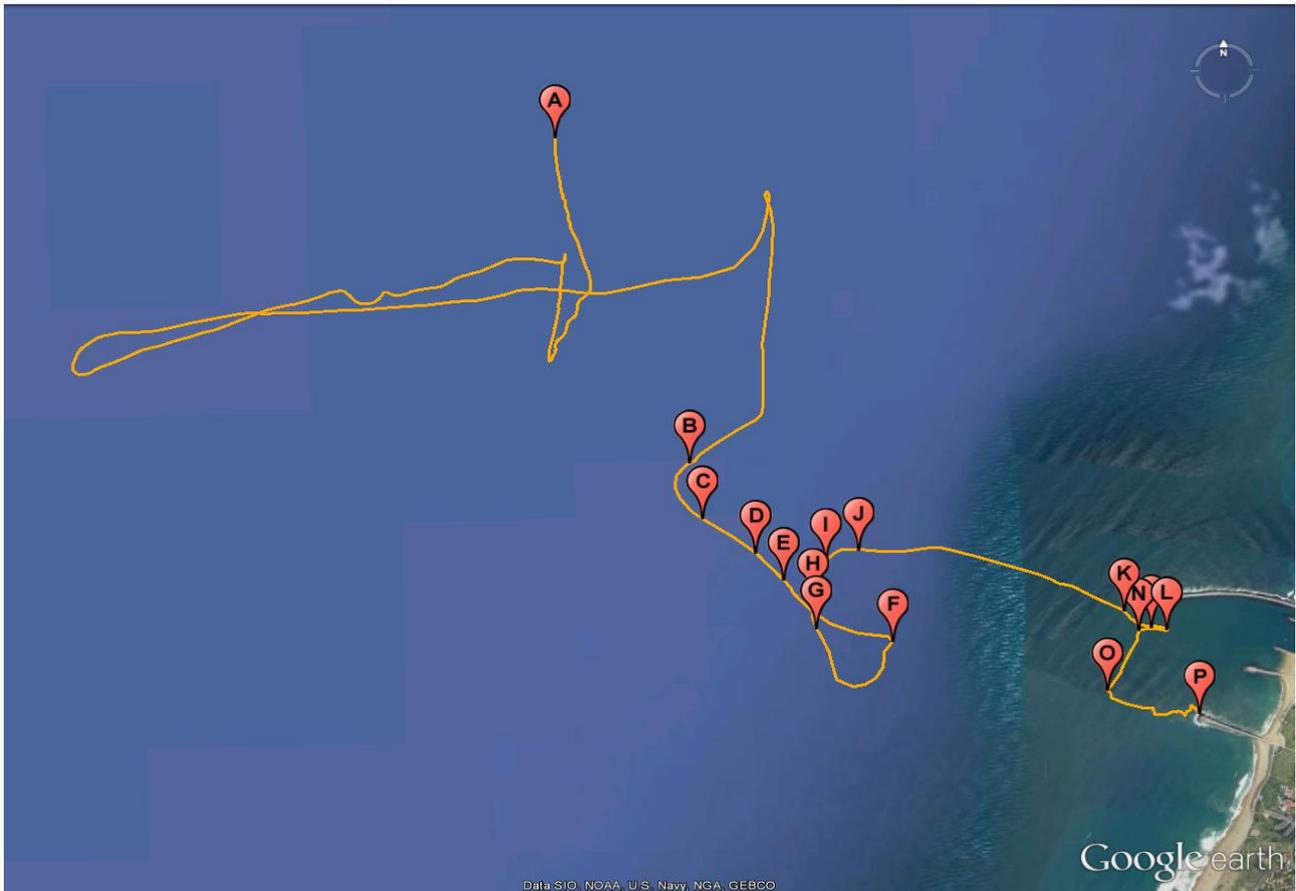
Figure 6. Ship's track from her arrival at the Port of Bayonne surrounding area

The graph in Figure 6 depicts the locations of the ship’s GPS antenna arranged at a distance of 94 m to the ship’s bow. The various headings of the bow were not marked. The motions of the pilot’s boat and the merchant ships assisted by the Pilot Service in Bayonne before LUNO that morning are not indicated, either. No AIS data of BALEA harbor tug are available.

The following table includes the explanation of the letter-assigned milestones in the figure. This explanation is based on the statements both pilot and crew provided. Milestone time and place were established according to emitted AIS data¹⁵.

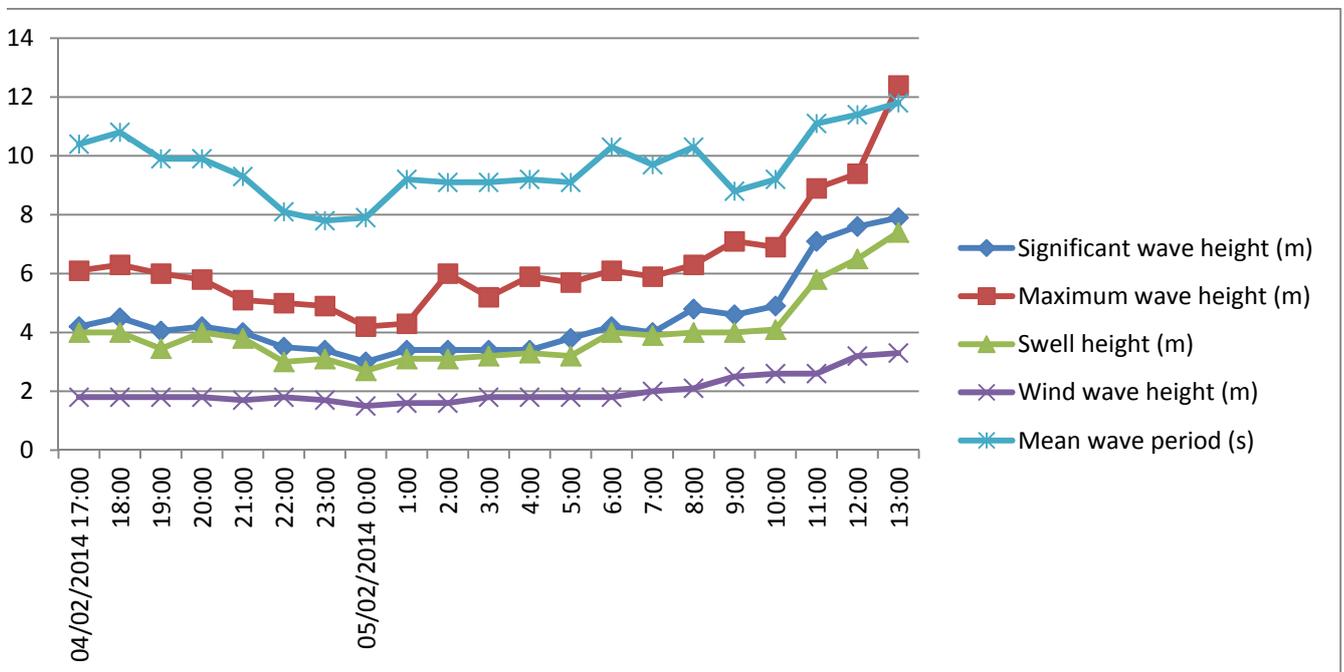
Figure 13. San Sebastián Buoy Data.

Wind and sea conditions in the area will be hereinafter analysed. For this purpose, the data San Sebastián buoy registered will be taken into consideration in order to obtain an estimate of wind and sea state in the area. This buoy is the one closest to the track LUNO followed to reach Bayonne. See Figure 13.

After leaving Pasajes at 19:18 hours on 4th February, LUNO was sailing in an area where the combined sea significant height was between 3 and 4 m, maximum wave height 4.3 m to 5.5 m, mean wave period of 9.5 s and direction of wave propagation to west. The wind component of waves was smaller with a significant height of 1.8 m, which veered from WSW to SSW, and finally to W again at 21:30 hours approximately.

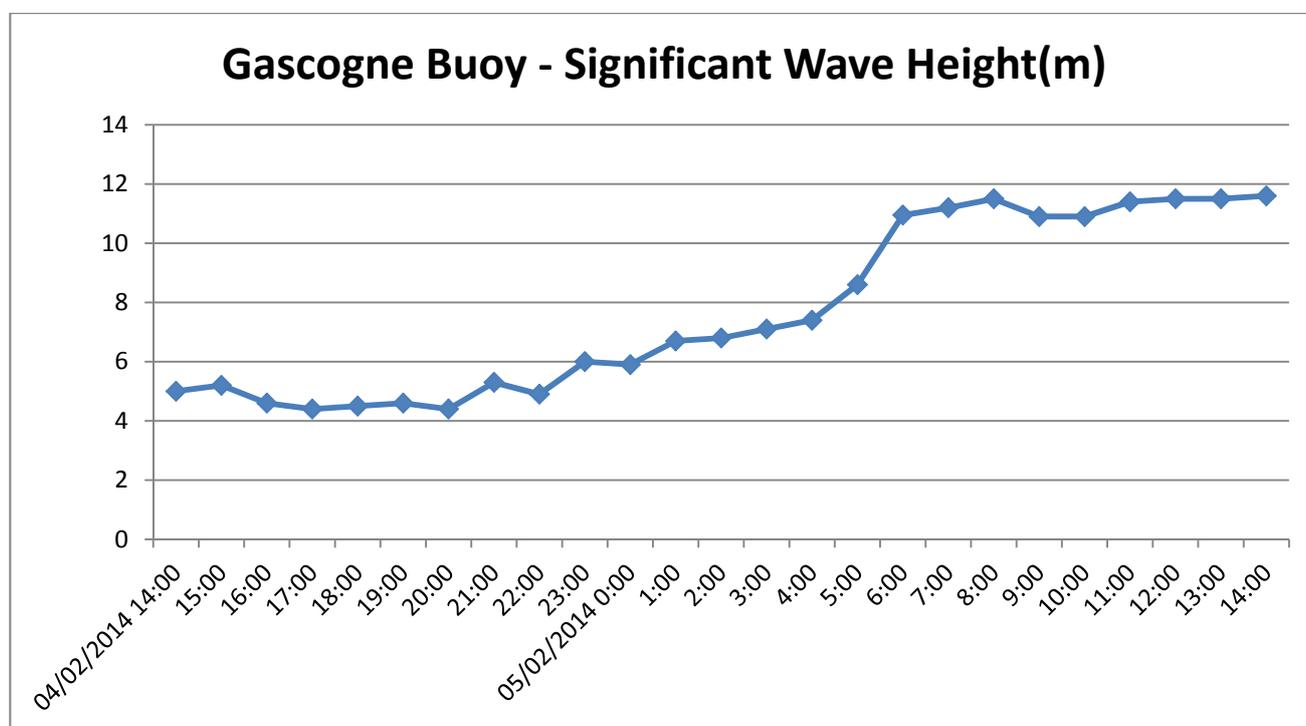
Figure 14. Gascogne Buoy Recorded Data.

Figure 14 depicts Gascogne buoy data, which is located in the Bay of Biscay (45° 12'2" N 5° 0'0" W) and kept by the British *Met Office* in cooperation with *Météo-France*.
