Interim Report A-032/2008

Accident involving aircraft
McDonnell Douglas DC-9-82
(MD-82), registration EC-HFP,
operated by Spanair, at
Madrid-Barajas airport
on 20 August 2008

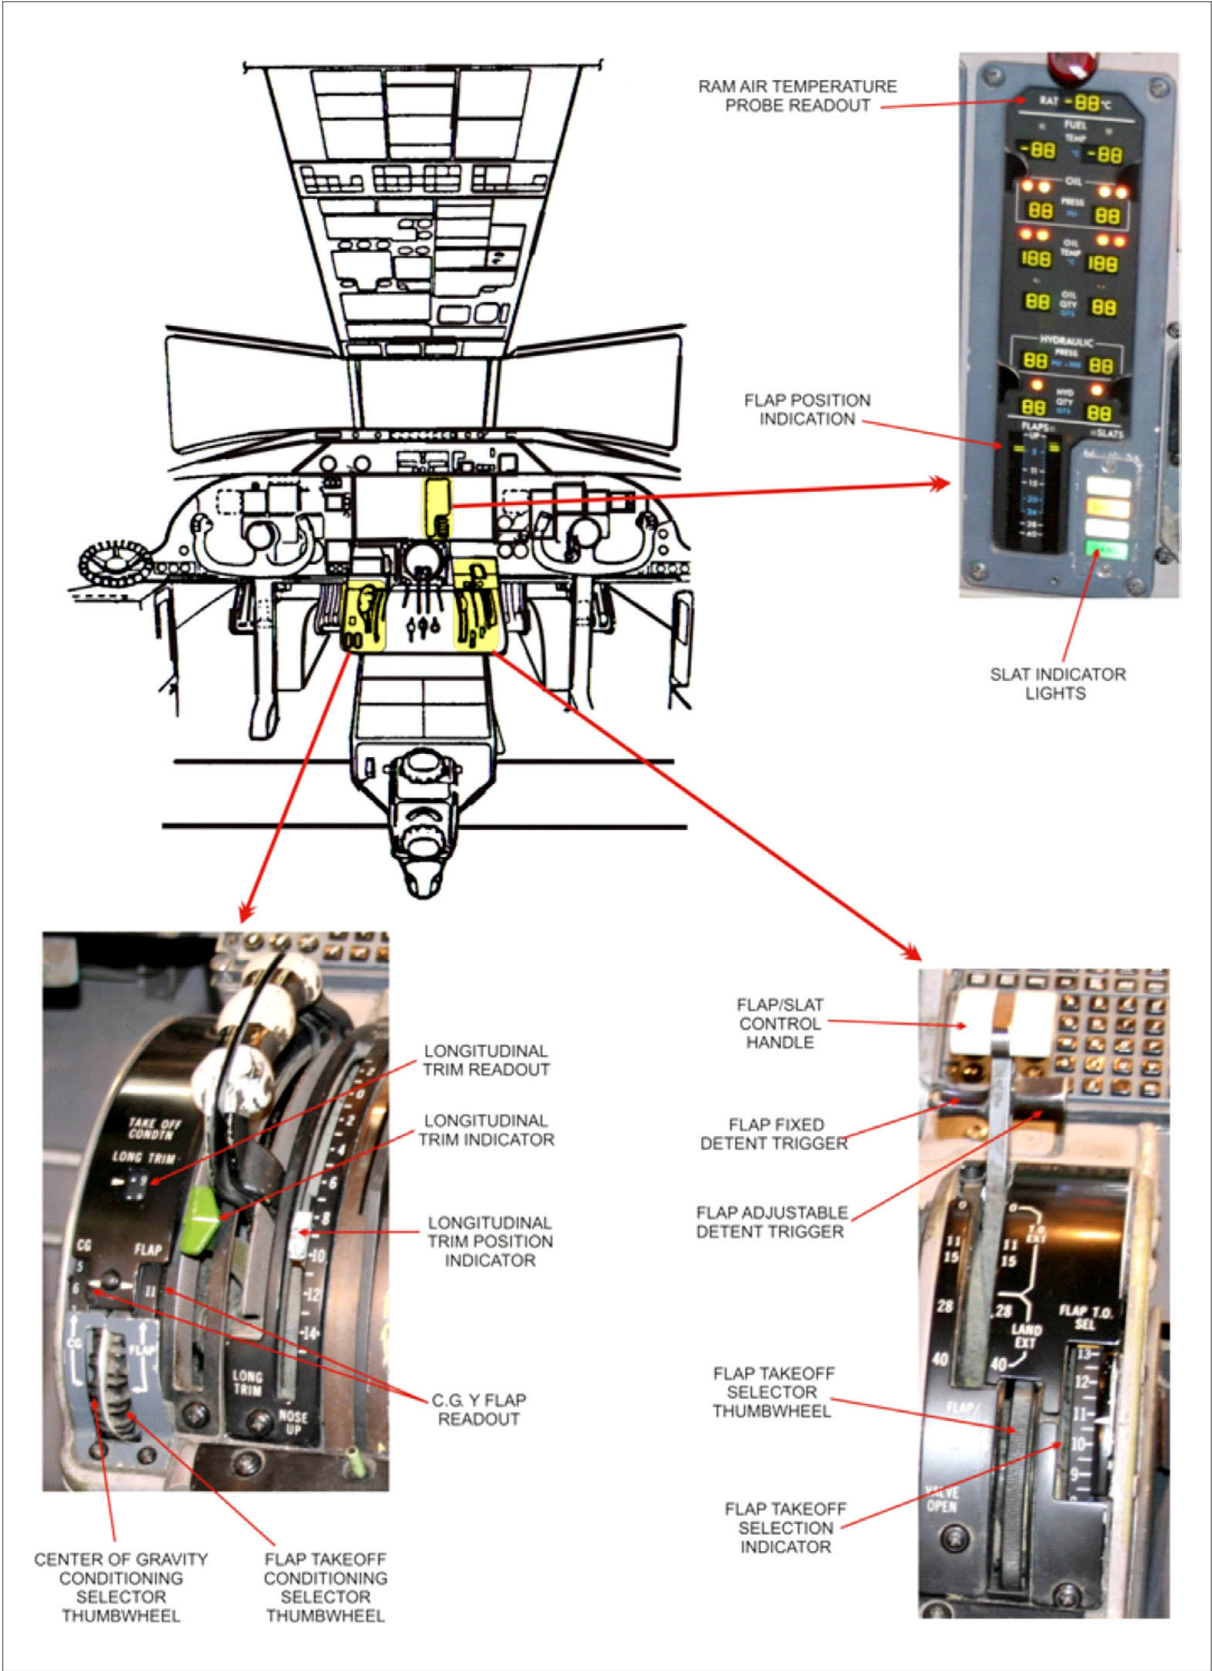
Figure 2. Flap/slat controls and indicators

The flap/slat lever is situated on the right front part of the pedestal. It moves through a slot with two graduated scales, one on each side. Both scales have markings to indicate the UP/RET, 0, 11, 15, 28 and 40 degree positions. Two additional areas are labeled on the right scale, one between 0° and 24°, which correspond to takeoff values, and another between 24° and 40°, which correspond to landing values.

Inputting the value for the flap angle as indicated above also moves an axle that reaches across the pedestal to its right side, where it actuates a hinge that positions a flap warning microswitch for takeoff. When the position selected on the flap control lever matches the value input with the wheel on the takeoff condition panel, a cam presses on the microswitch, which then sends a signal to the takeoff warning system (TOWS), indicating that the flap selection is correct, so that the TOWS flap warning is not activated.

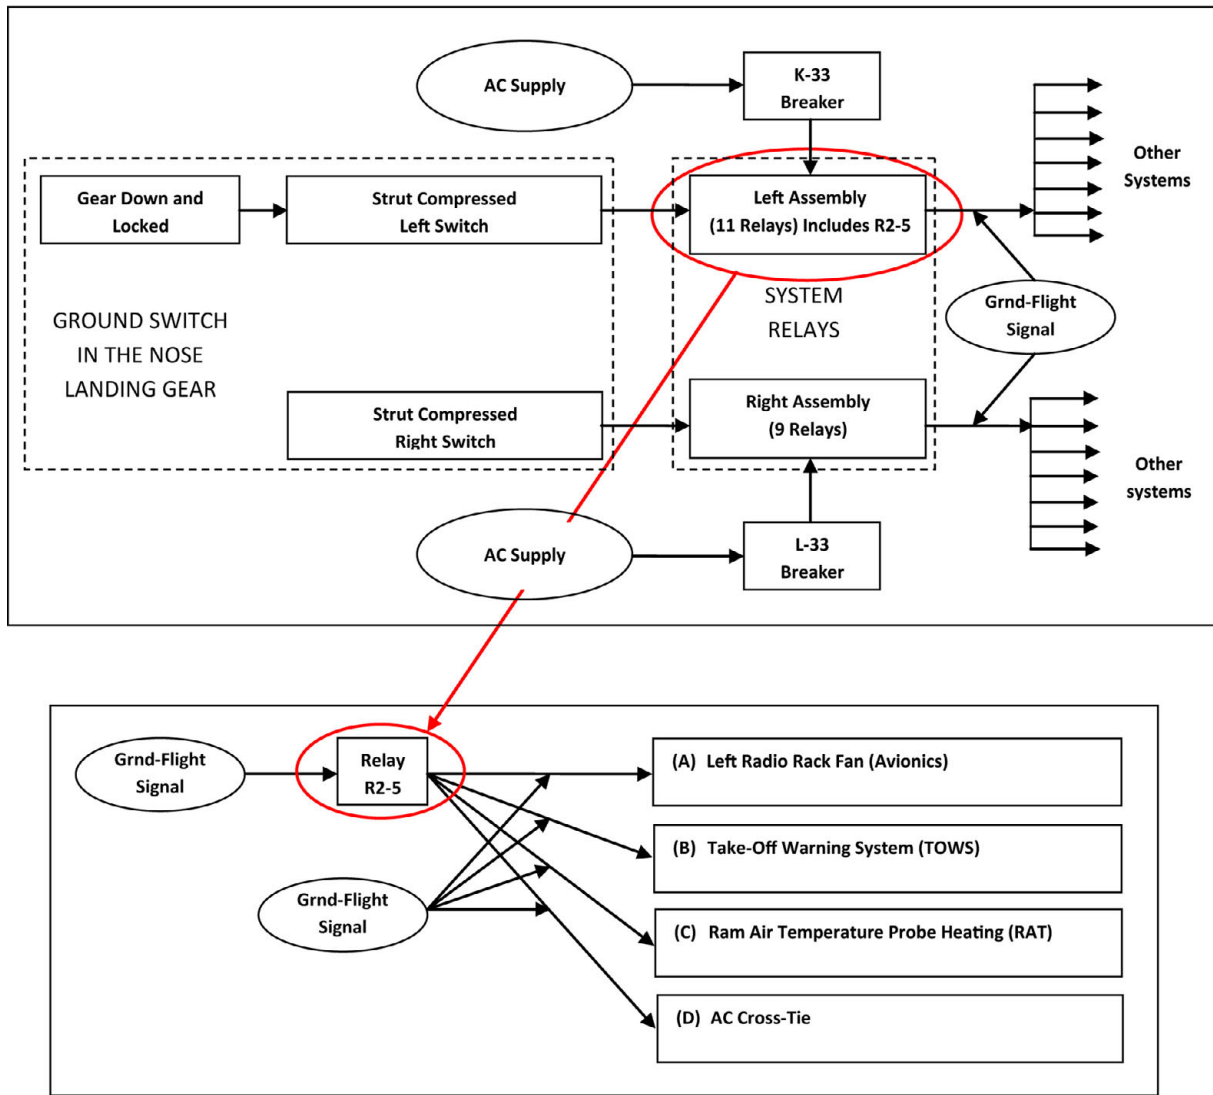
Figure 3. General diagram of the ground sensing system. Relay R2-5

The system consists of three switches located on the nose landing gear that detect whether the aircraft is on the ground or in the air, twenty relays located in the avionics compartment, two circuit breakers located in the cockpit and two 115V AC power supplies (See figure 3).

In the nose landing gear there is a switch that closes if the gear is down and locked (airplane on the ground) and opens otherwise (airplane in flight), and two switches, situated to either side of the first, that close if the strut is compressed, which happens when the airplane is on the ground, and open when the strut is extended, that is, when the airplane is in flight.

- *Section "B"*: Take-off warning system (TOWS), which sounds an aural warning in the cockpit when the aircraft is about to take off in an improper configuration. When the airplane is on the ground with the nose gear strut compressed, both the number 1 and 2 contacts in this section of the relay close to arm the TOWS. When the airplane is in flight, contacts 1 and 2 open and the TOWS is disabled.
A 28V DC signal flows through section B of relay R2-5.

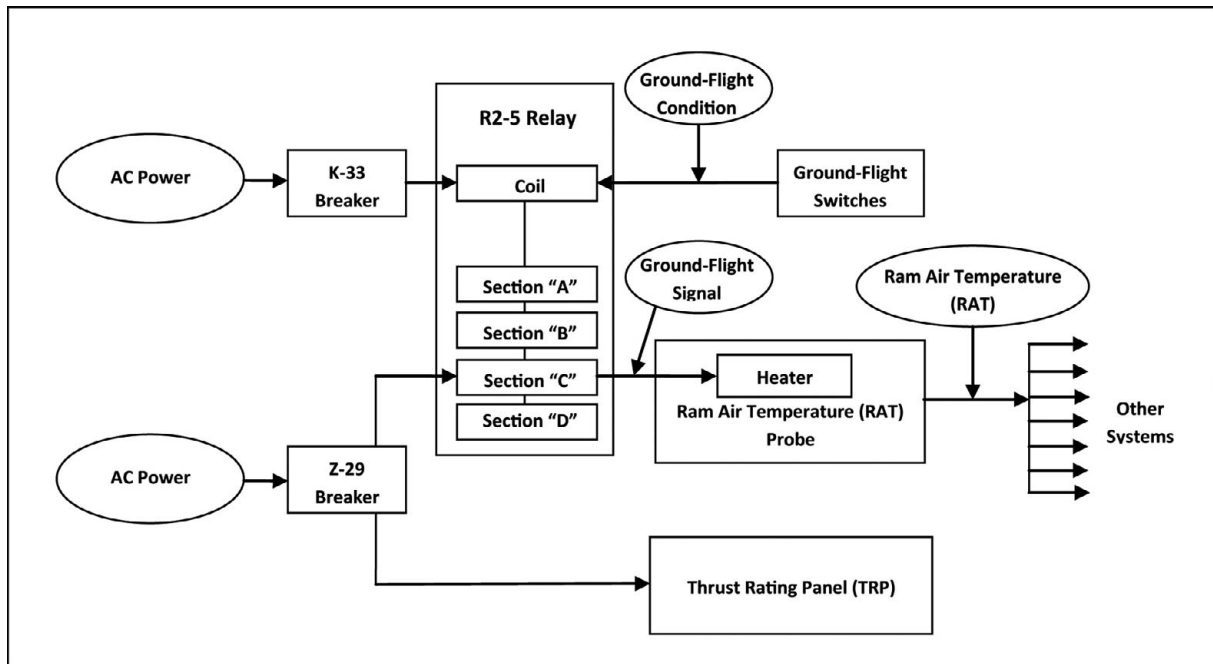
Figure 4. Diagram of the RAT probe heater

When the pilot engages the heaters using the rotary switch meter selector and heat, the heater receives AC power from a circuit which includes a circuit breaker that is found in position Z-29 in the lower panel located behind the LH seat in the cockpit and labeled as "Ram Air Temp & Probe Heater". This circuit is completed through the "C" section contacts of relay R2-5 in the left assembly of the ground sensing system, which removes the current when the aircraft is on the ground.

The RAT probe temperature is displayed on the central flight instrument panel, in the top part of the system display panel (SDP). If the system is not working properly and the heater is on with the aircraft on the ground, the probe will measure abnormally high temperatures while on the ground, far above ambient.

AC Power to the Thrust Rating Indicator Panel (TRI), which is part of the thrust Rating System (TRS), is also routed through the same Z-29 circuit breaker. This panel will not

function if it does not receive power, as a consequence of which the TRS will be unavailable and the auto throttle will not receive signal from the TRP and so the EPR setting is to be entered manually.
