## Report EXT Andorra 2011

Accident involving  
an AS 350 B3 helicopter,  
registration EC-LHP, operated  
by Heliand (CAT Helicopters),  
in Pleta de Juclar (Canillo –  
Principality of Andorra),  
on 15 June 2011

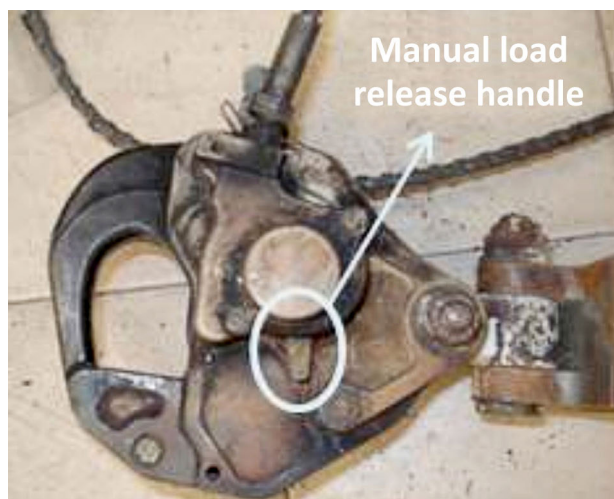
Figure 5. Load hook

The skids and the load hook cradle were facing up. Although subjected to the fire, they retained most of their structure, except for the bottom bar on the cradle, which was found with its rubber coating, and the aft part of the left skid, which was undamaged by the fire and found just ahead of the main wreckage (between it and the impacted pine tree). The aft part of the right skid indicated that the skid structure had been torn off by another metal component (see Figure 8). The load hook was in the closed position with no traces of the sling.

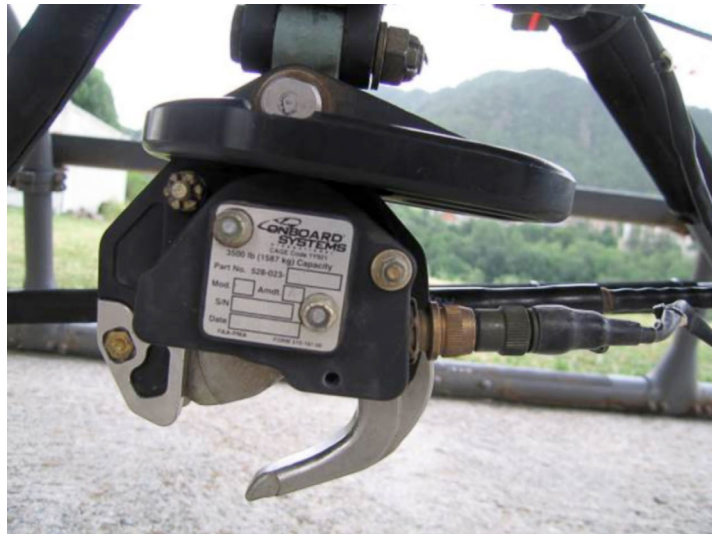
Figure 16. Hook similar to the one in the accident, in the open position

Both the helicopter pilot and mechanic were described as professional and methodical by their company colleagues and by the operators who were to be transported up to the refuge and who had worked with them before. It was possible that both confided in the know-how of the person who unhooked the load and assumed the sling had been detached without confirming this after the fact, as required by the procedures in Part A of the Operations Manual (see Section 1.17). The potential distraction provided by one of the cages almost tipping over and how this person was able to prevent it could have led the crewmembers to forget about the sling and to overlook the physical check, both in person and in the rearview mirrors. Though unlikely, it is also possible that the geometrical configuration of the assembly consisting of the hook and the sling hooking system (end piece, end cap and plastic identifying label on the sling) during the landing could have been such that, even though the hook opening system was armed and the hook opened, the end piece on the sling remained in the same position due to irregularities in the terrain of the staging area preventing the release of the sling. Had

this happened, however, the hook would have remained in the open position, making it easier for the sling to fall later during the flight. That is why this scenario is regarded as unlikely, though it cannot be ruled out.

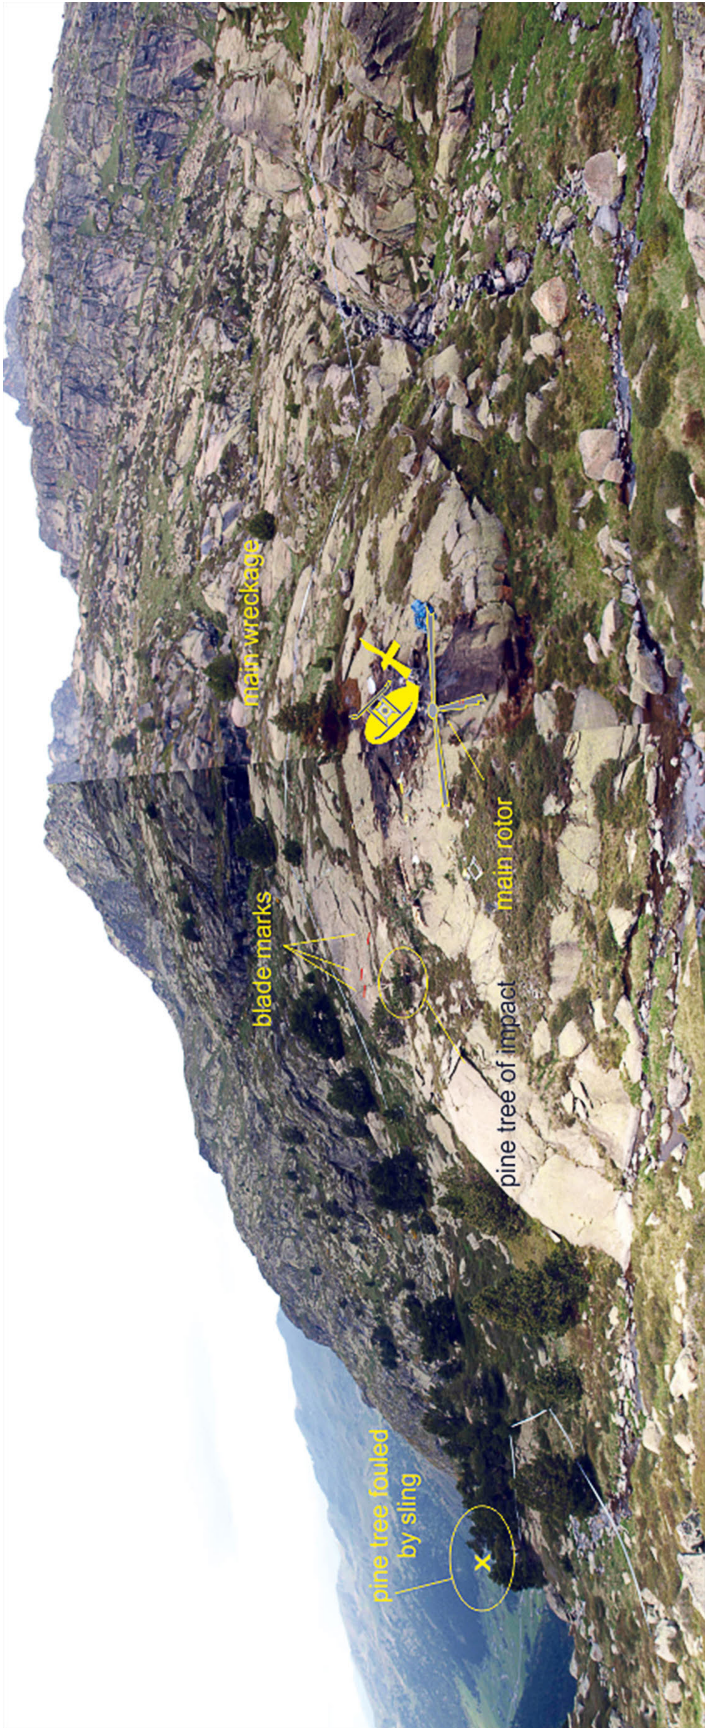
### **Debris field**

The main aircraft wreckage was found atop one of the crags. It was rotated at a 270° angle with respect to the flight path and upside down, with the helicopter's skids facing up (see Appendix B).

The sling was found on the other side of the stream, to the right of the helicopter's flight path and some 80 m away from the main wreckage. It was cut in two. The bottom part, of 4.5 m in length and with the safety hook still attached to it, was more or less aligned with the main wreckage. The remaining 5.5 m of sling was found with the ring for attaching it to the helicopter. It was about 25 m away from the other part, aligned with it and parallel to the helicopter's flight path.
